Re: Soil and Groundwater Testing Report for Layton Army Reserve Center
1125 NE 8th Avenue
Gainesville, Florida
Project No. 12-5373-04

FIGURE 1.
SITE LAYOUT SHOWING SAMPLING LOCATIONS
C.R. LAYTON USARC
GAINESVILLE, FLORIDA

The City of Gainesville/ Army Reserve Center Evaluation

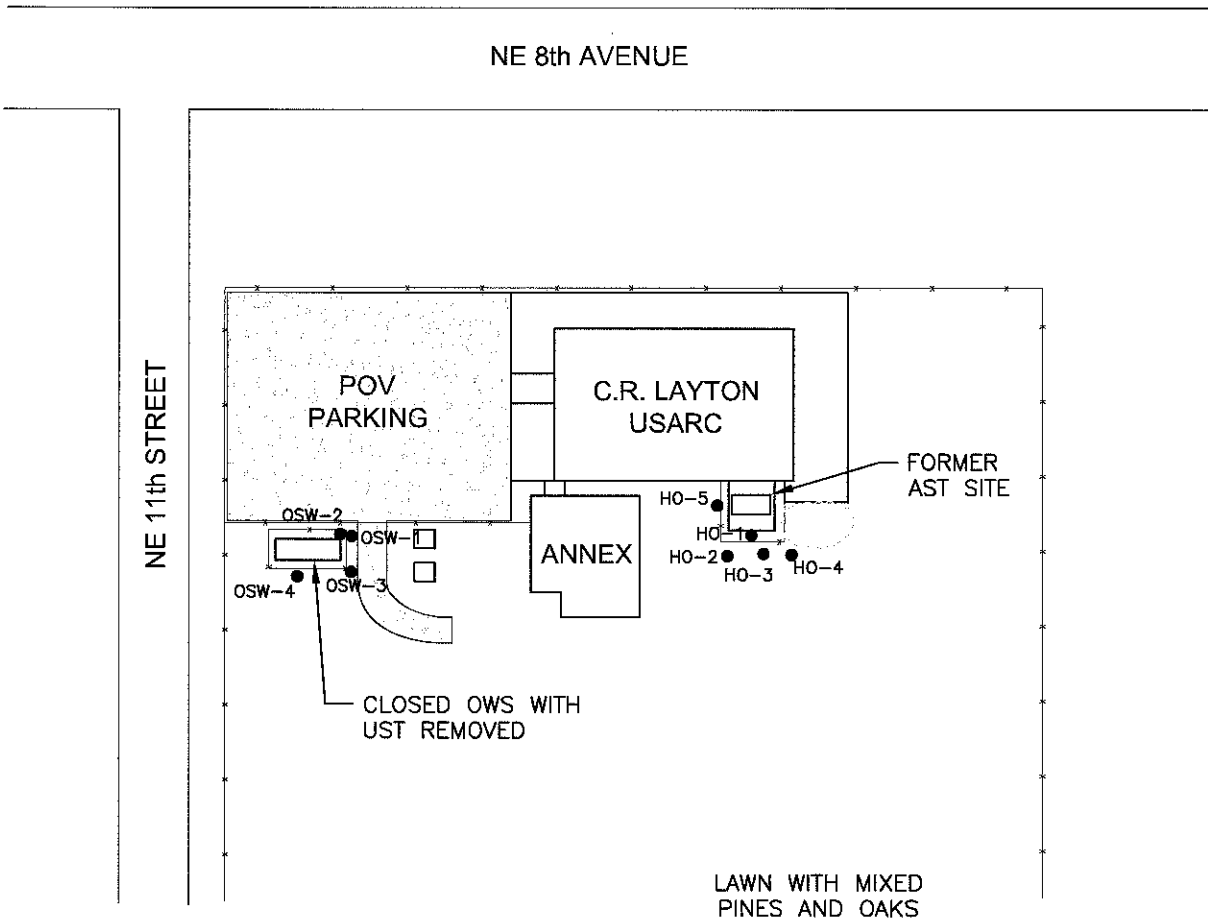
None of the soil samples collected registered readings above background levels on the OVM. The soil sample from the area of the oil/water separator (OSW-3-8) was collected above the water table from the boring located in the center of the former UST.

The former heating oil AST location was identified on a map forwarded by The City. The soil sample from the heating oil AST was taken above the water table from the boring located in the expected down gradient south end of the former tank pad.

Soil boring locations OSW-1 through OSW-4 and HO-1 through HO-5 are shown on Figure 1.

Soil analytical results from borings installed at the former oil water separator UST OSW-3-8, and heating oil AST HO-1-8 did not identify any parameters above the laboratory practical quantitation limits or the soil cleanup target levels (SCTLs) list in Florida Administrative Code (FAC) 62-777.

Groundwater analytical results from oil water separator UST OSW-1, OSW-3, and the heating oil AST HO-1 and HO-4 were reported below the laboratory practical quantitation limits and the groundwater cleanup target levels (GCTLs) set forth in FAC 62-777 for the parameters analyzed.

Based on the testing results of soil and groundwater in the REC areas of the former oil/water separator and the former fuel oil AST, no adverse impacts from these two areas were identified.
