CITY OF GAINESVILLE

OLD FIRE STATION 1
ASSESSMENT

SUBMITTED TO:
CITY OF GAINESVILLE

August 31, 2021

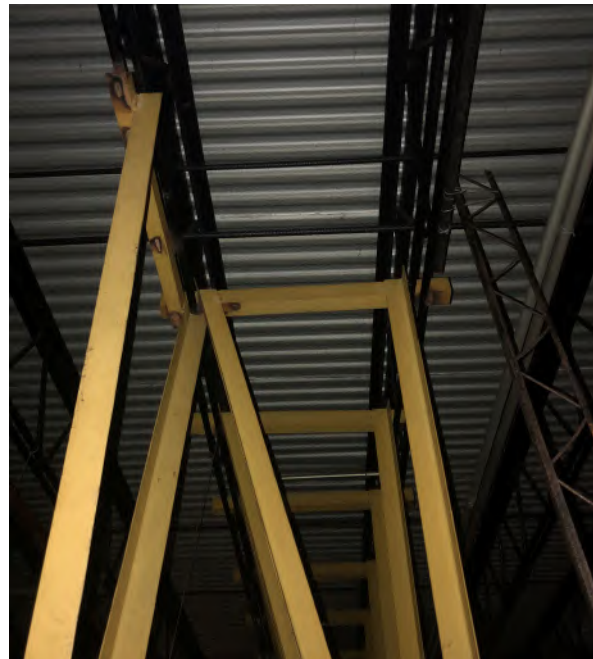
The building plan initially appears to have been intended to have an option for two pull-through bays on the first level; however, observations revealed no evidence of fasteners on the northeast facing bay that would indicate that a door was ever installed there. Therefore, we believe that the south bay has always been a pull-through bay, and the north bay has always been a shorter, back-in bay suitable for an ambulance. The remaining northeast quadrant of the ground floor includes a kitchen, and an area that appears to have been variously used as a day room, or as a training room. Observations above the ceiling found a system of supports that supported folding or moveable partitions. This indicates that the area was originally configurable for a number of different activities. The moveable partitions have been removed, and the ceiling / wall interface indicated that permanent partitions were installed at an unknown date in their current configuration.

Figure: The folding partition structural supports for a folding partition above the day/training room.

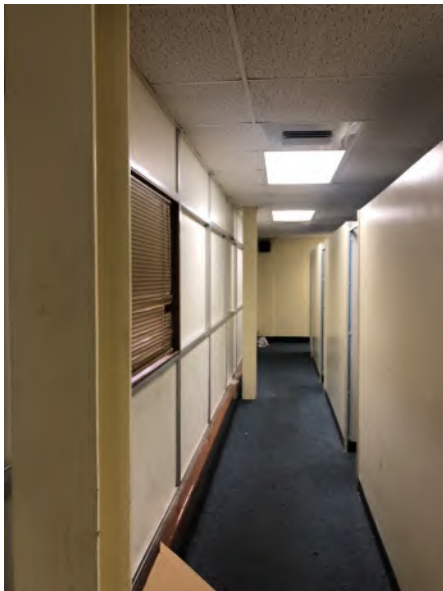
Figure: Second floor bunk area, showing sleeping cubicles on the right and wood siding (previously-open south-facing aluminum storefront) on the left.

All glazed openings in the building have been covered with a protective screen system that appears to have been intended as protection from wind-borne debris. The south-facing glass on the second floor has mostly been replaced with opaque panels from the interior, and wood siding has been installed over the entire storefront system on the exterior.

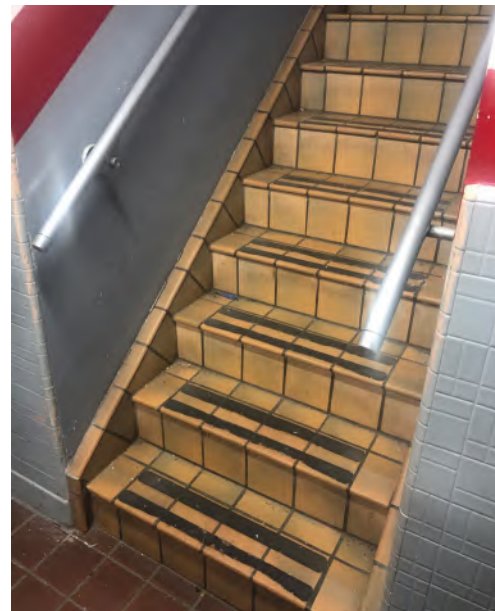
- 2) Stairway - The existing stairway is completely non-compliant, with tread depth and riser height dimensions that do not meet the basic building code requirements even for able bodied individuals. The stairway also lacks guards at the upper landing. The UF proposal indicates that the existing stair would be demolished and a new stair elevator core is planned, so this is recognized and would be addressed in that renovation plan.

Figure: Stair leading up to the second floor. Built at 39" wall-to-wall with 2" wide handrails.

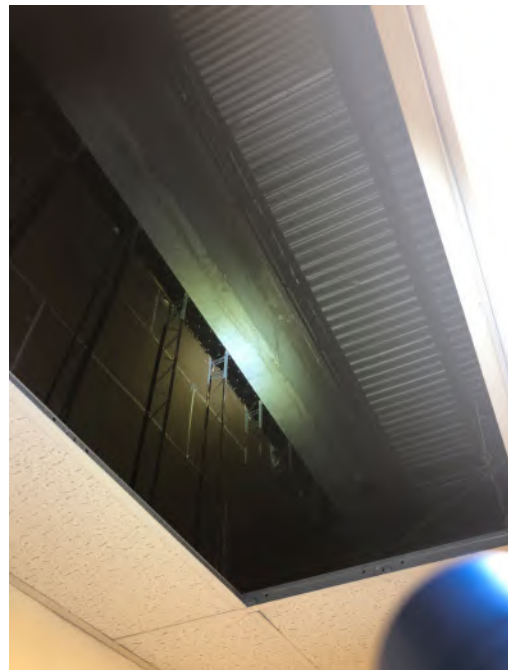
- 1) Wall Systems - In general, the exterior building envelope is masonry, and does not show signs of cracking or other deterioration. So, in terms of weather resistance, the building envelope is in satisfactory condition. Under the new use, insulation could potentially be added to the exterior walls on the interior face.
- 2) Storefront Systems - The existing storefront glazing has been covered over with a hurricane screening system intended to protect the glass from wind borne debris. This also cuts visibility through the glass, and detracts from the building aesthetic. In the attached budget analysis, it is assumed that all the existing glass would be replaced, in order to match the new storefront system that would be installed in the bay doors.

Figure: Removed ceiling panel reveals the masonry wall system with steel structural members.

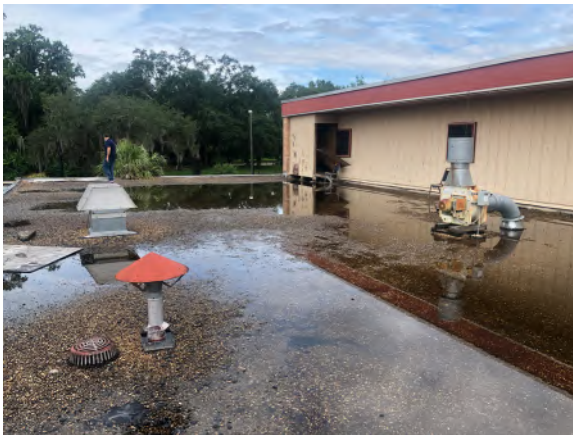
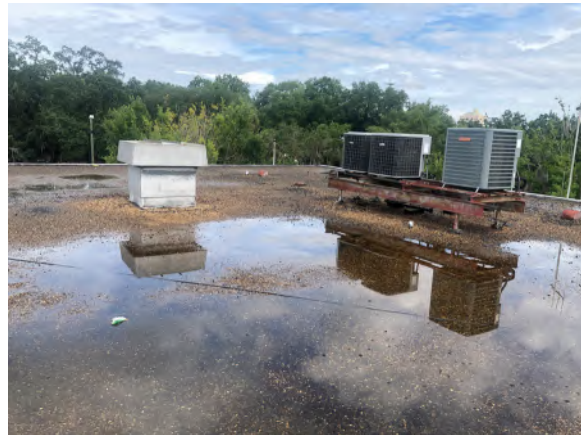
- 1) Roof System - There are two roof sections; one over the south apparatus bay, and the second over the second-floor crew quarters, which is a half story (only partially occupying the second level.) The existing roof system is a built-up roof (BUR) with internal roof drains. Given the age of the building, this roof is beyond the end of its expected service life. The roof condition is poor, and evidence of leaking was observed on the second floor, at the mechanical unit curb flashing. BUR systems have become less commonly installed on new buildings due to the high cost of installation, performance under high wind conditions, and health hazards to installers from kettle fumes. The recommended solution to replacing this type of roof would be to tear off the existing system down to the deck, and replacing with a two-ply modified bitumen system over tapered insulation to achieve positive slope to the roof drains. This replacement system would be less expensive to install, should provide a 20-year warranty, and would reduce the dead load (weight) supported by the roof structure.

Figures: Built-up-roof (BUR) and standing water. Despite the drain located in the lower left corner of the left photo, there is insufficient slope for draining excess water.

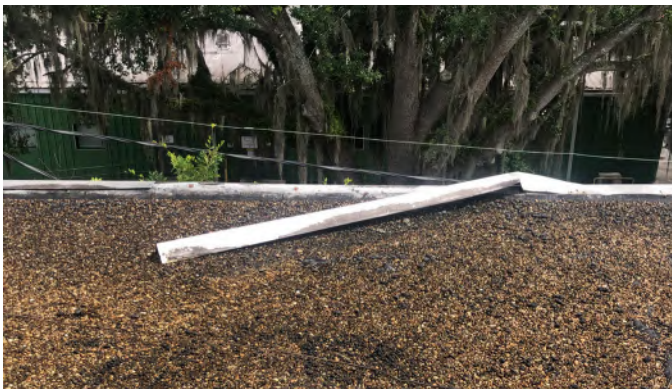
Figure: Damaged eave flashing as seen from the second floor roof.

- 2) Flashing - Several sections of the eave flashing have come away from the roof edge, and there is evidence of flashing failure at the HVAC unit on the second-floor roof. A new roofing system will include new flashing in all areas.
- 3) Slope/Drainage - The roof deck appears to have deformed, so water is not being directed to the drains, resulting in about 1.5" of ponding water on the roof surface, as it had rained heavily the day before.

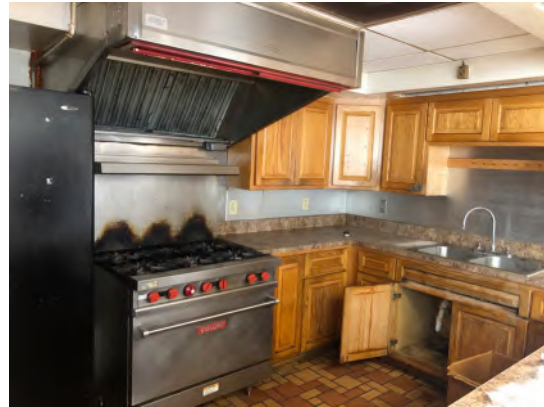
- 1) Casework - The existing casework is in poor condition. The casework observed is past its useful life, and replacement would be recommended if it were to remain in the current configuration.

Figure: Kitchen casework.

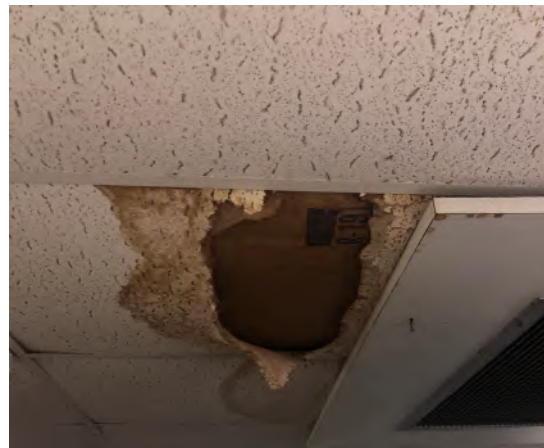
- 3) Thermal/Moisture - While no odors were encountered that would suggest persistent moisture or humidity problems, the existing garage bays are unconditioned, and so humidity levels have certainly fluctuated leading to condensation over the years. During regular usage with the bay doors frequently opened, passive ventilation would have flushed the air regularly. In the current storage usage, however, the doors are not regularly opened, so interior air quality has likely suffered. The proposed renovation would certainly introduce mechanical ventilation into this area, which would improve the air quality. Visible indications of roof leaking (staining) were observed on the second-floor ceiling. The second-floor ceiling system also has 4" thick fiberglass batt insulation laid on top of the ceiling, which is not the preferred method of providing insulation in horizontal assemblies. This insulation should be removed. The roof system recommended above would provide code compliant roof insulation above the structural deck.

Figure: Stained and damaged ceiling tile in the second floor bunk area.

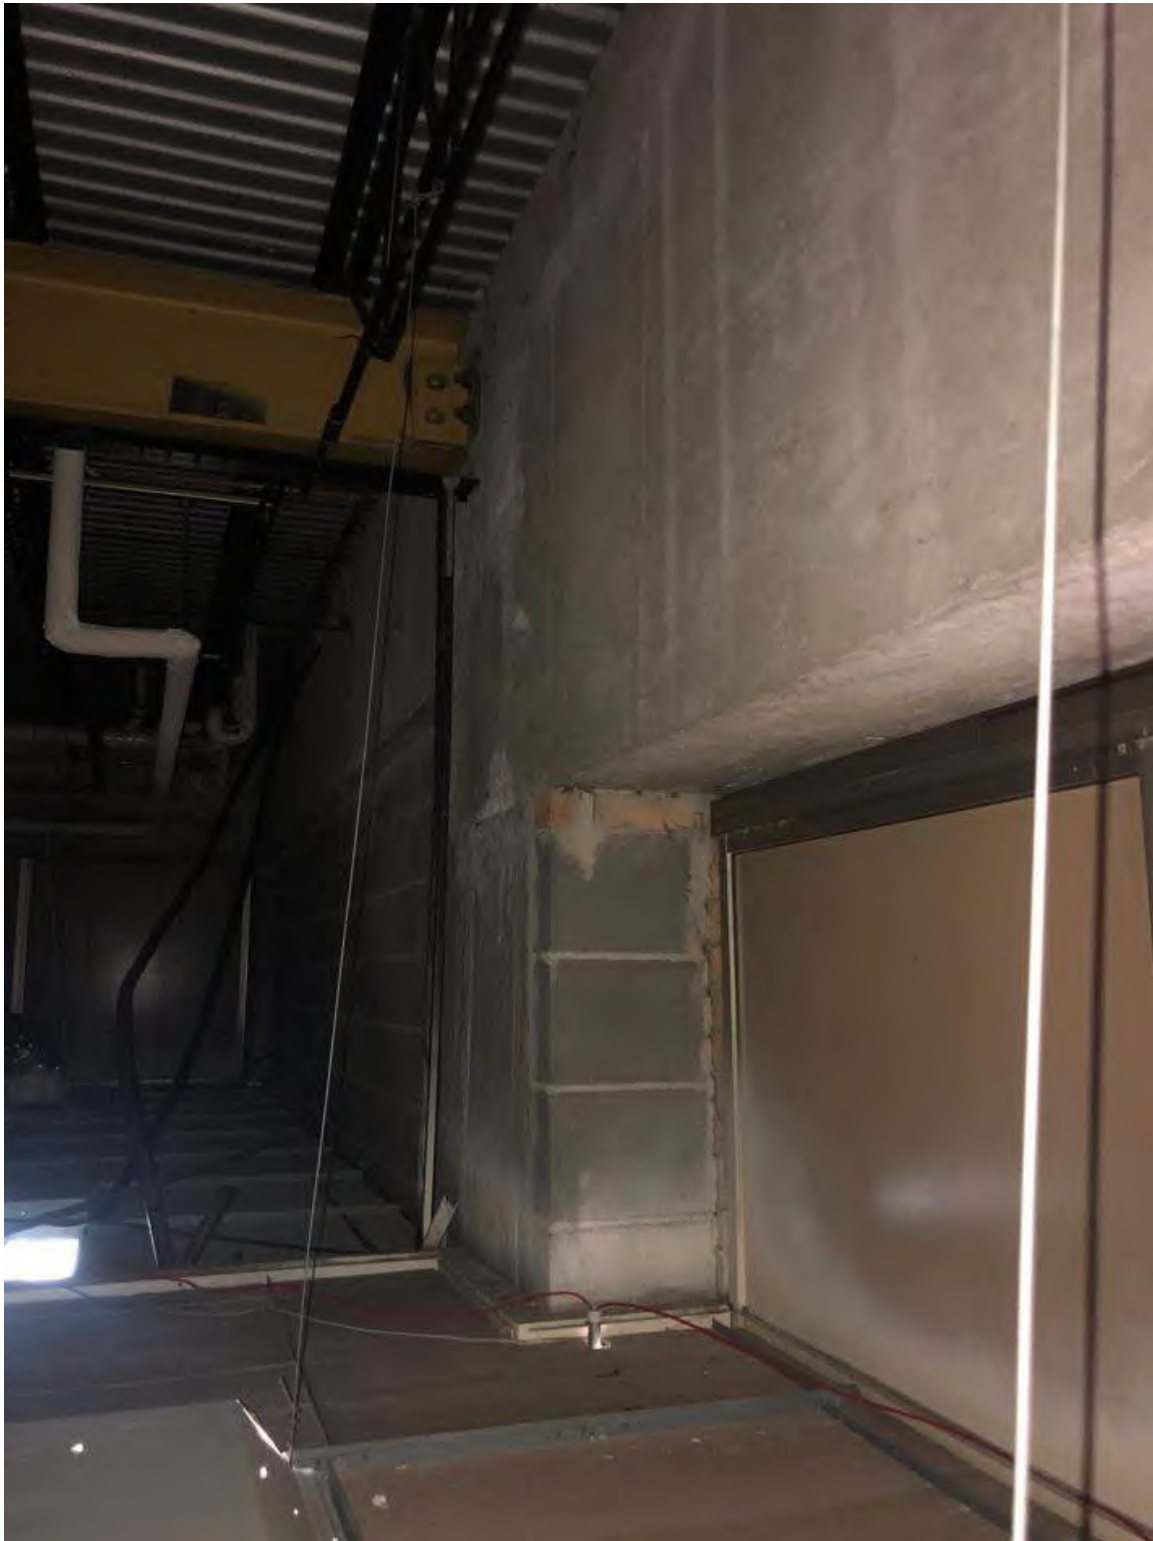
The structure of the building consists of load bearing 8" and 12" exterior masonry walls which have various depths of concrete tie beams/headers around the perimeter (see image 3). The interior support system consists of approx. 8"x6" steel wide flange columns (see images 4 and 5). These columns are consistent through the height of the building. The roof and floor framing for the respective sections of the building are noted below.

IMAGE 3: CMU WALL WITH PERIMETER CONC BEAM

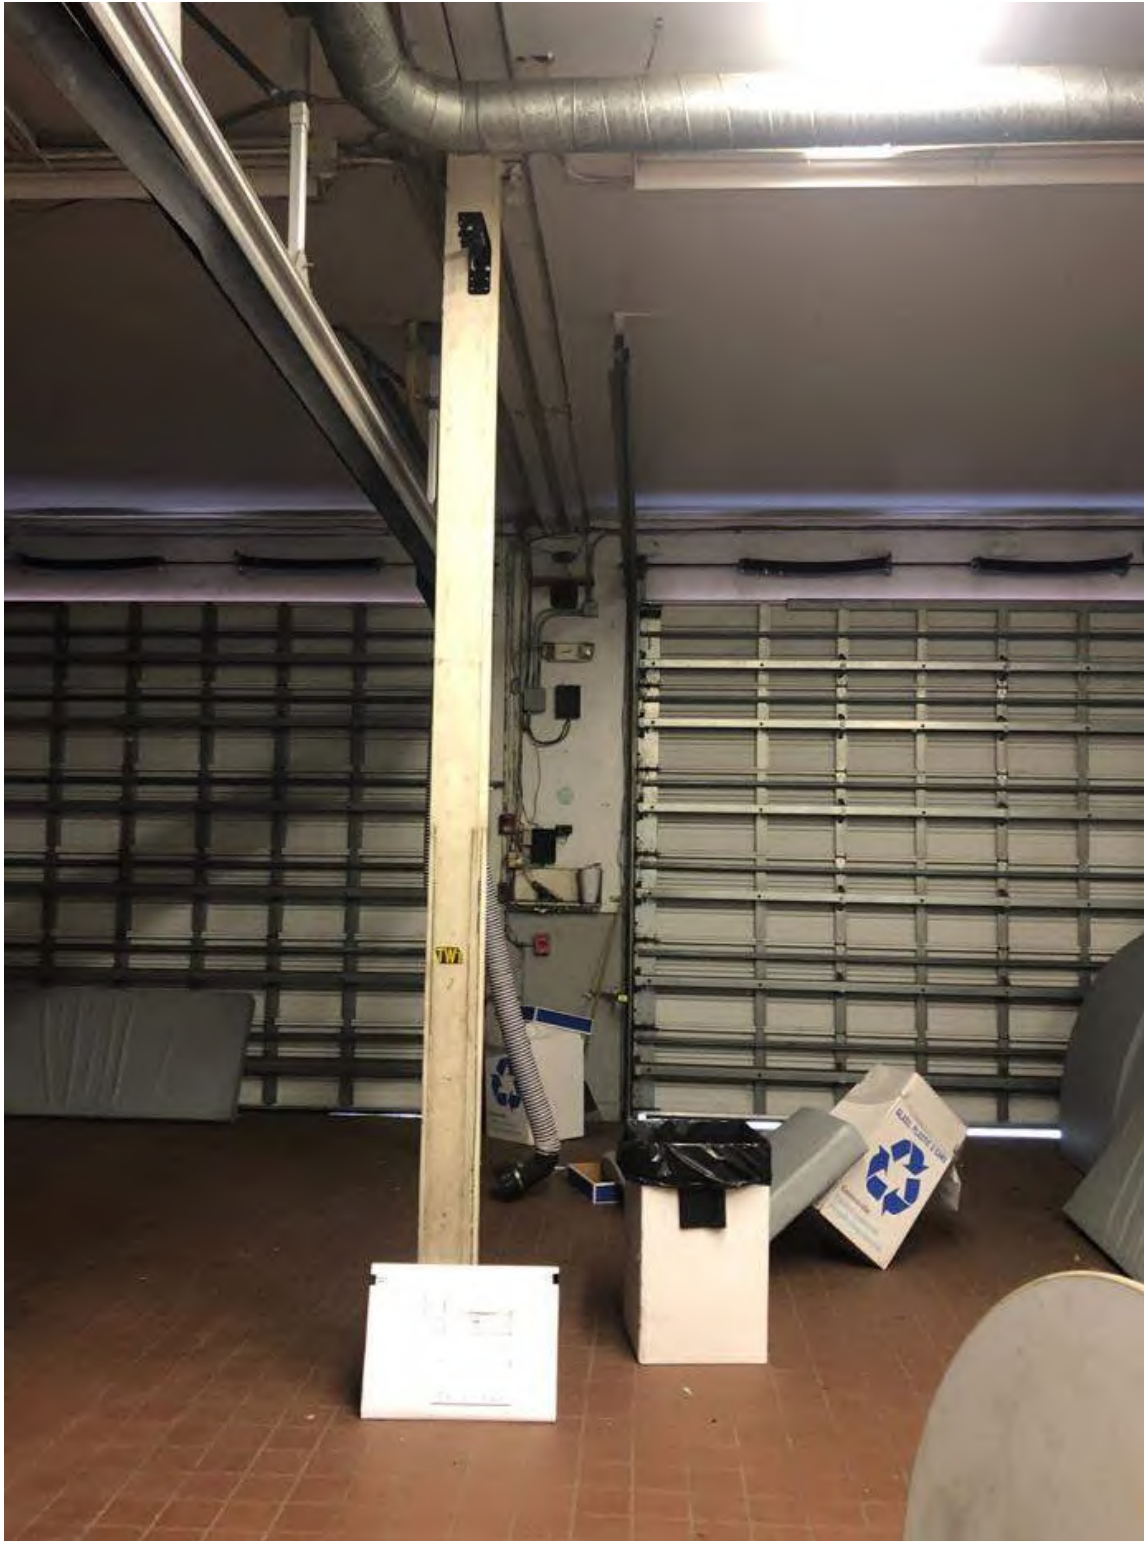
IMAGE 4: INTERIOR COLUMN IN APPARATUS BAY

- The steel column can either be removed and replaced with an 8"x8" wide flange steel column or reinforced by way of adding steel plates, steel channels, etc. or by providing a moment connection at the foundation.

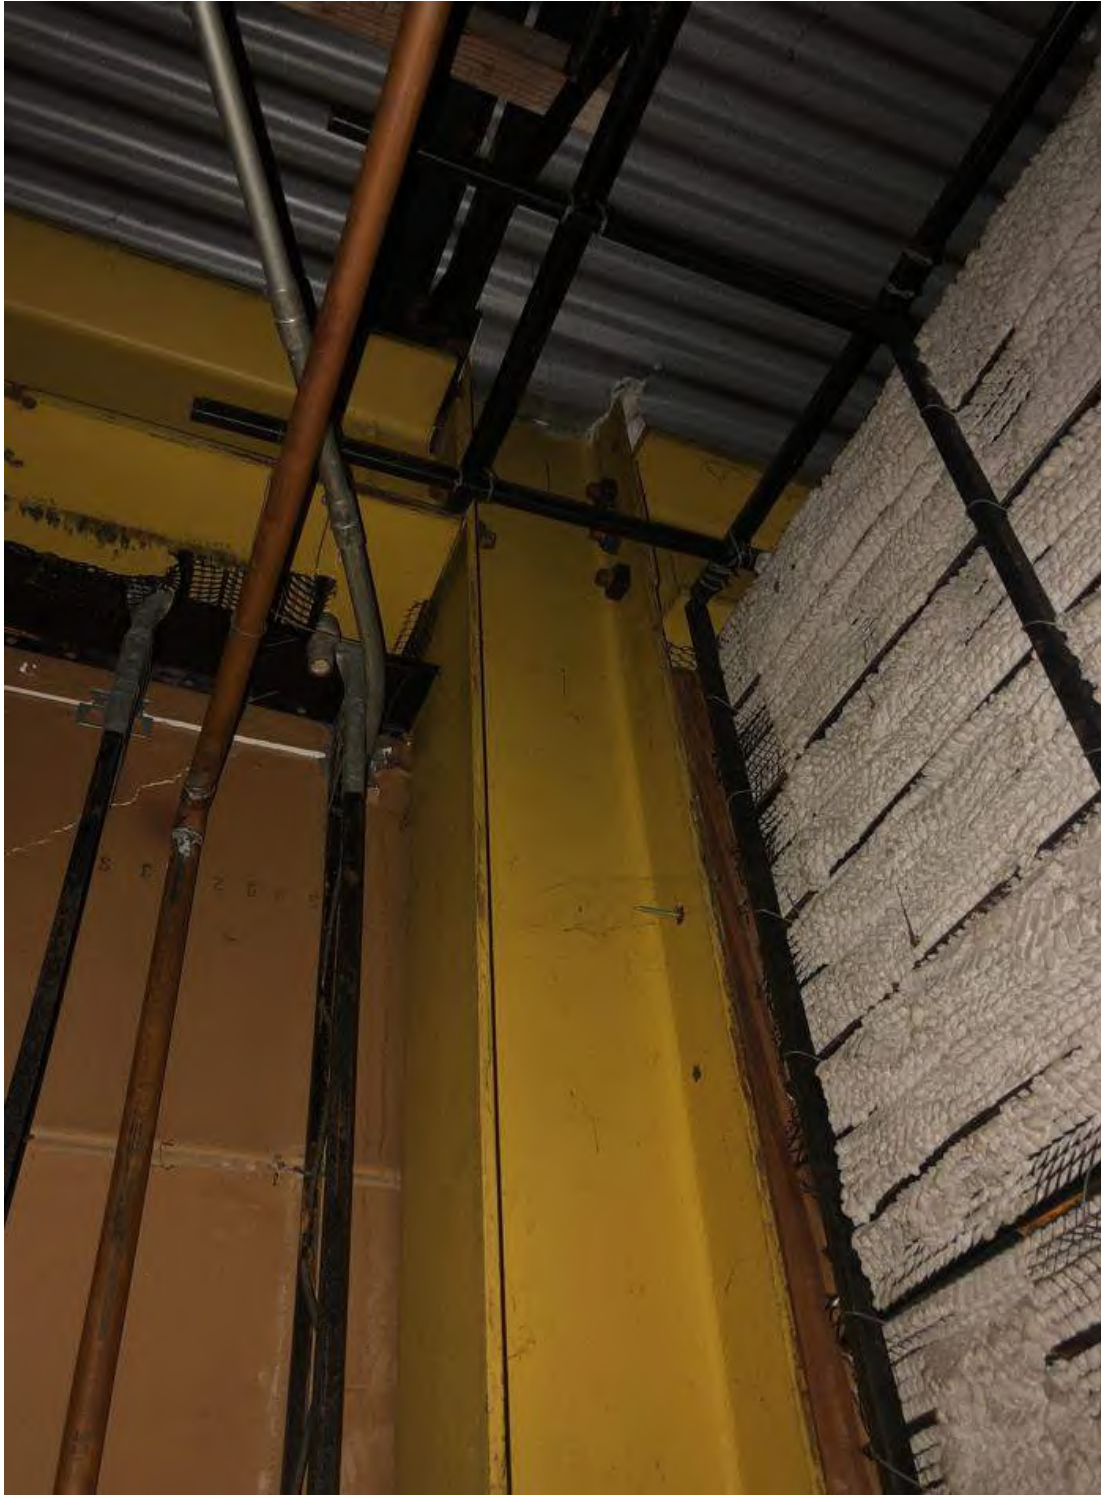
IMAGE 5: STEEL BEAM TO COLUMN CONNECTION

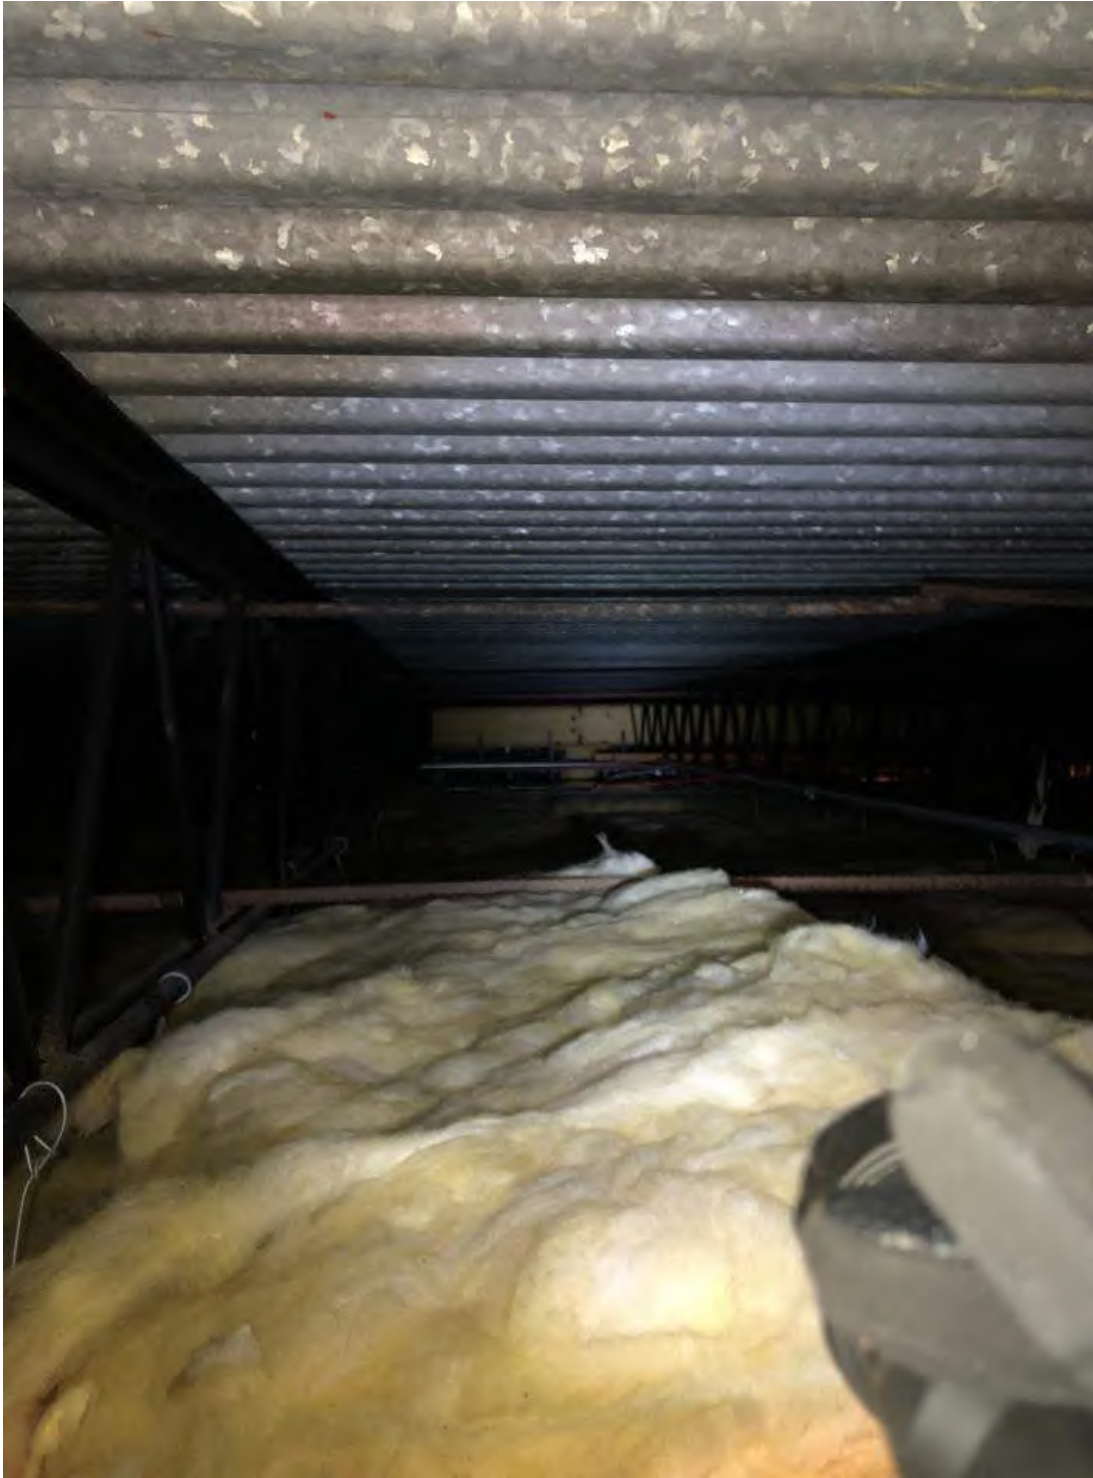
IMAGE 6: ROOF AND JOISTS OVER APPARTUS BAY

- After a preliminary analysis of the existing roof structure, it is our professional opinion that the existing roof framing is satisfactory for the current loading but will need to be removed and replaced for the proposed occupancy change as described in SPARC352. These are described in more detail below:
 - Remove and Replace with Non-Composite Deck – Option 1
 - Remove and replace existing deck with new 3 ½" concrete slab over ½" non-composite metal deck (4" total thickness).
 - Existing 14" deep steel joists to be removed and replaced with new 24" deep steel joists spaced at 2'-0" oc.
 - Existing 8" deep steel joists to be removed and replaced with new 10" deep steel joists spaced at 2'-0" oc.

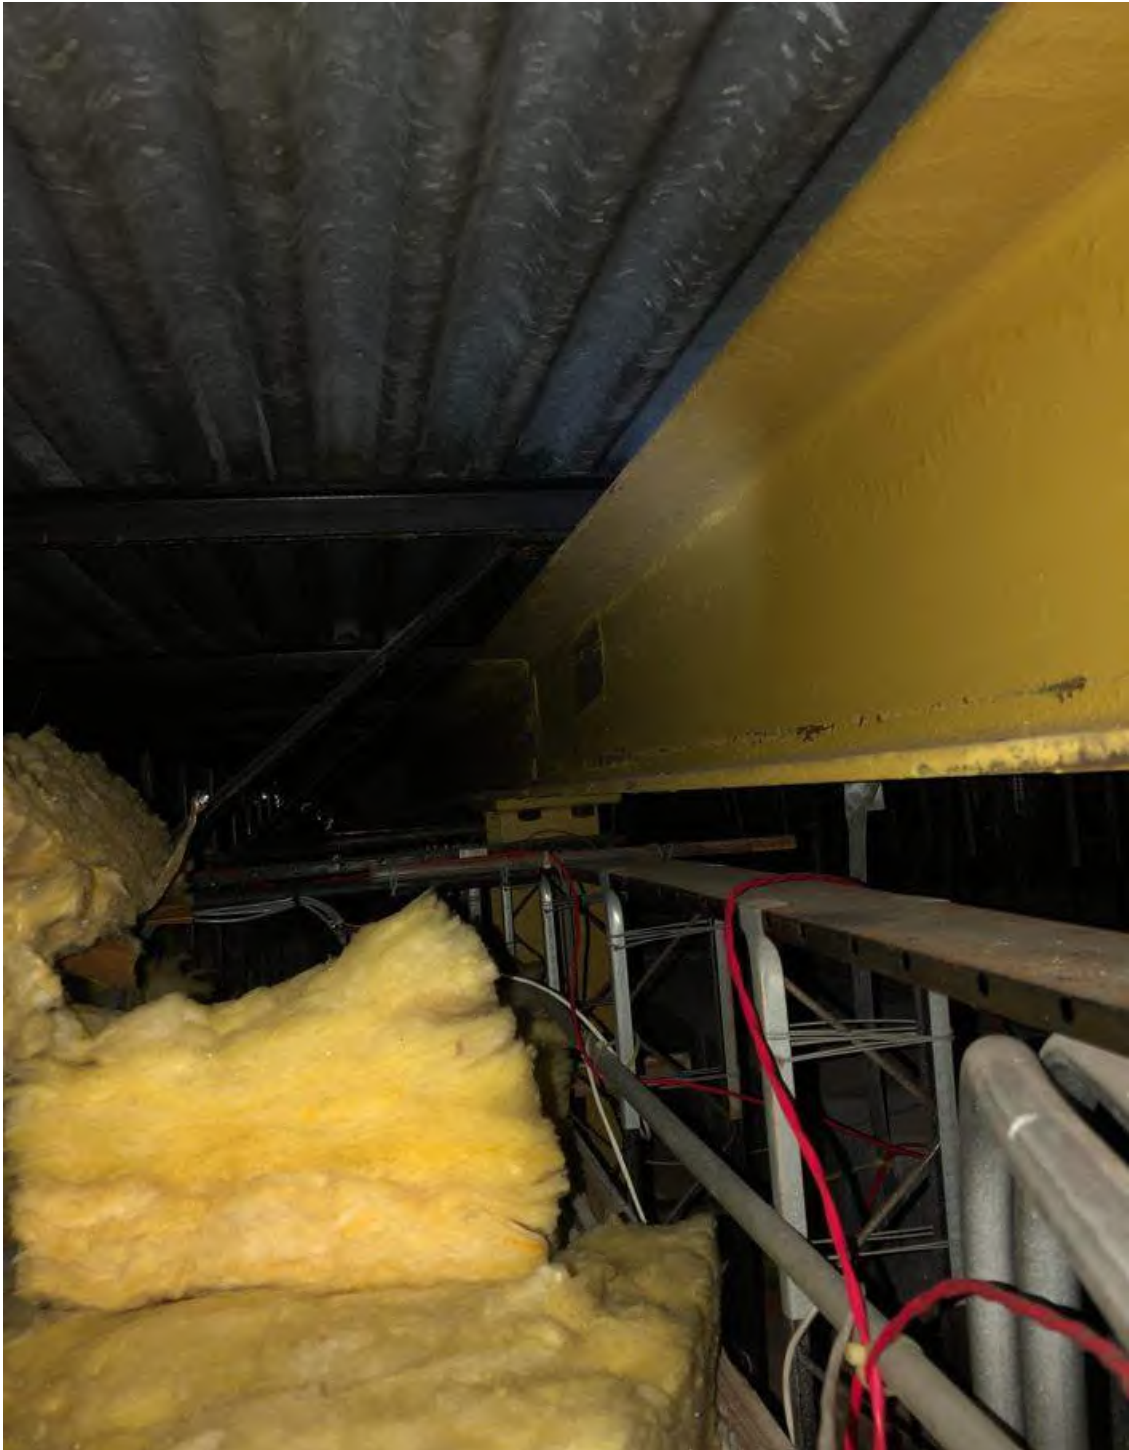
IMAGE 7: ROOF STEEL BEAM OVER STEEL COLUMN

- Steel girder can either be removed and replaced with new 16" deep steel wide flange or can be heavily reinforced by way of adding steel plates, steel WT beams, etc.

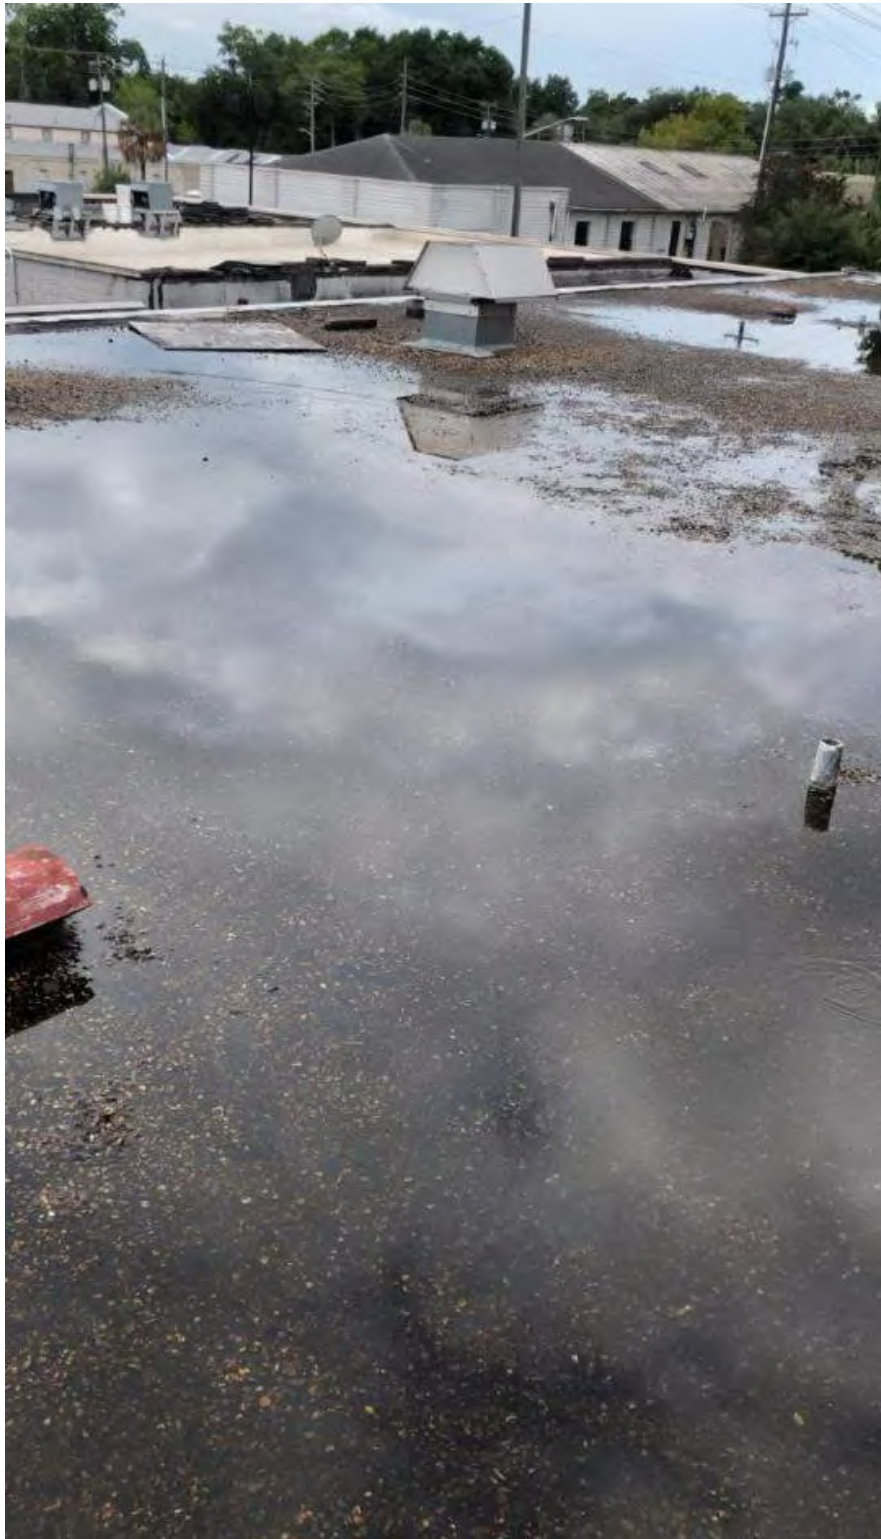
Within the main building, the structural elements were in good condition. There were no noticeable signs of structural damage or water intrusion; however, there were large puddles of standing water on both the low roof and the high roof, indicating deflection due to ponding or improper slope/drainage.

IMAGE 8: STANDING WATER ON ROOF OVER APPARATUS BAY

- There were no signs of structural damage due to the standing puddles of water, however; the standing water indicates poor drainage or insufficient slope. It is recommended that the drainage and roof slope be modified.

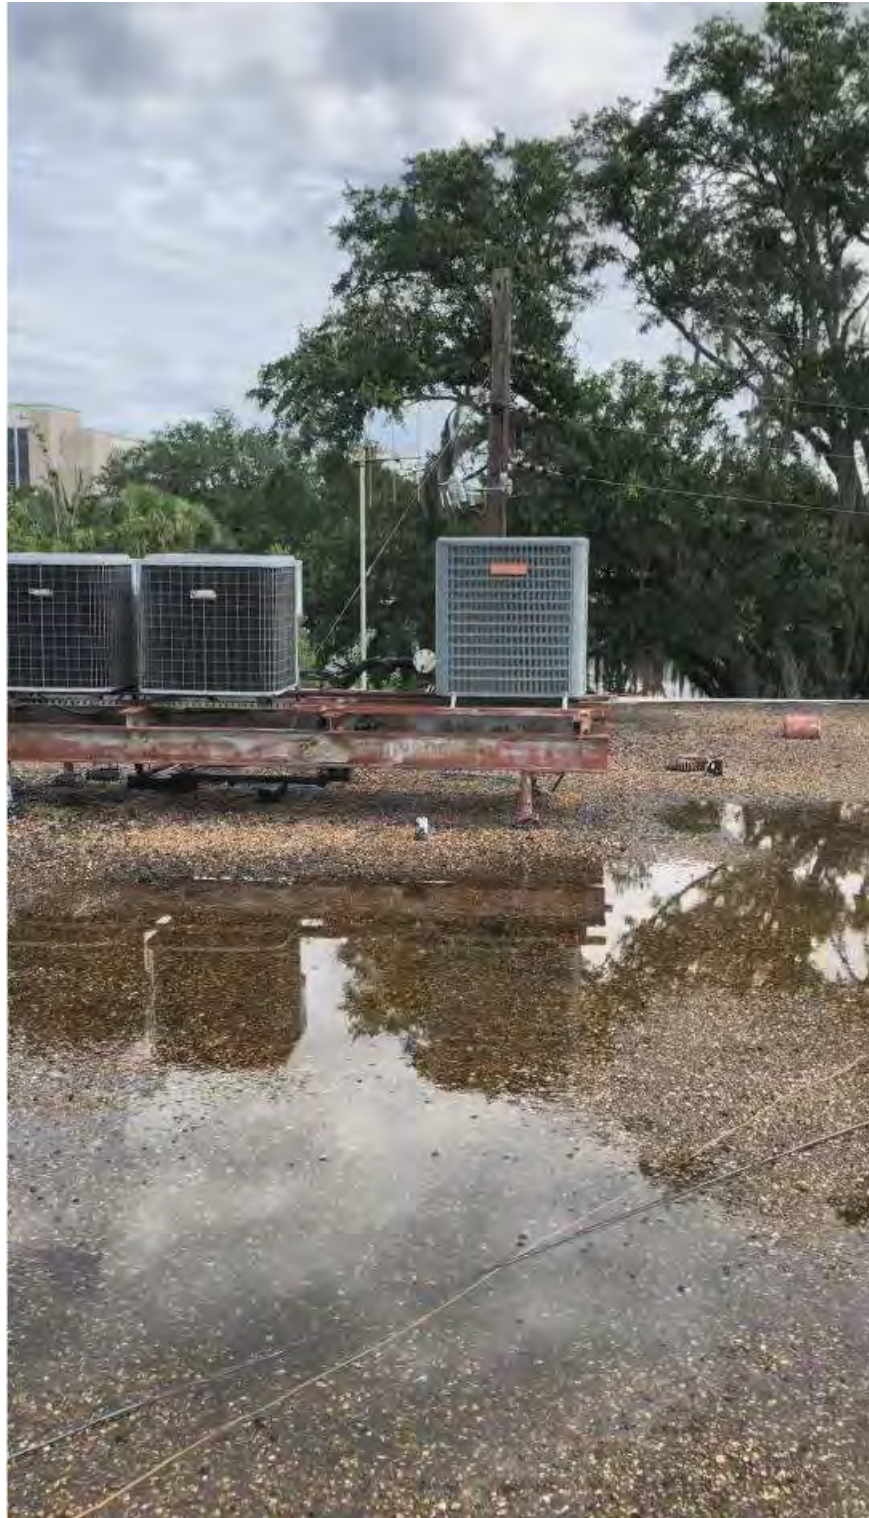
IMAGE 9: STANDING WATER ON ROOF OVER TWO-STORY SPACE

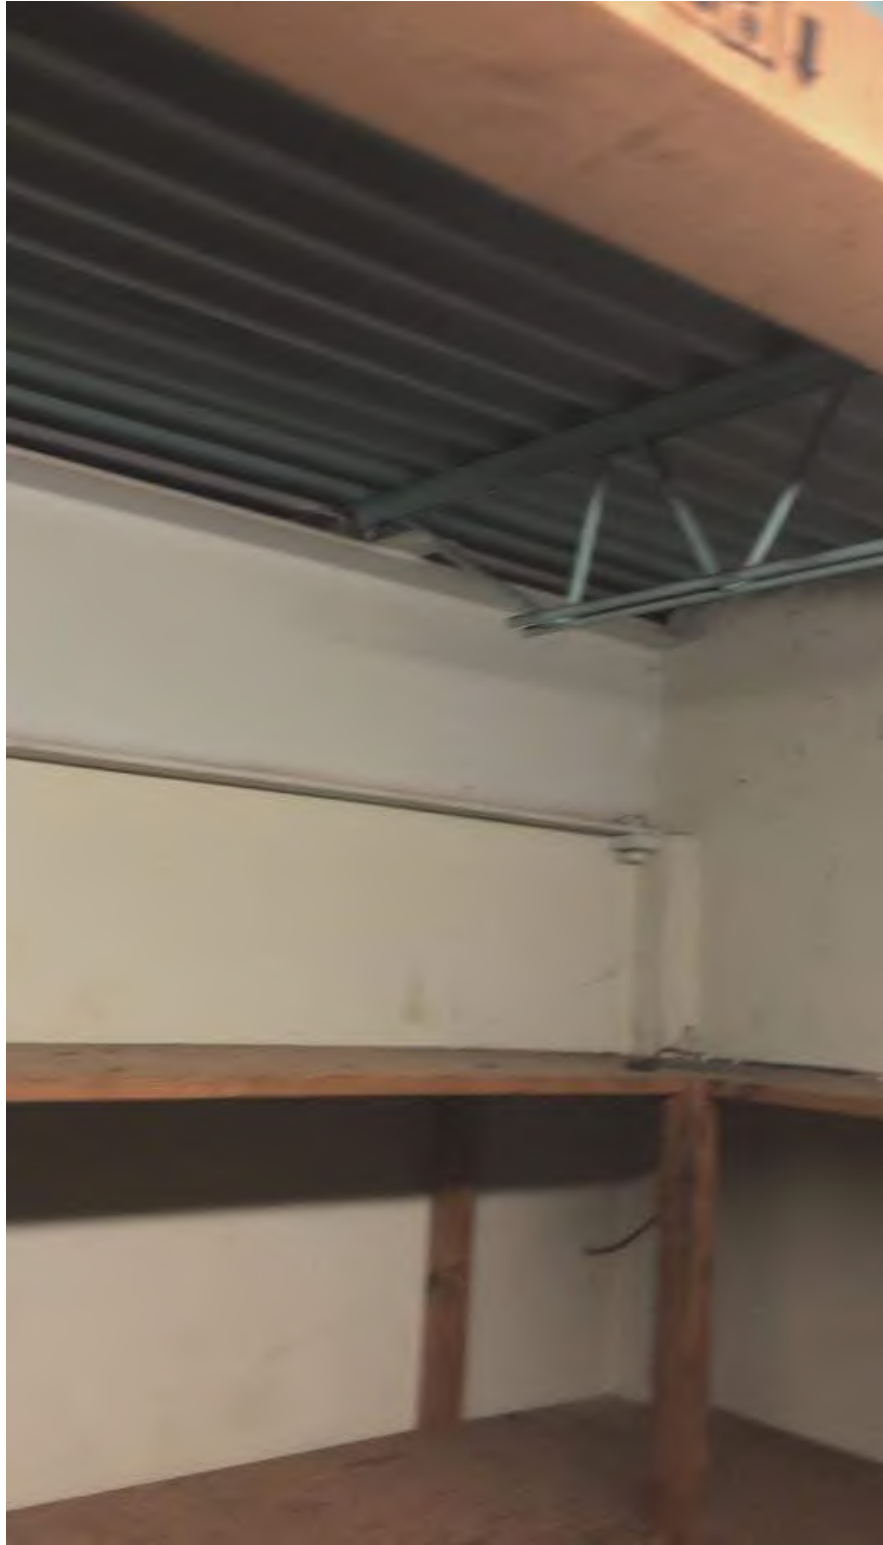
IMAGE 10: STEEL JOIST ON STEEL GIRDER BETWEEN APPARATUS BAY AND STORAGE ROOM

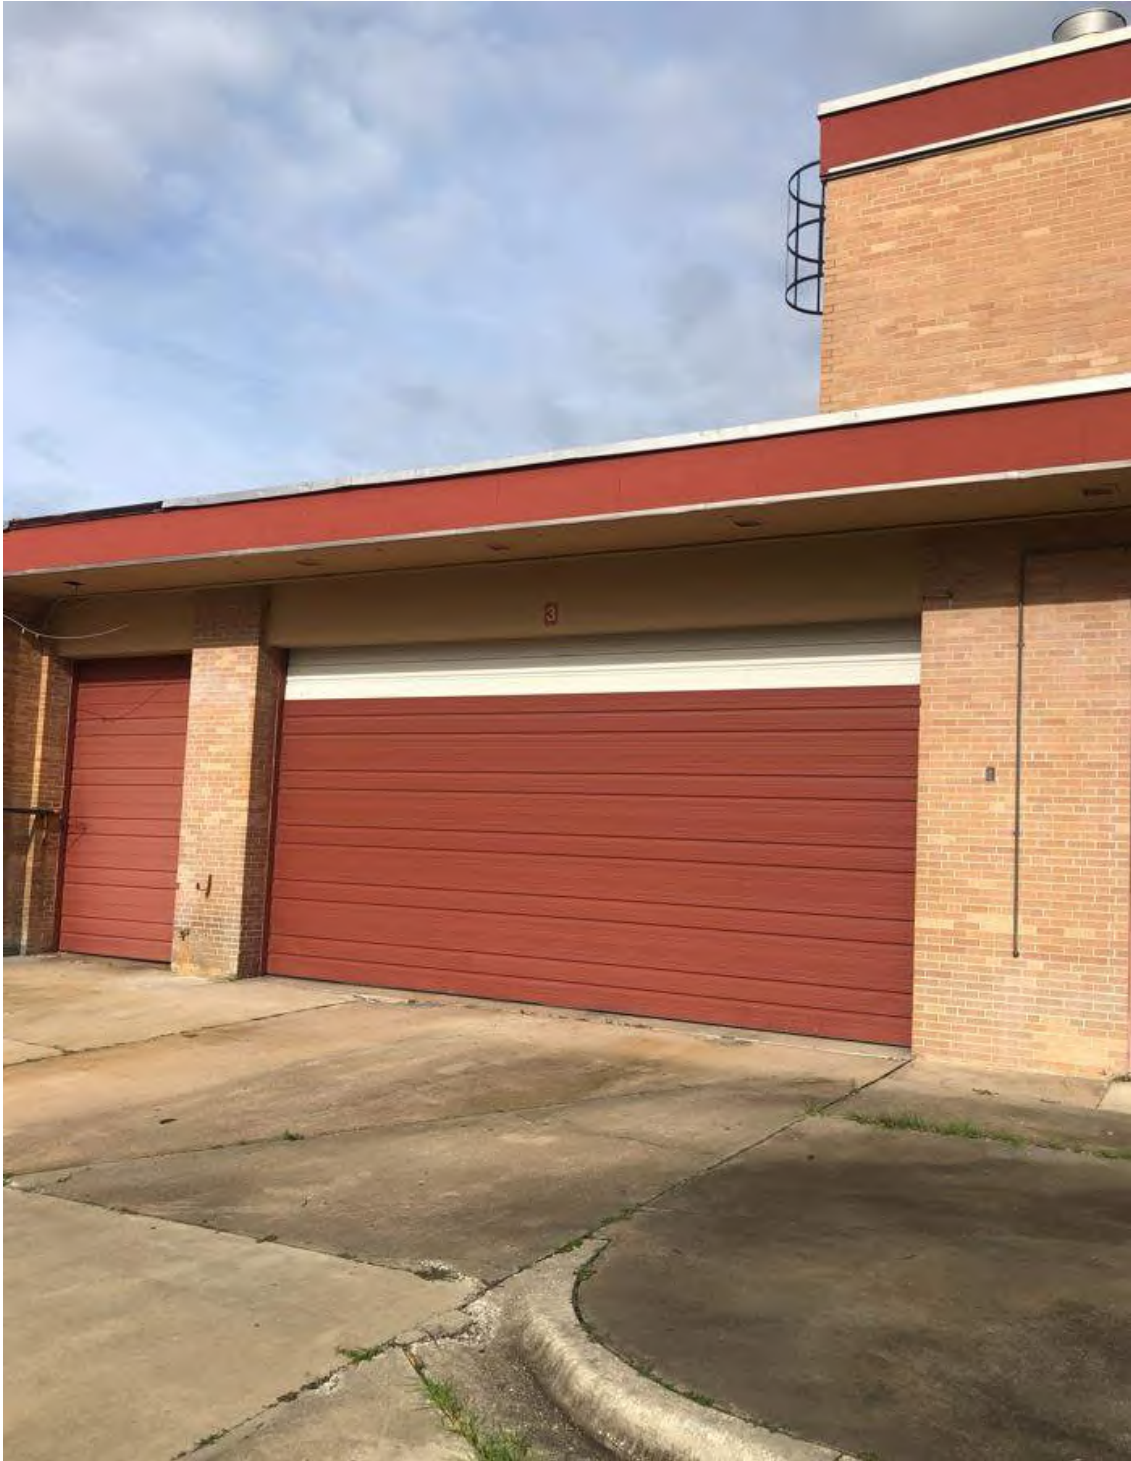
IMAGE 11: EAST EXTERIOR FACE OF BUILDING

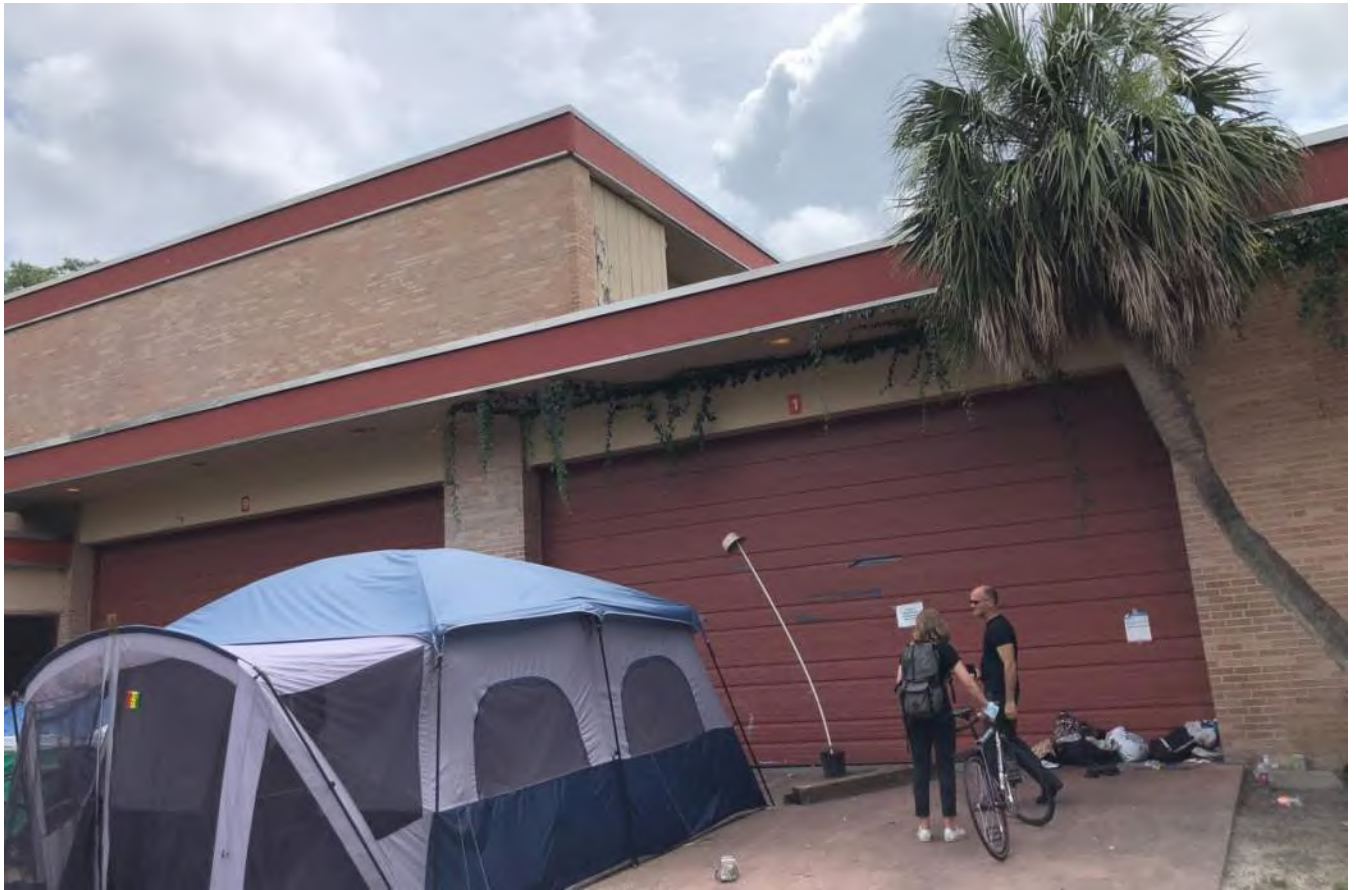
IMAGE 12: WEST EXTERIOR FACE OF BUILDING

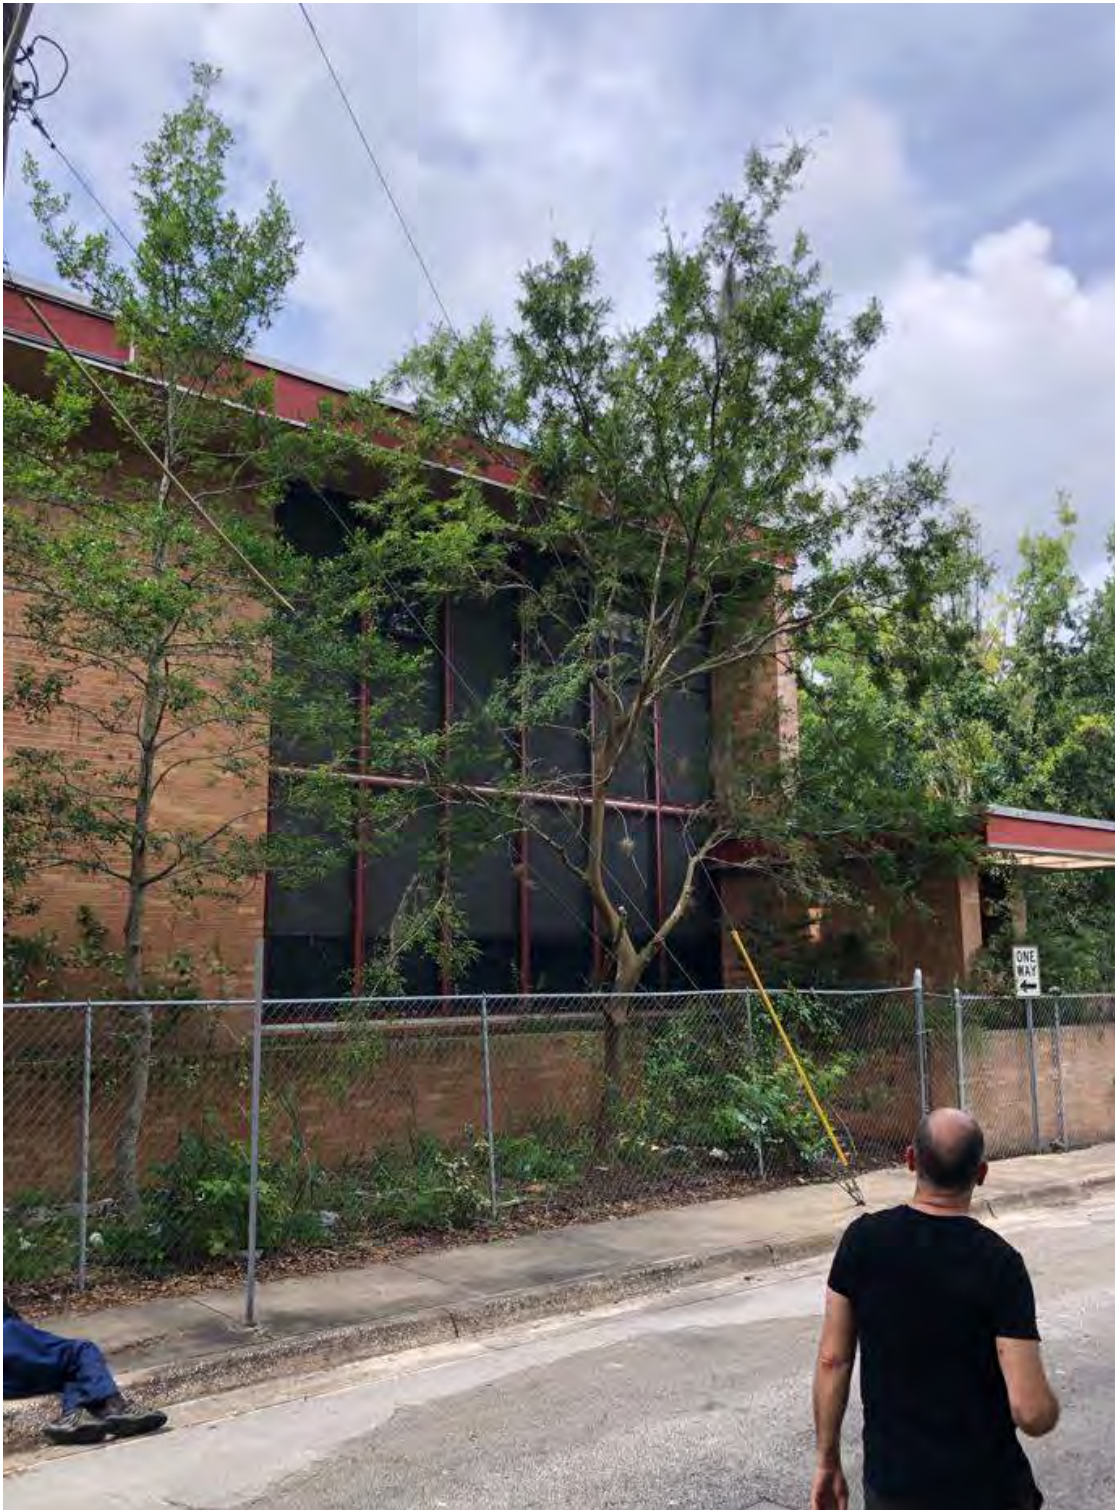
IMAGE 13: NORTH EXTERIOR FACE OF BUILDING
