**SPUTO AND LAMMERT ENGINEERING, LLC**  
STRUCTURAL ENGINEERS  
1731 NW 6<sup>th</sup> STREET, SUITE D, GAINESVILLE, FL 32609  
PHONE: 352-378-0448 FAX: 352-373-1331  
E-MAIL: salestructures@gmail.com

26 October 2021

Re: Thelma Boltin Center, 516 NE 2 Ave, Gainesville, FL - Partial Roof Collapse

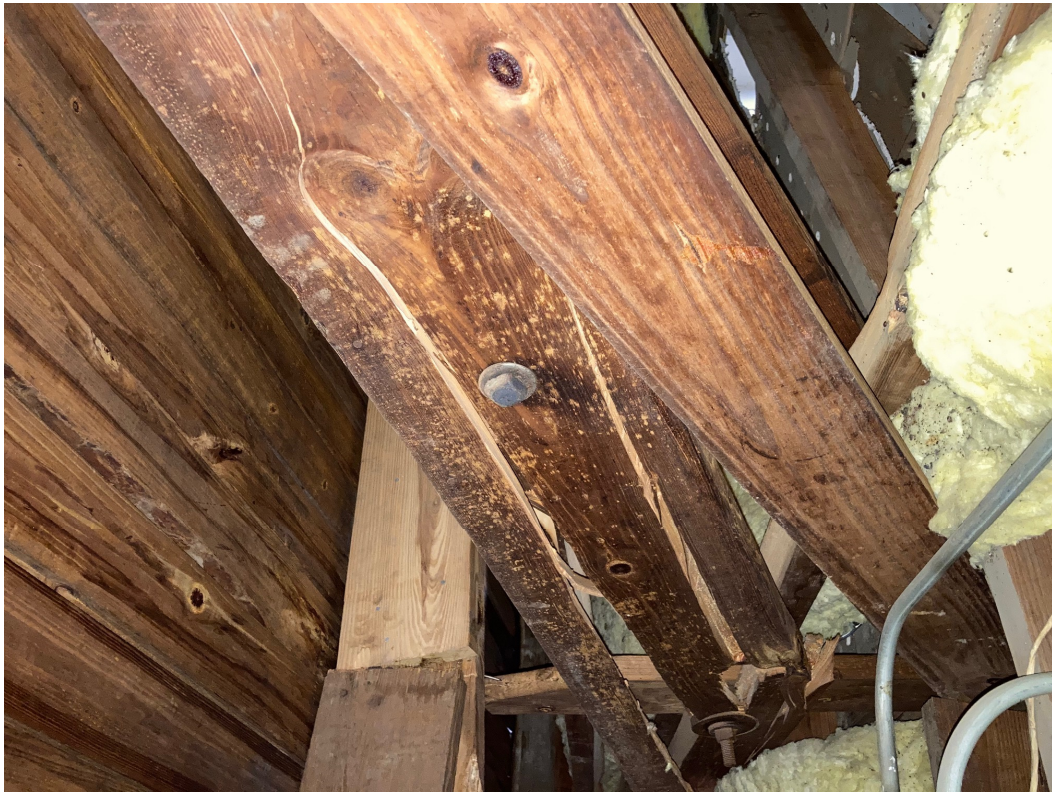
During the initial observation visit on 08 January, it was apparent that the roof over the auditorium stage had sagged approximately 8 to 12 inches. Accessing the above-ceiling space showed that the truss over the stage had suffered a catastrophic failure at the west end. The last two truss panels had failed and had wedged themselves into a temporarily stable condition by pressing against themselves and the exterior wall. I recommended that the truss be properly shored to prevent a sudden complete collapse.

Due to the limited access and safety concerns, I was unable to definitively determine where the failure began, however from previous experience with similar damaged trusses and from the literature, the failure may have originated where a longitudinal crack intersected a bolt at a connection.

Figure 1. West end of truss

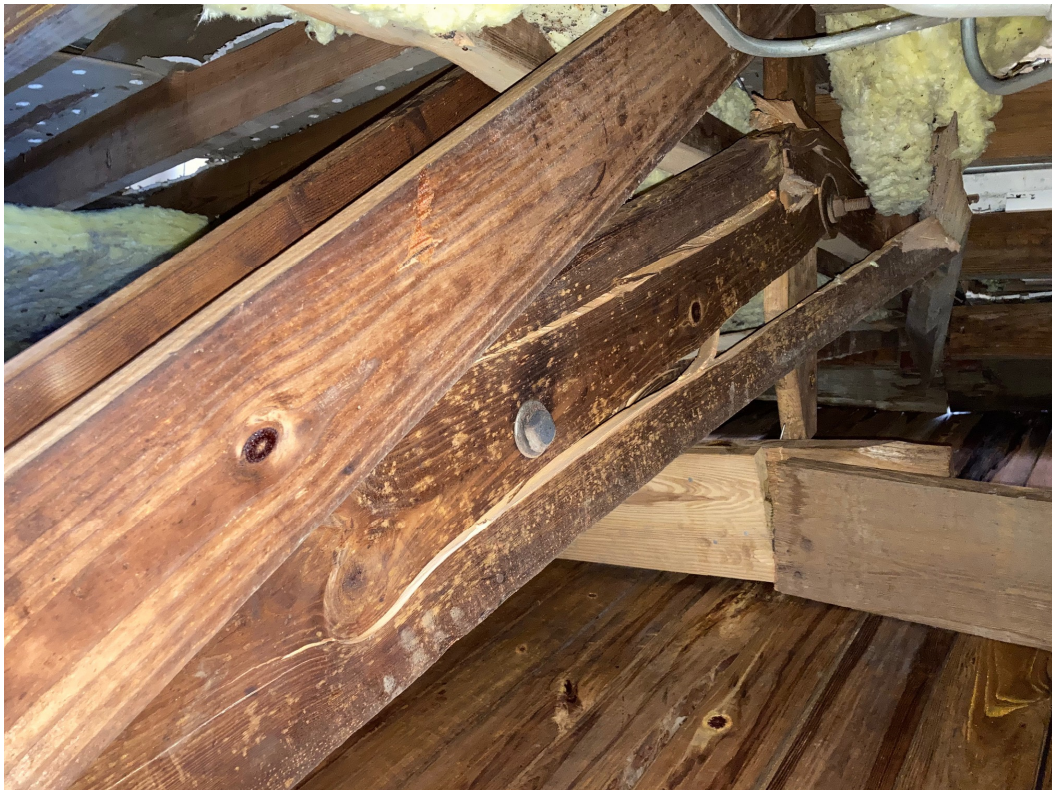
Figure 2. West end of truss

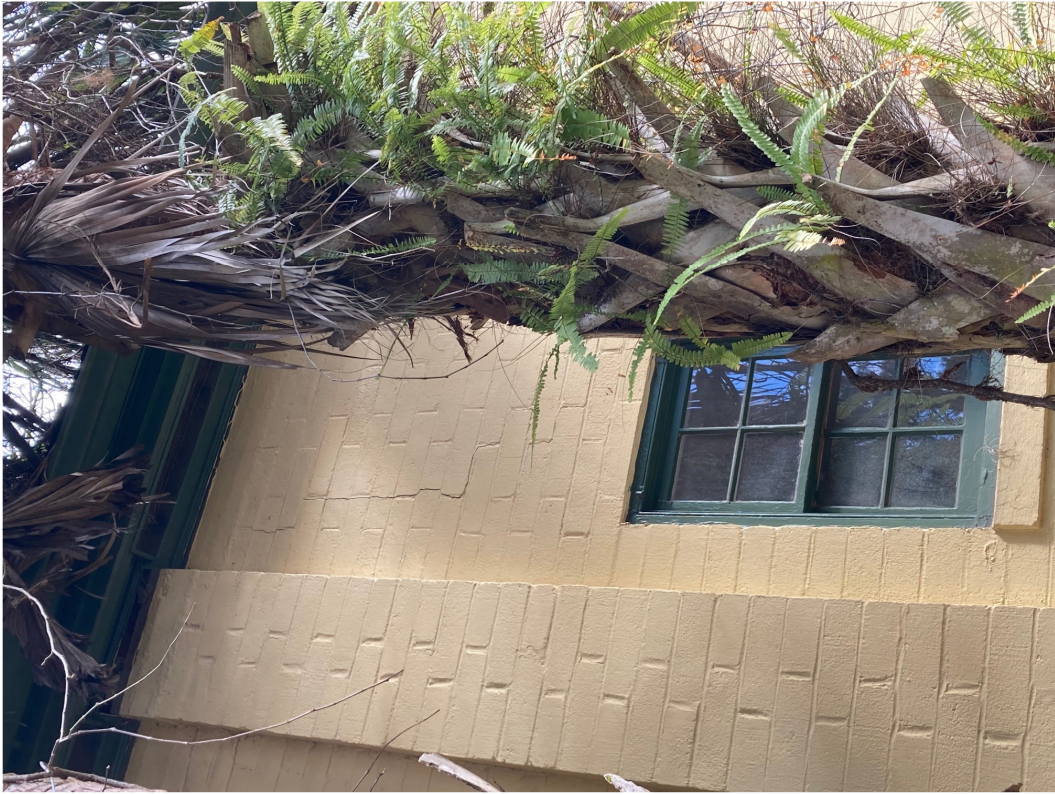
Figure 3. Exterior masonry wall with crack

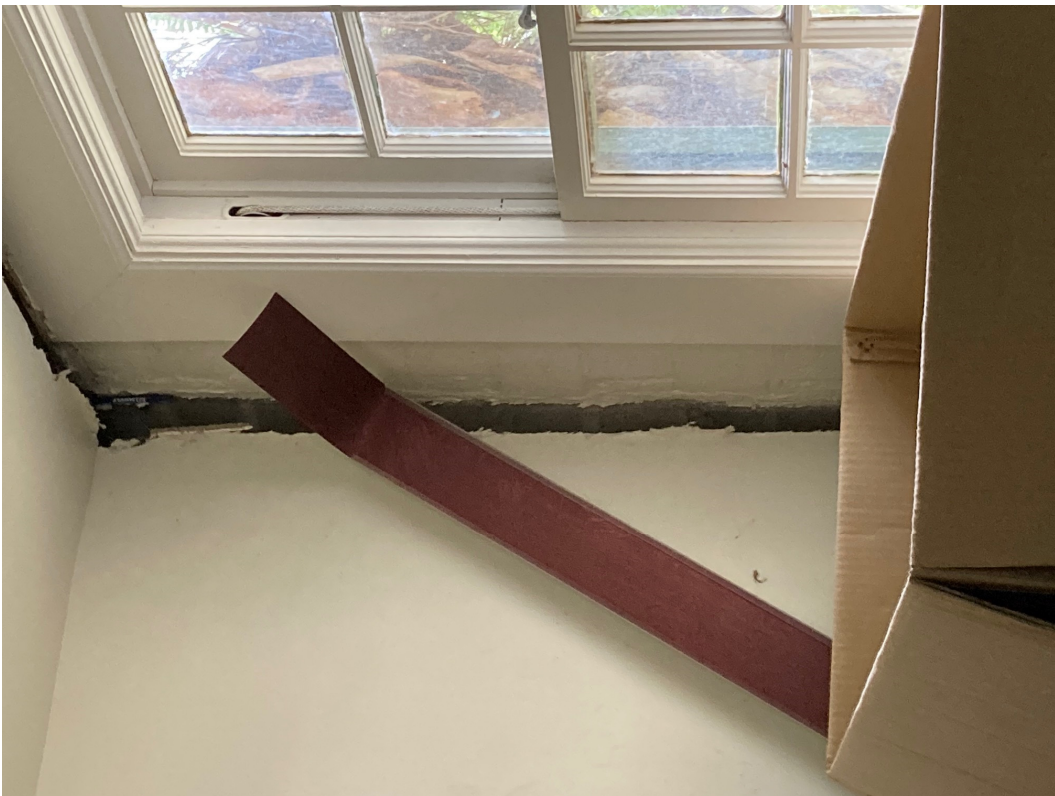
Figure 4. Interior wall damage

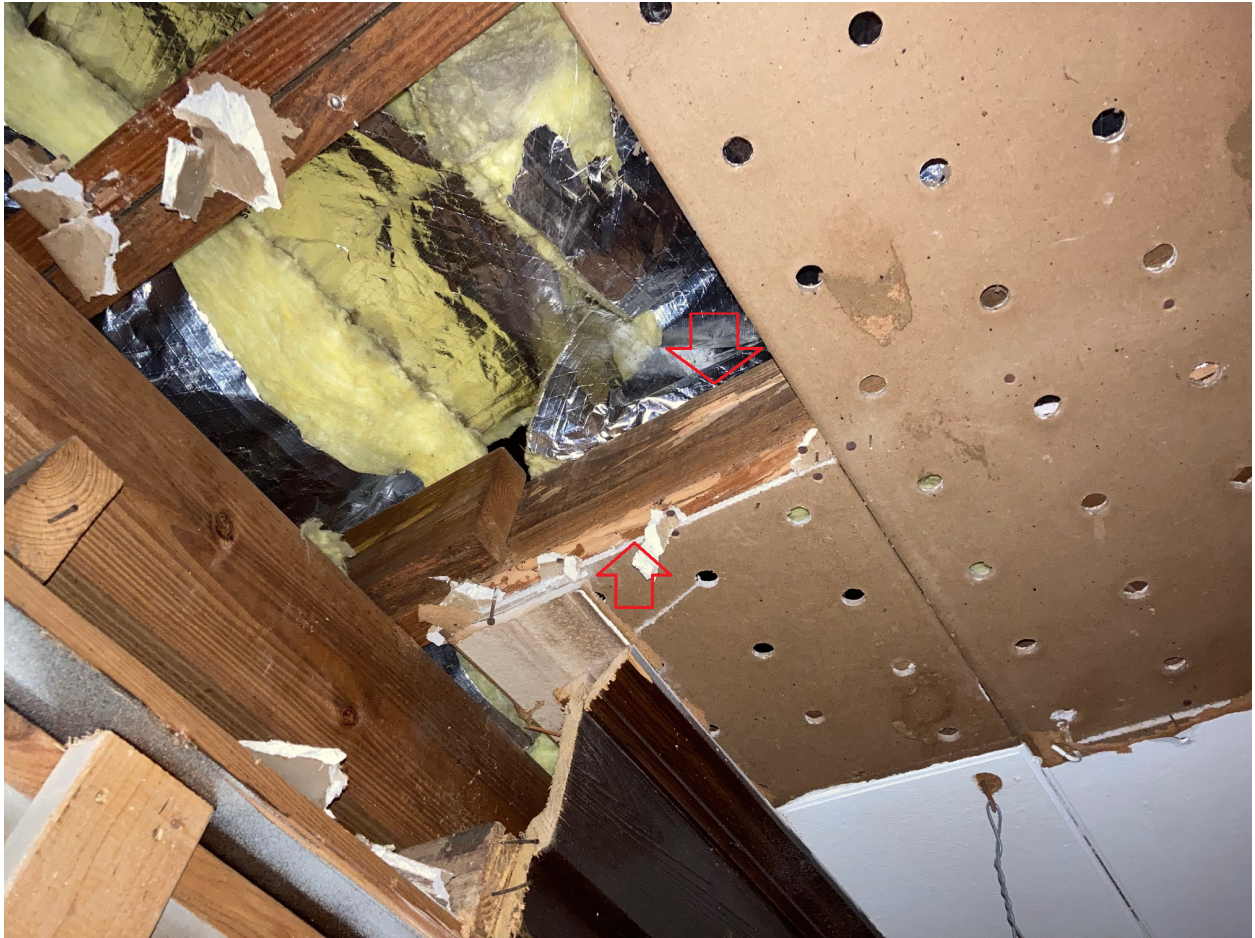
Figure 5. Termite damage to ceiling joist

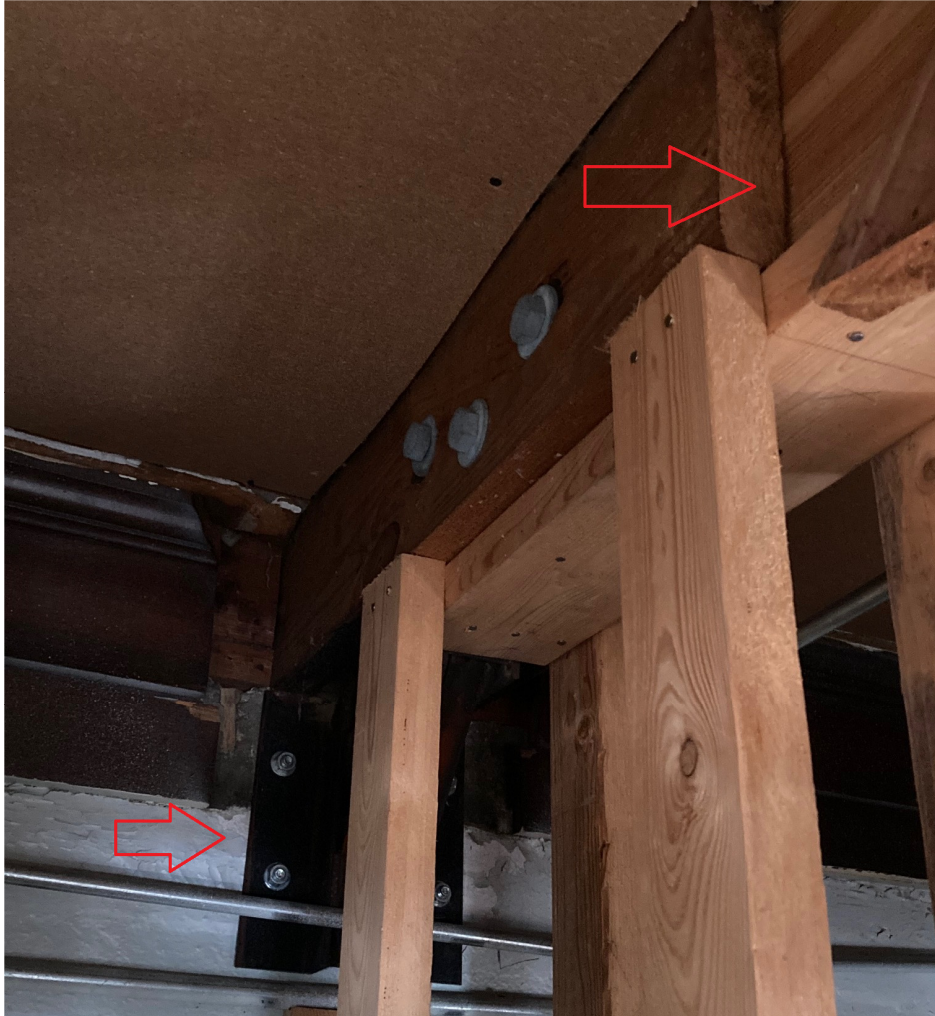
The truss closest to the south wall was repaired at some point in the past. Most likely this repair was performed prior to a collapse of the truss. The bottom chord and some over the truss webs were replaced at the east end, and a new steel bracket was attached to the masonry wall to support the east end of the truss. Termite damage to the wood, to both the original and replacement material, was readily seen.

Figure 6. Retrofit seat and repaired (spliced) truss chord at south truss

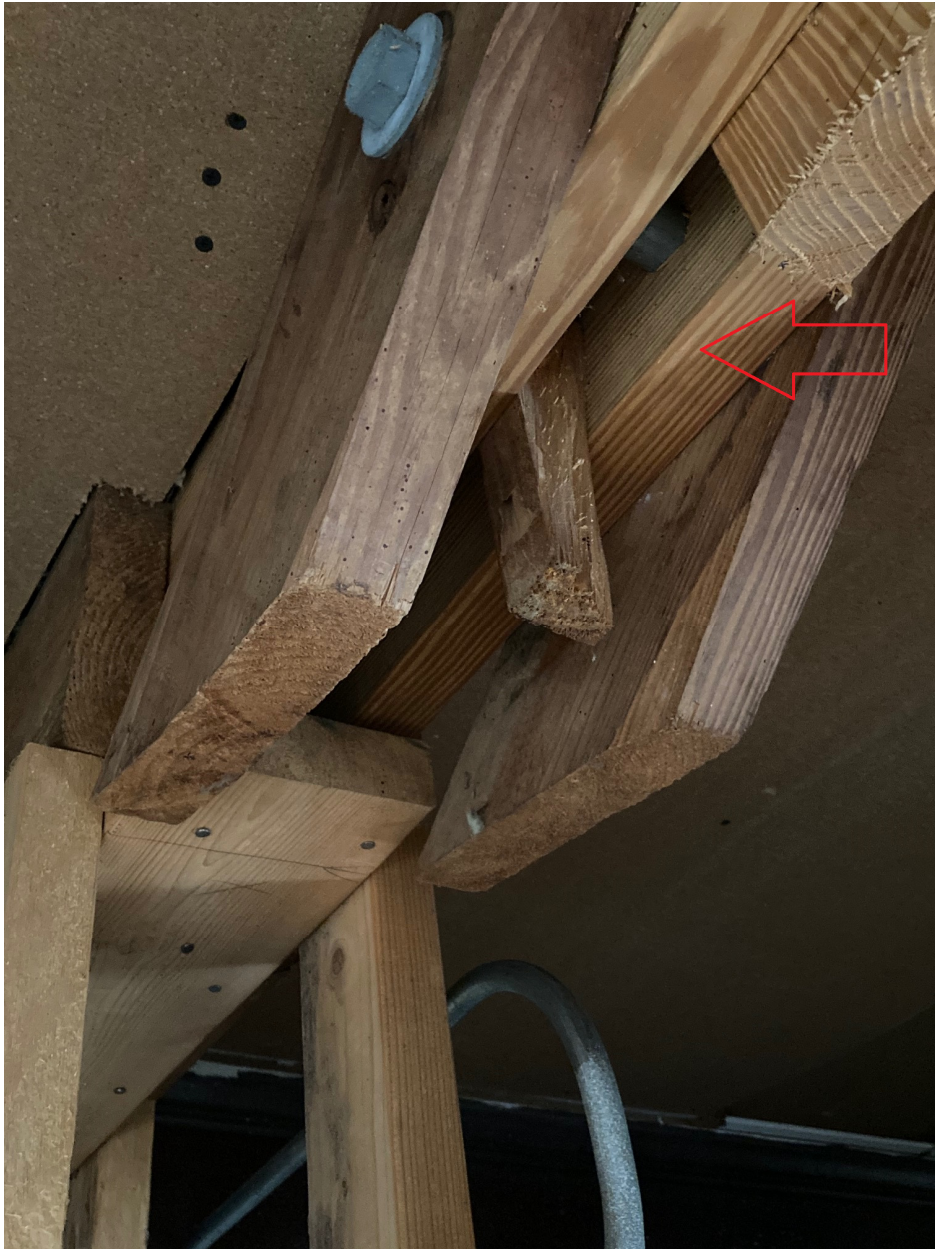
Figure 7. South truss. Failed web member with exposed bolt not engaging replacement web

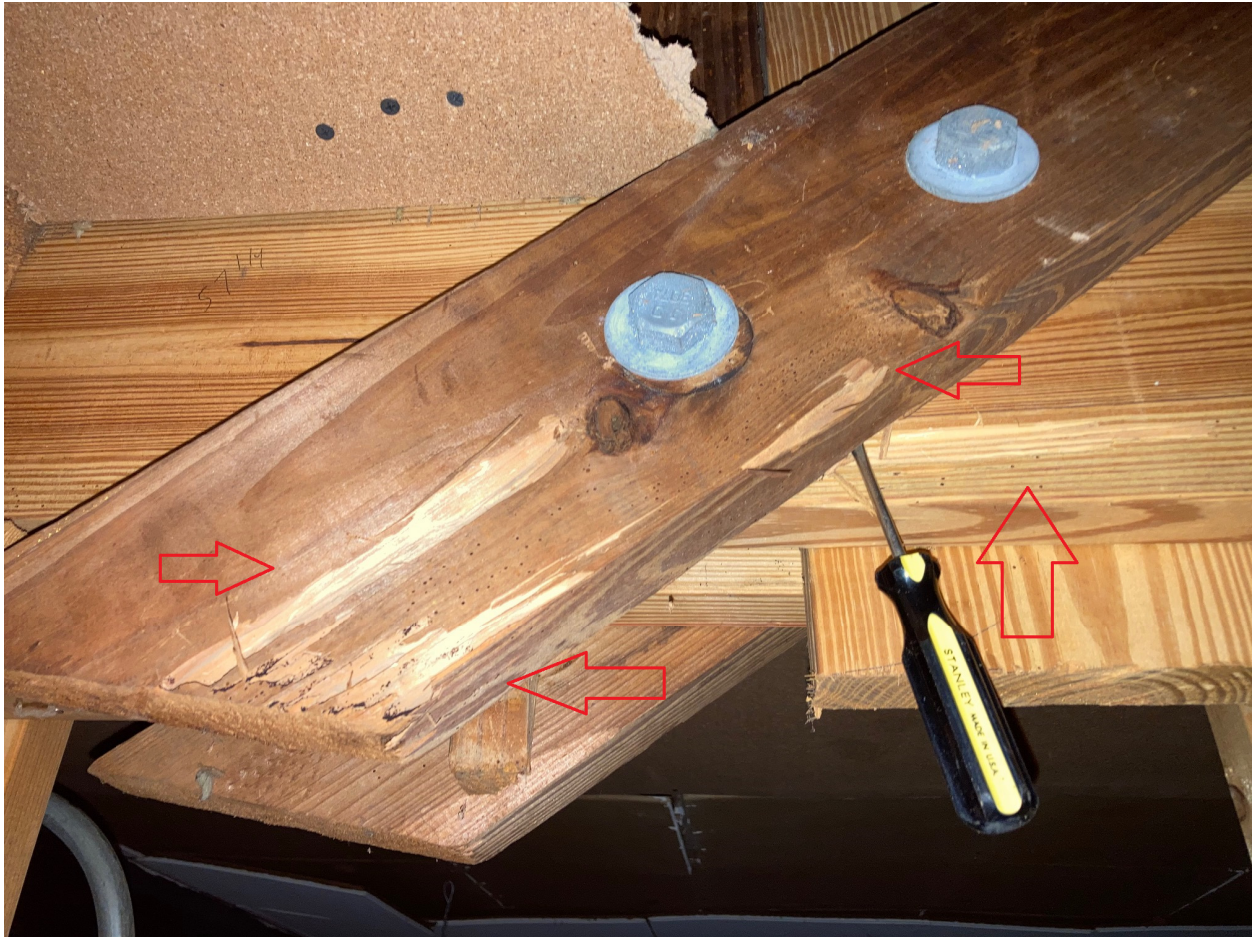
Figure 8. South truss. Note visible termite damage to both old and replacement wood. When the screwdriver was inserted between the plies, black pellets dropped, indicating the probability of termite activity and damage between the wood plies.

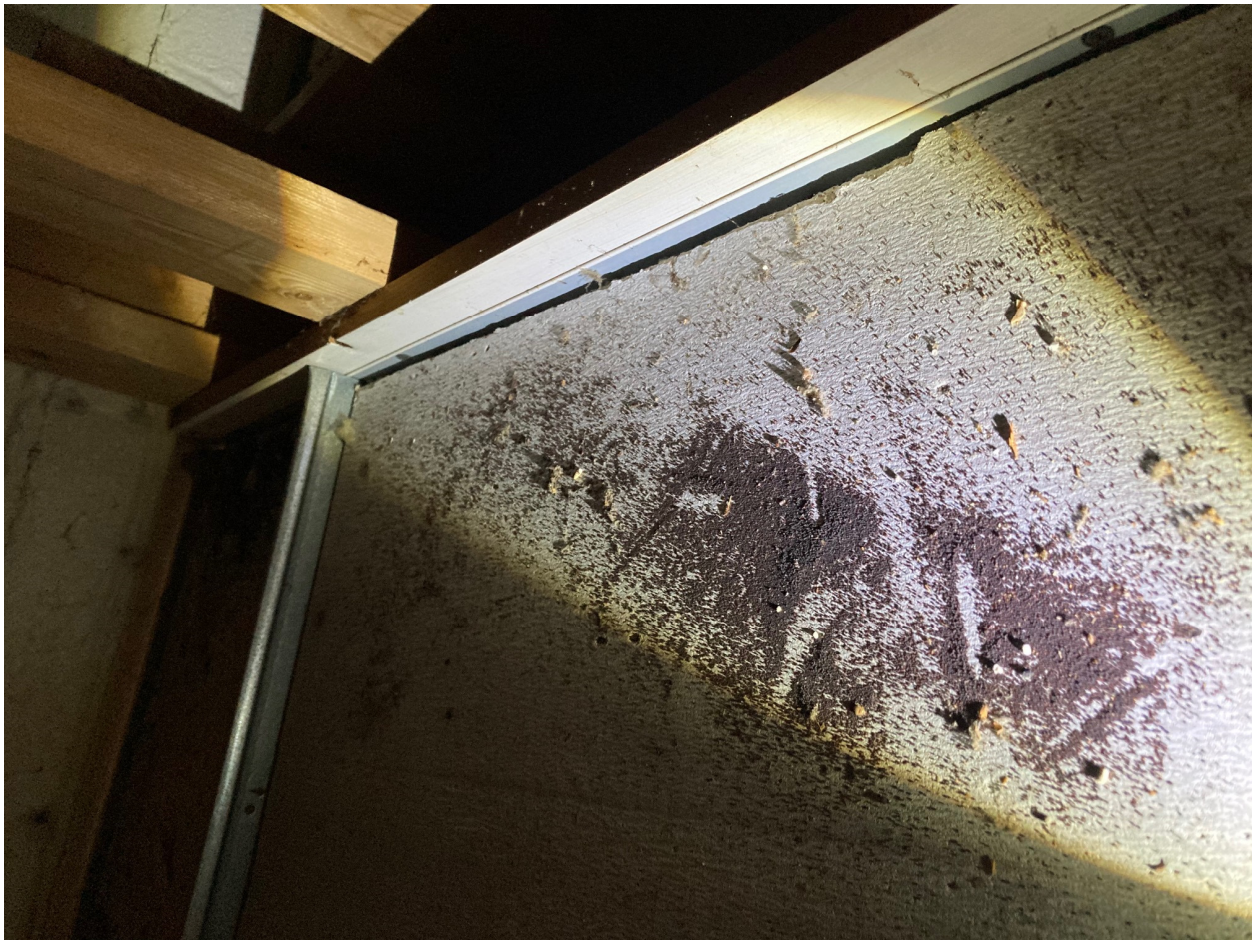
Since there were fairly large amounts of the black pellets on the acoustical ceiling and in the wood trim (both items added during the 1990's renovation) I can surmise that there was an infestation since that renovation, which may or may not be currently active.

Figure 9. Example of black pellets from suspected termites on suspended ceiling added during 1990's renovation.

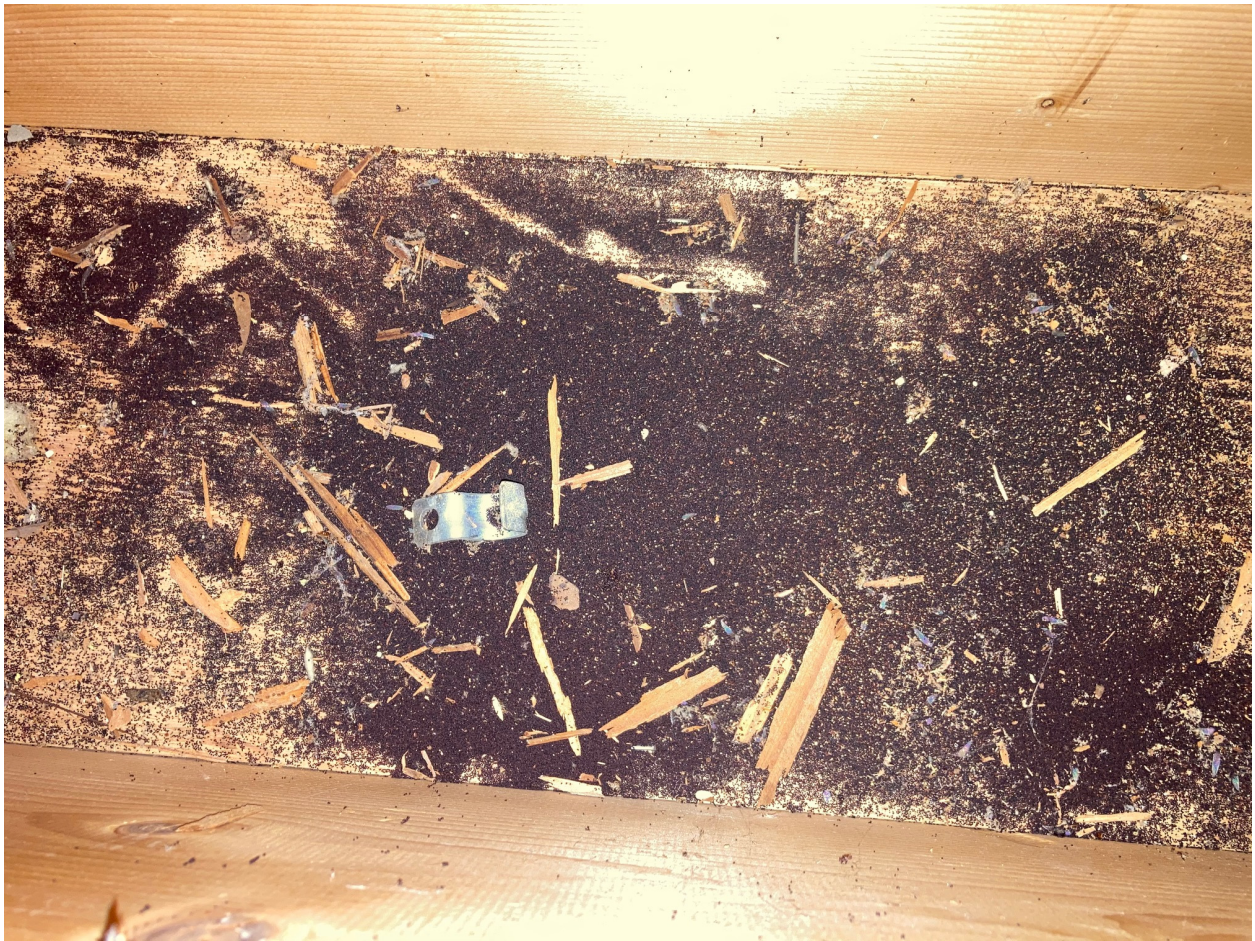
Figure 10. Example of black pellets from suspected termites on trim boards added during 1990's renovation.

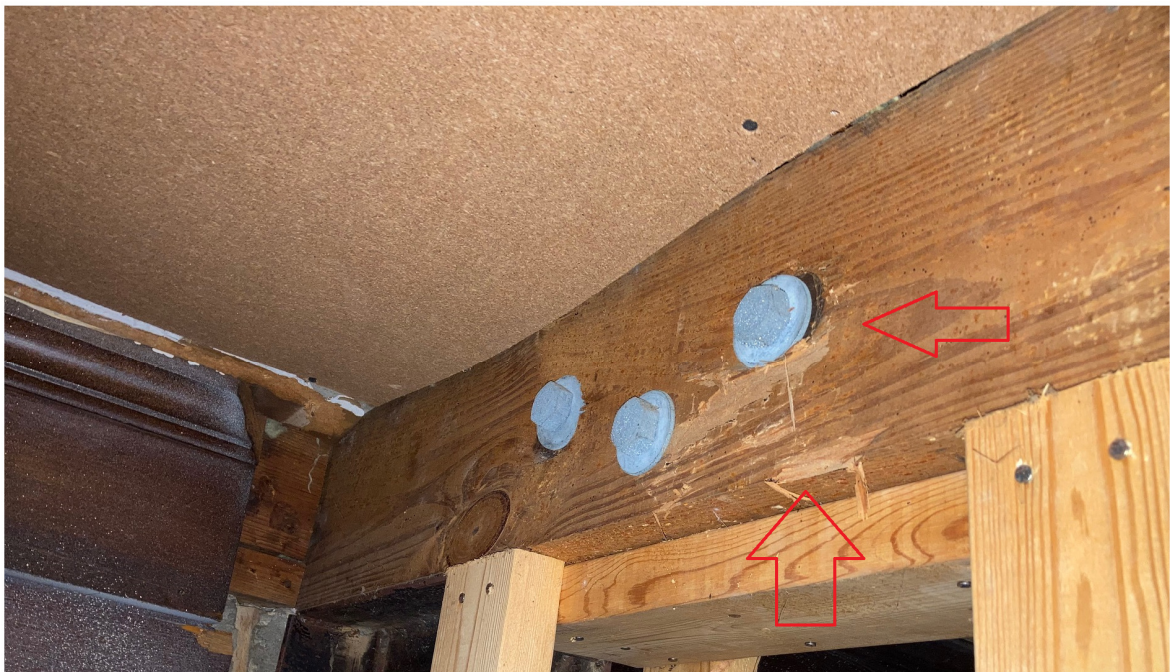
Figure 11. Termite damage to truss chord, including under bolt heads

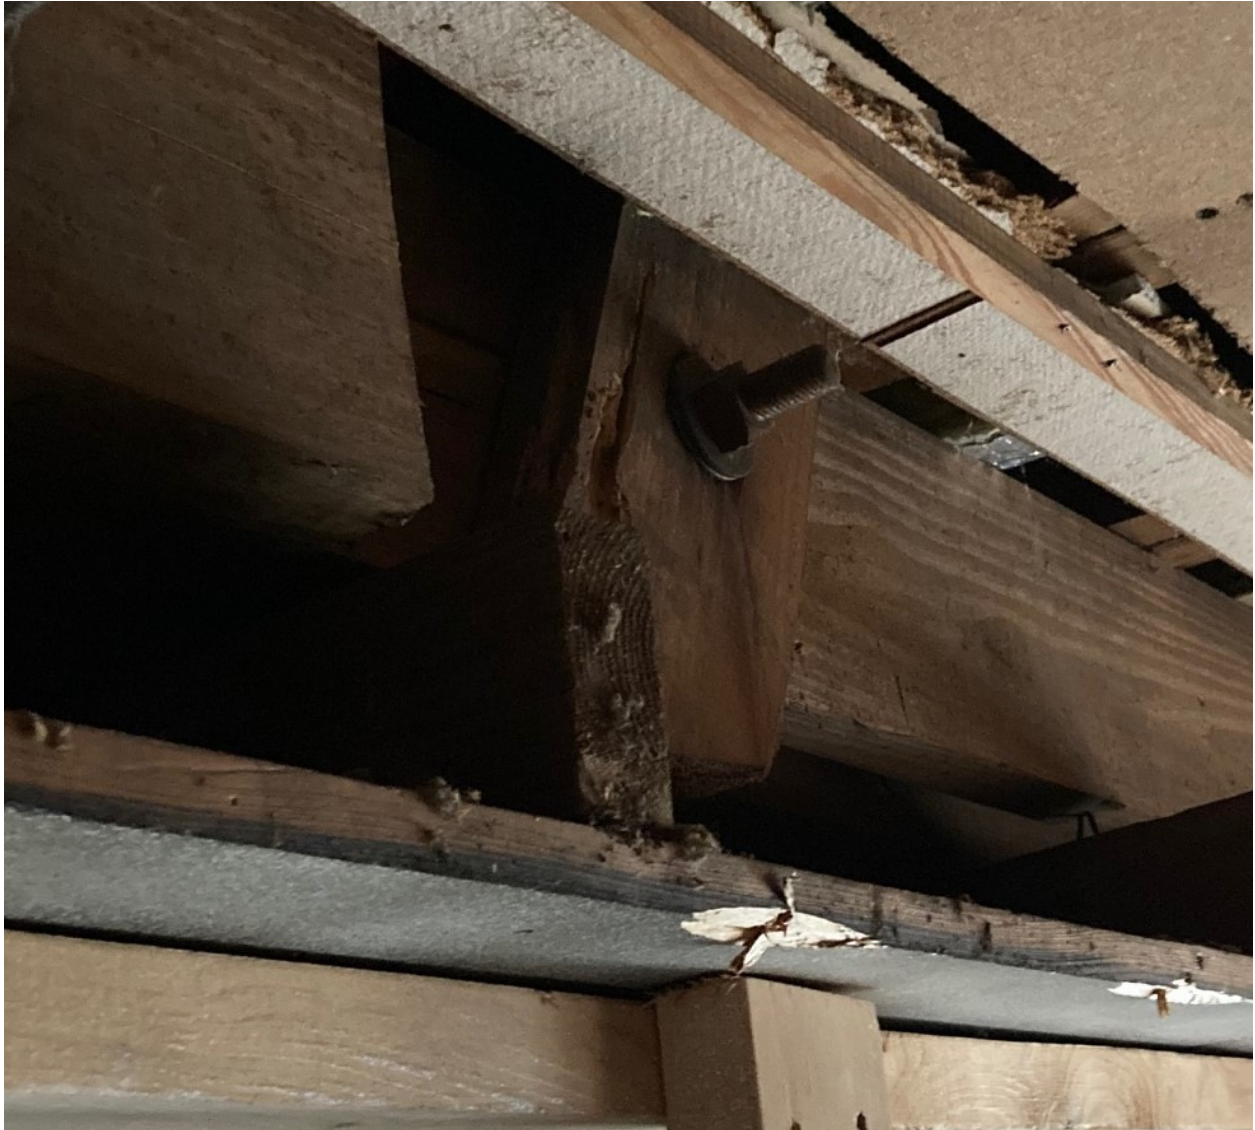
Figure 12. Termite damage extending into connection

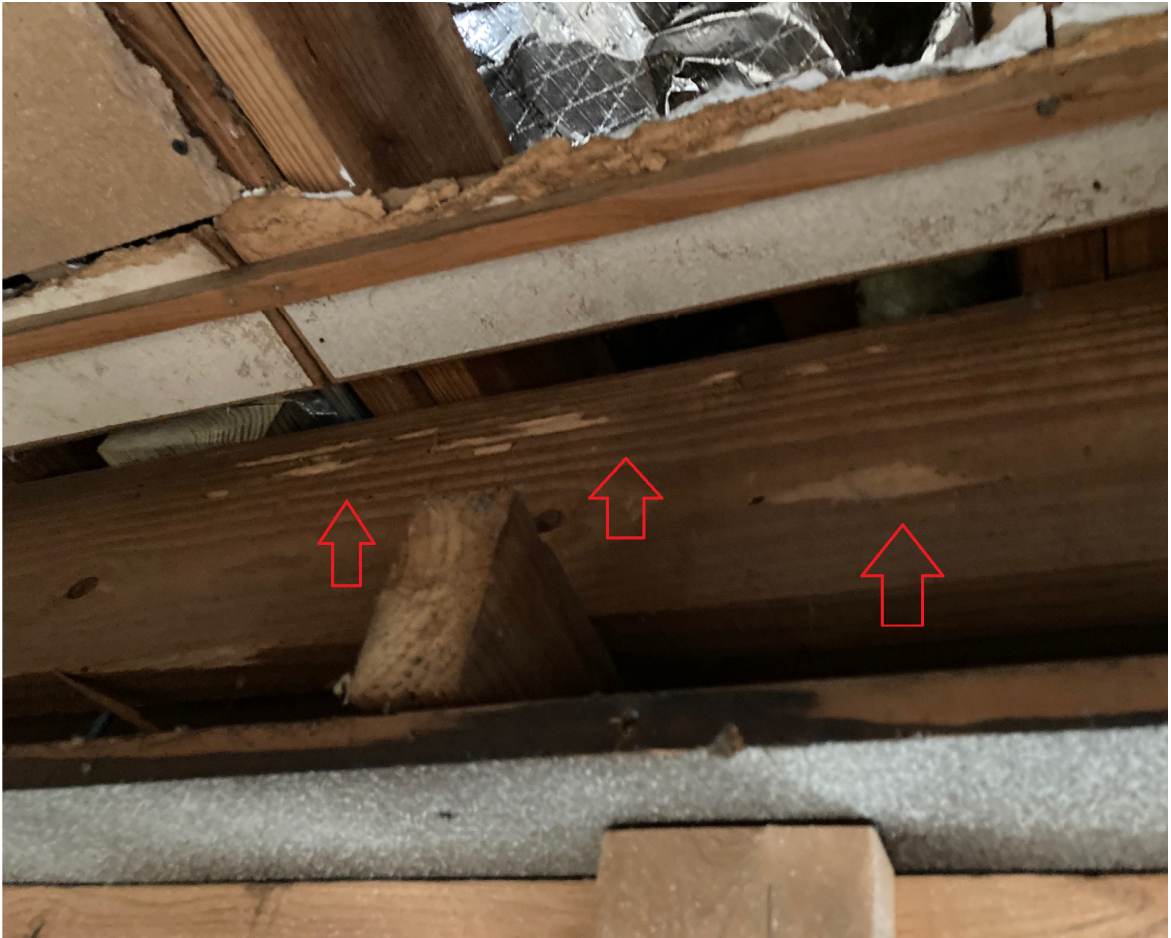
Figure 13. Termite damage along truss chord
