**Asbestos Survey Update Report**

**C.R. Layton U.S. Army Reserve Center (FL005)  
1125 Northeast 8<sup>th</sup> Avenue  
Gainesville, Florida**

**Contract No. W912QR-12-D-0027  
Delivery Order Number 0002**

**June 2013**

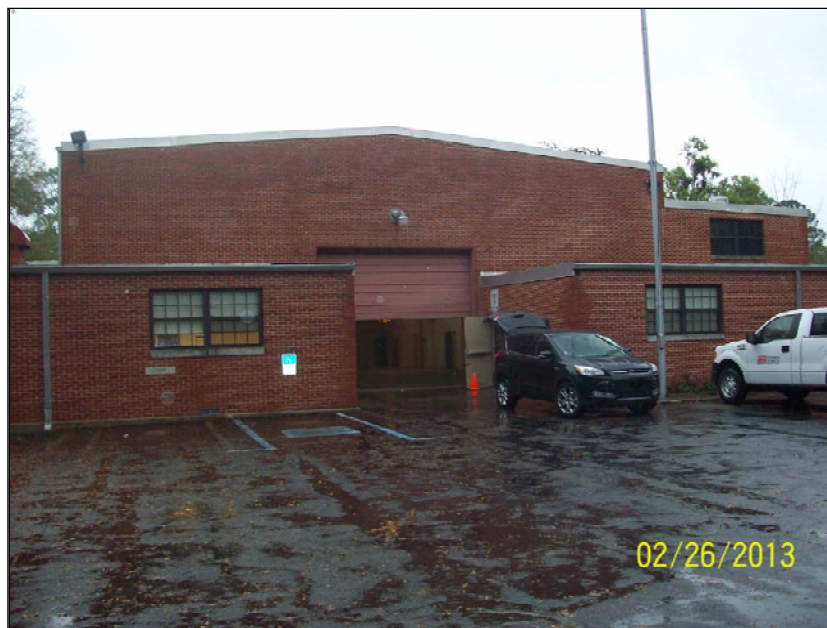
**Photo 1:** Front of USARC Building. Confirmed ACM: roof flashing material

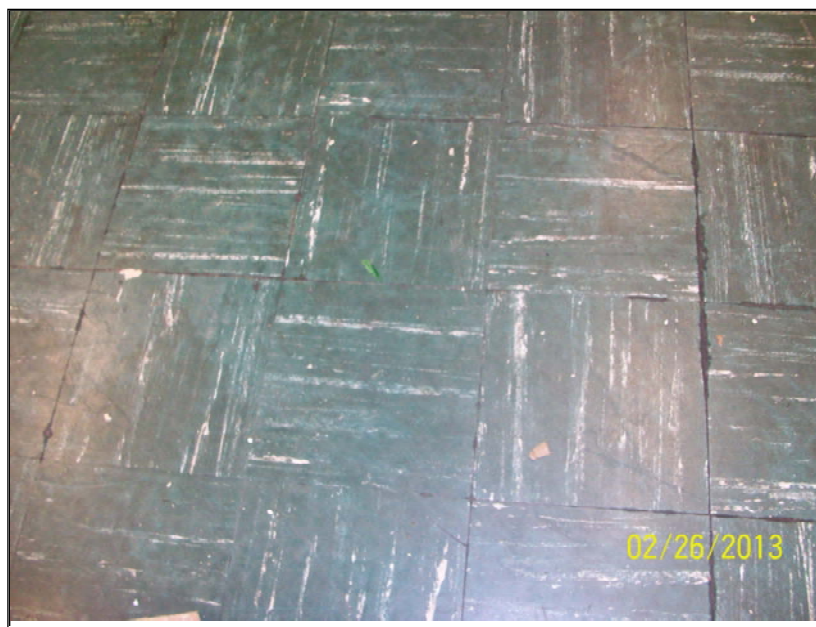
**Photo 2:** Confirmed ACM: 12-inch by 12-inch green floor tile and mastic

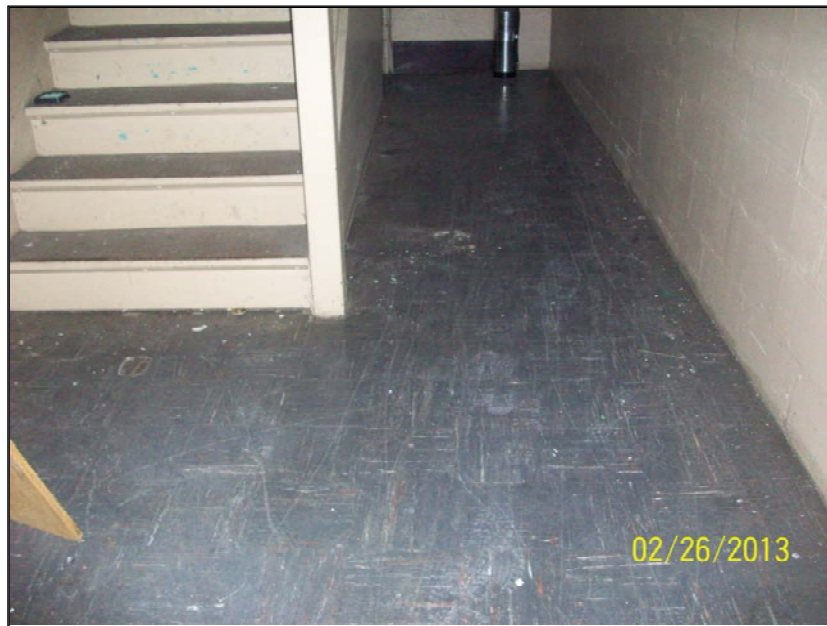
**Photo 3:** Confirmed ACM: 9-inch by 9-inch black floor tile and mastic

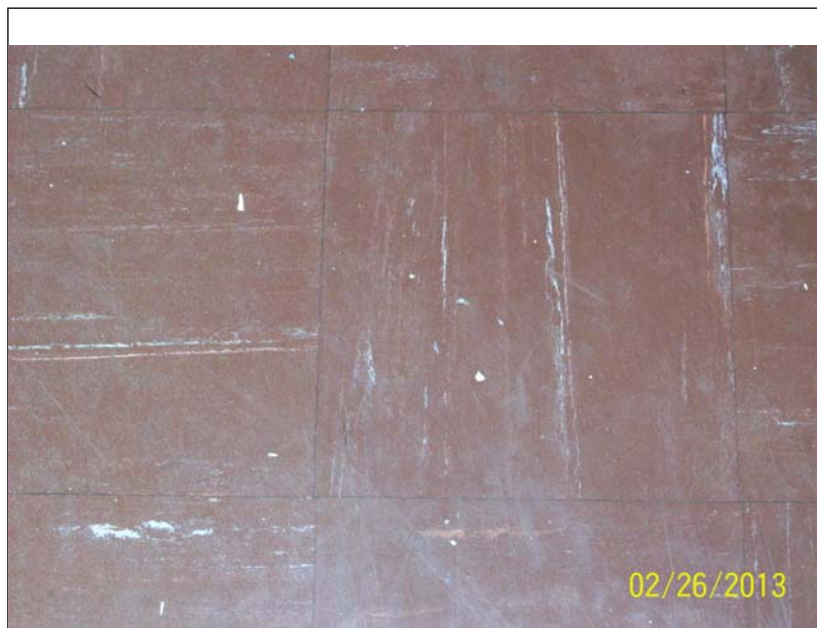
**Photo 4:** Confirmed ACM: 9-inch by 9-inch brown floor tile and mastic

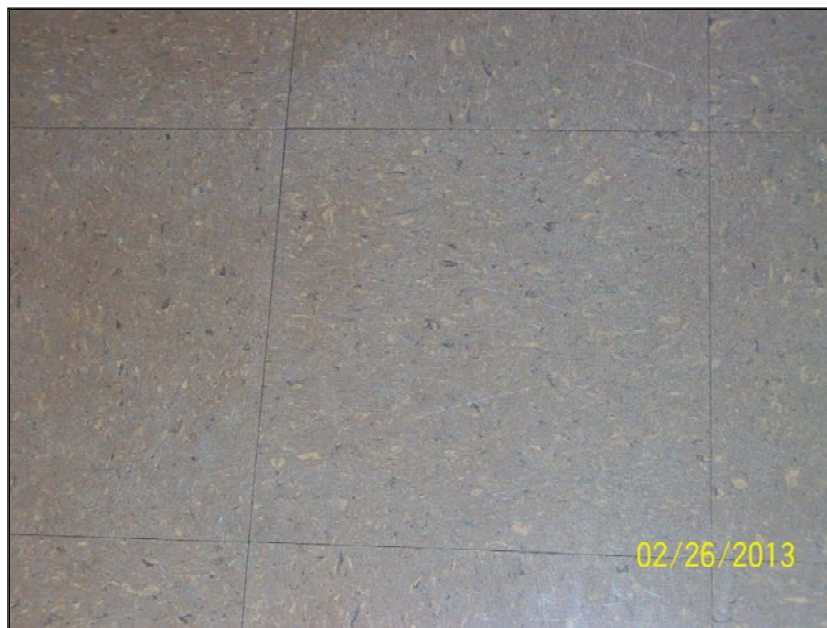
**Photo 7:** Confirmed ACM: mastic underneath 12-inch by 12-inch tan floor tile

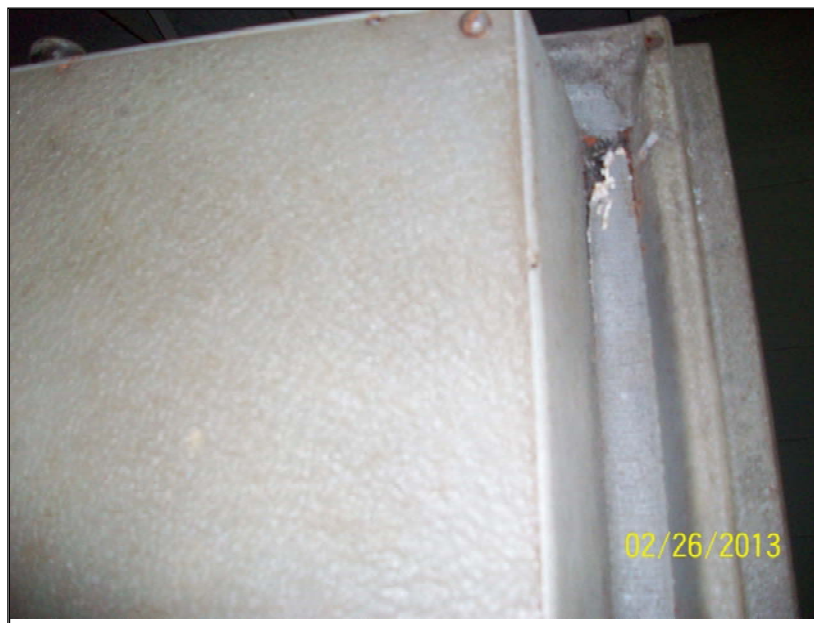
**Photo 8:** Confirmed ACM: woven gasket adhered to the seal of the arms vault door

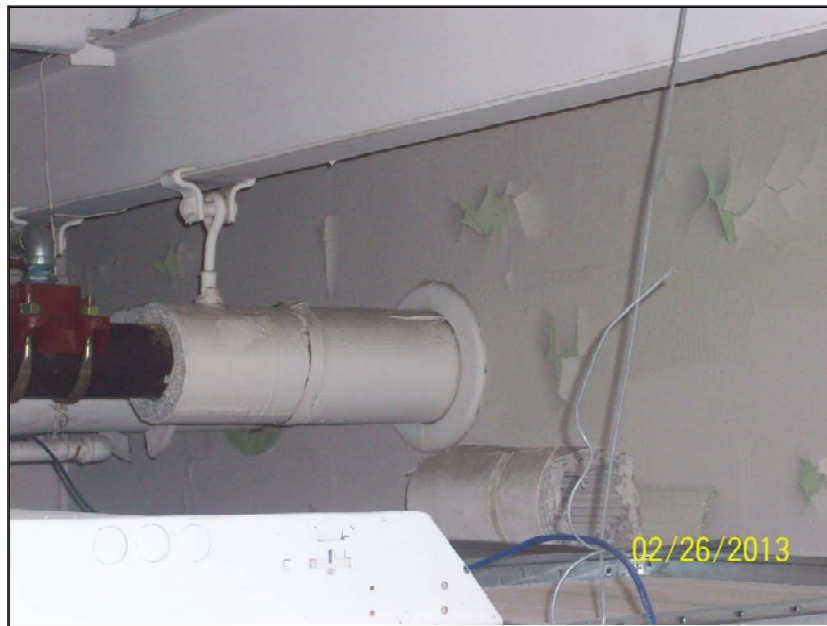
The confirmed or assumed ACMs were observed to be in good to fair condition at the time of the survey update field inspection. Approximately 1 percent total of the ACM pipe insulation has been damaged in rooms 101, 102, 110, and the firing range.

**Photo 9:** Confirmed ACM: pipe insulation (please note dislodged section)

- Approximately 1 percent total of the ACM pipe insulation has been damaged in rooms 101, 102, 110, and the firing range 124. PSI recommends repairing the damaged pipe insulation. ACM's should be maintained in a good, non-damaged condition through use of an Operations and Maintenance (O&M) program. Regulated ACM (RACM) must be properly removed by a licensed asbestos abatement contractor prior to renovations or demolition that would disturb the

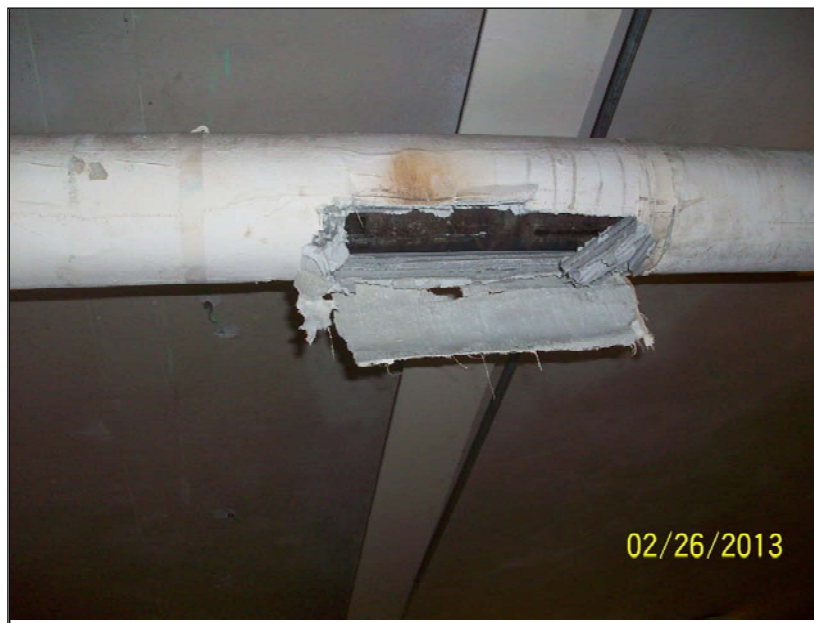
**Photo 10:** Confirmed ACM: pipe insulation. (Please note damage)

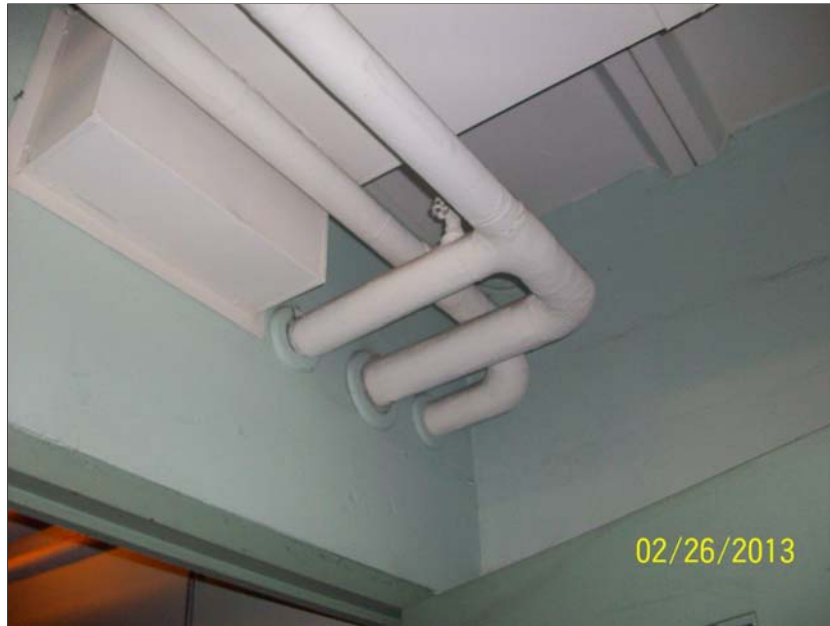
**Photo 11:** Confirmed ACM: pipe fitting insulation

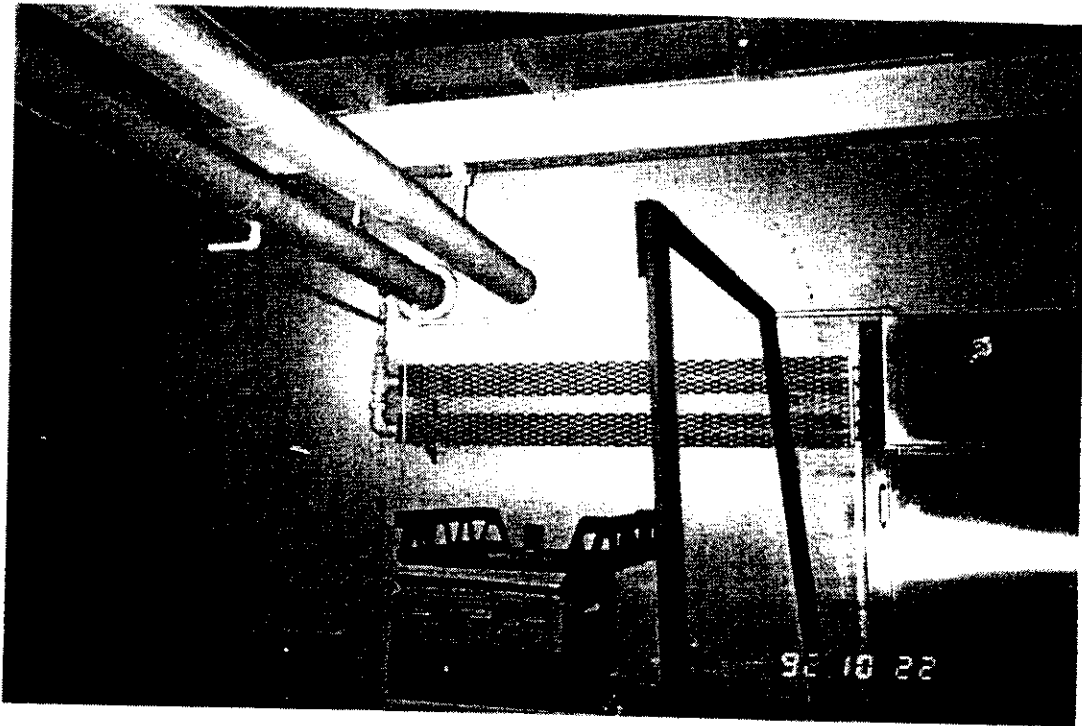
C. R. Layton USARC - Steam Pipe Insulation

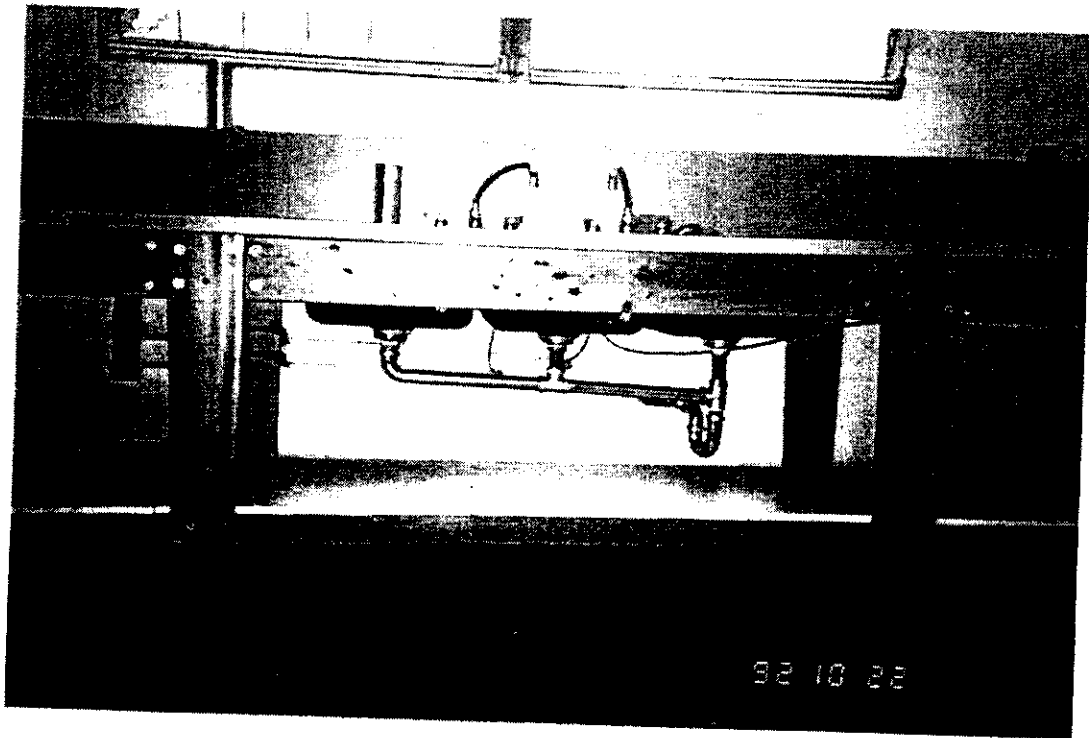
C. R. Layton USARC - Sink Sound Attenuation
