## CWC Duval Community Case Study 2015-16

In November 2015, two Community Weatherization Coalition (CWC) auditors completed an audit at the home of 15-1102 as part of our “autumn audit blitz” in the Duval Community. The blitz, partly funded by the Gainesville Renewable Energy Center (GREC), resulted in 13 audits in the Duval community in autumn 2015 and spring 2016. 15-1102 is an elderly widow on a fixed income who, despite living alone, reported having utility bills exceeding \$400/month during the peak heating/cooling seasons.

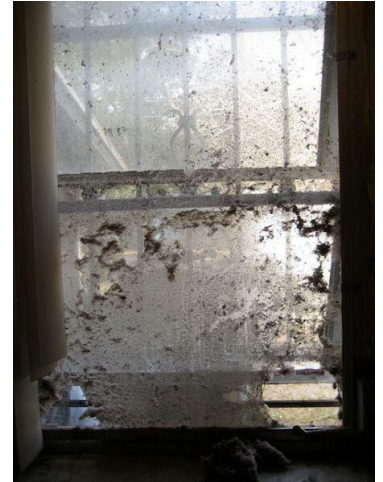
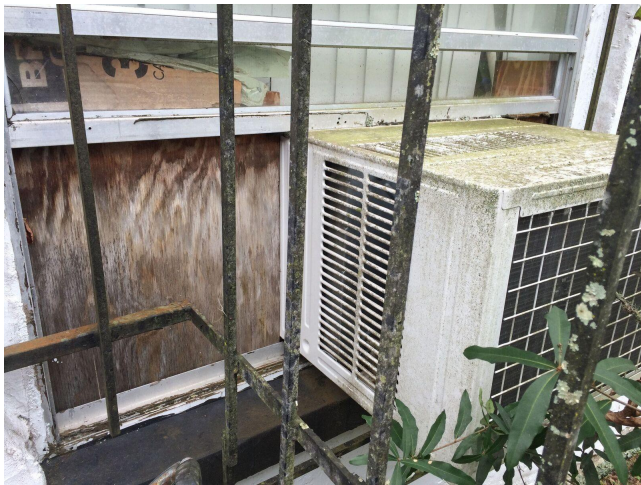
**-Building envelope:** the client was in severe need of added weatherstripping, caulking, and repairs to her doors. In her utility room, which was in conditioned space, her dryer vent was venting out of a broken awning-style window which was left permanently open. Though 15-1102 had replaced a few of her windows, several others had broken panes and/or missing screens. She was also missing screens on several of her soffit vents, allowing openings for vermin to enter her attic. Finally, her attic was poorly insulated, with only 2-3” of old, settled loose fill insulation and an uninsulated attic hatch.

**-Building envelope:** we created a properly-sealed dryer vent through an exterior wall instead of the window and repaired the window so that it would close properly. We also had her sliding glass doors repaired so that they would open and close properly. We helped convince her to remove the window AC unit and to seal the windows. We added a fresh bead of caulk around all of her windows, added weatherstripping and a new threshold to her front door, and replaced her missing soffit vents. While we were not able to repair or replace other poorly-sealed windows in the home, we did provide her with an estimate from two window contractors for this work and 15-1102 plans to pursue these repairs on her own.

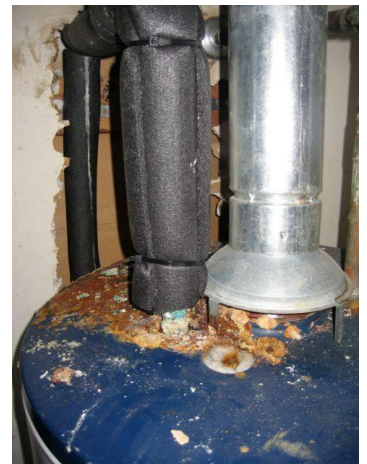
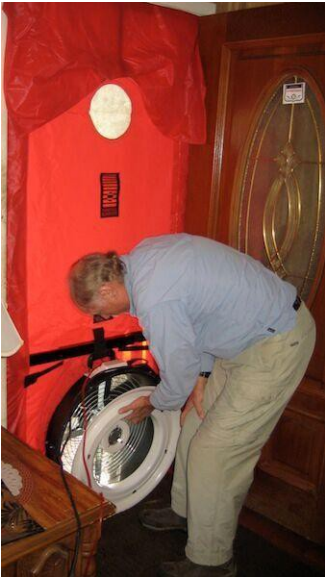
**-Water:** the auditors identified and replaced inefficient water fixtures, including installing kitchen and bathroom aerators and a low-flow showerhead. An active leak at the washing machine was uncovered, as well as safety issues with the washer plugged into a non-GFCI receptacle. There was also an active leak at the water heater piping, which had caused the water heater to become extremely corroded.

**-Water:** we worked with a plumbing contractor to replace her damaged water heater, bringing its installation up to current Code. We also repaired the leak issues with the washing machine.
