**STRUCTURAL
ENGINEERING**4566B NW 5TH BLVD
Gainesville, FL 32609
southardengineering@yahoo.com
Phone/Fax: 352-367-2526
CA # 9195

December 16, 2014

Subject: **Structural Assessment of House at
1227 NW 4th Ave
Gainesville, FL 32609**

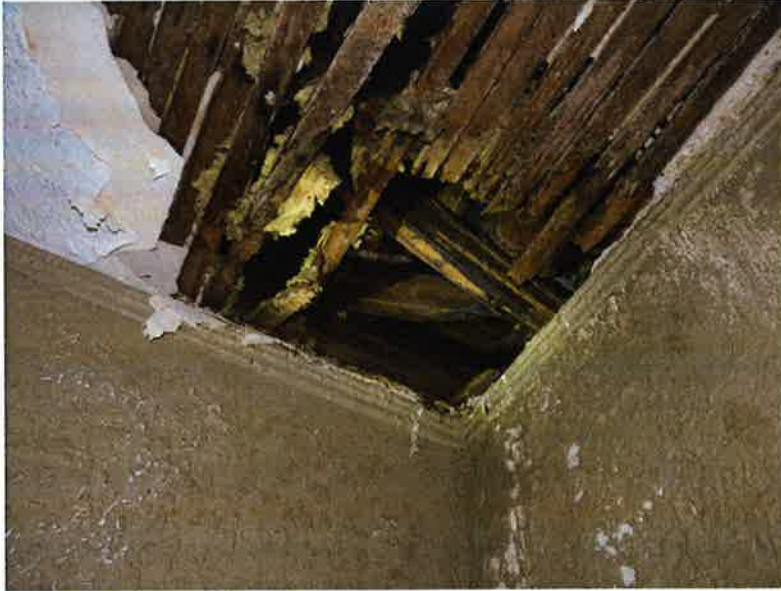
PHOTOGRAPH #1

Location:
1227 NW 4th Ave
Gainesville, FL 32609
Interior ceiling on East side

Description:
Roof leak has caused major
damage to ceiling and rafters

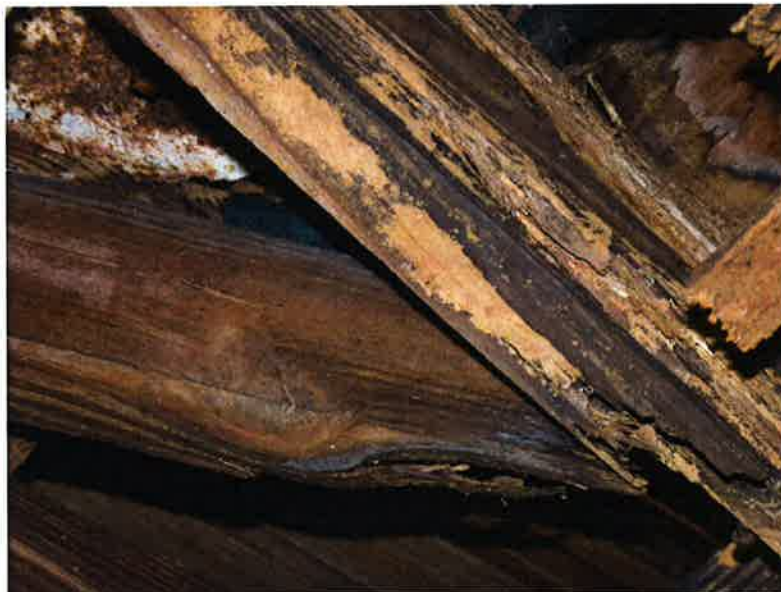
PHOTOGRAPH #2

Location:
1227 NW 4th Ave
Gainesville, FL 32609
Rafter end on East side

Description:
Damage to rafters caused by
a roof leak in this area

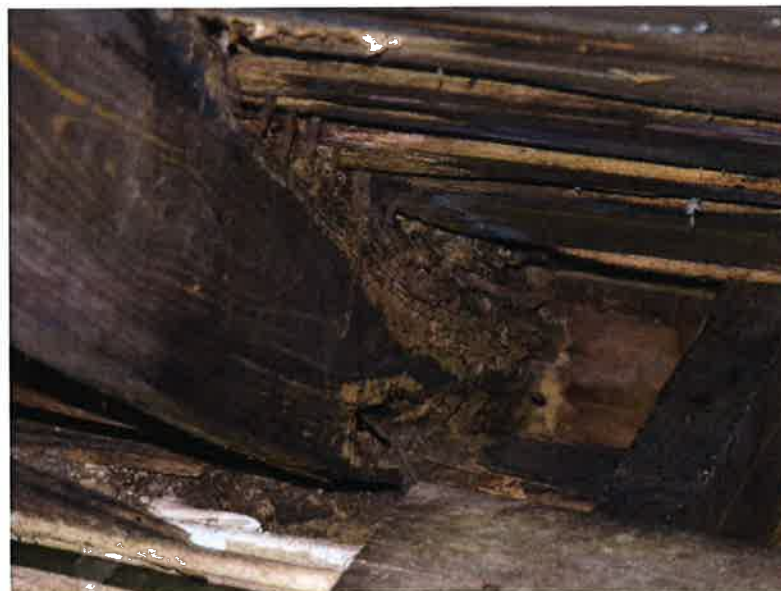
PHOTOGRAPH #3

Location:
1227 NW 4th Ave
Gainesville, FL 32609
Rafter end on East side

Description:
End of Rafter needs to be
replaced due to damage
caused by roof leak

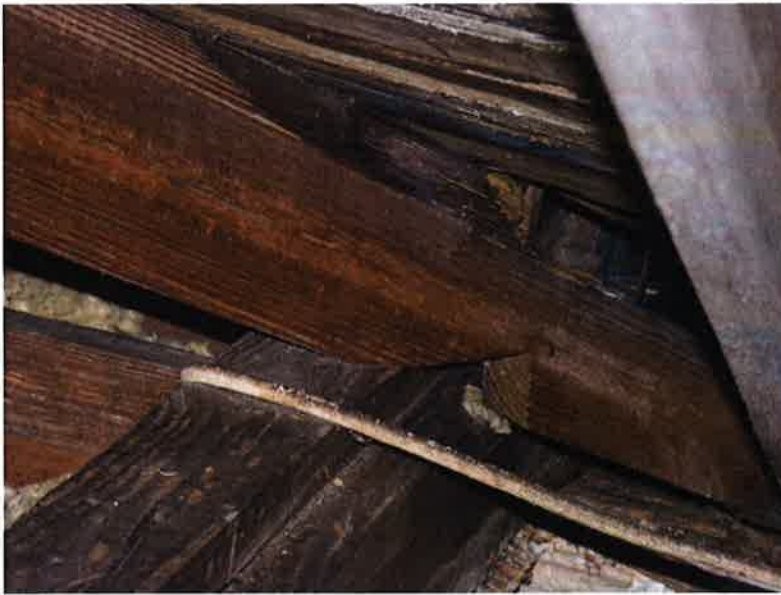
PHOTOGRAPH #4

Location:
1227 NW 4th Ave
Gainesville, FL 32609
Rafter end on West side

Description:
Roof leak has damaged roof
planks and rafter end

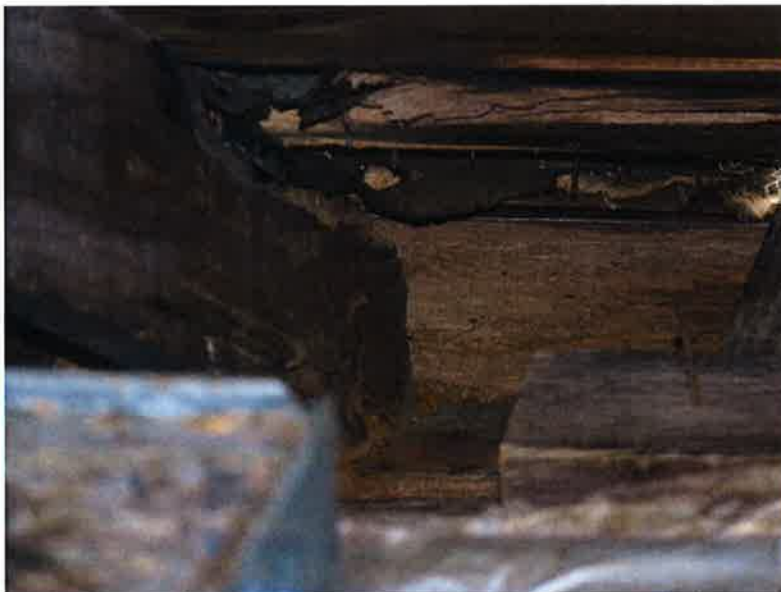
PHOTOGRAPH #5

Location:
1227 NW 4th Ave
Gainesville, FL 32609
Rafter end on West side

Description:
Another location where a
roof leak has damaged the
end of a rafter

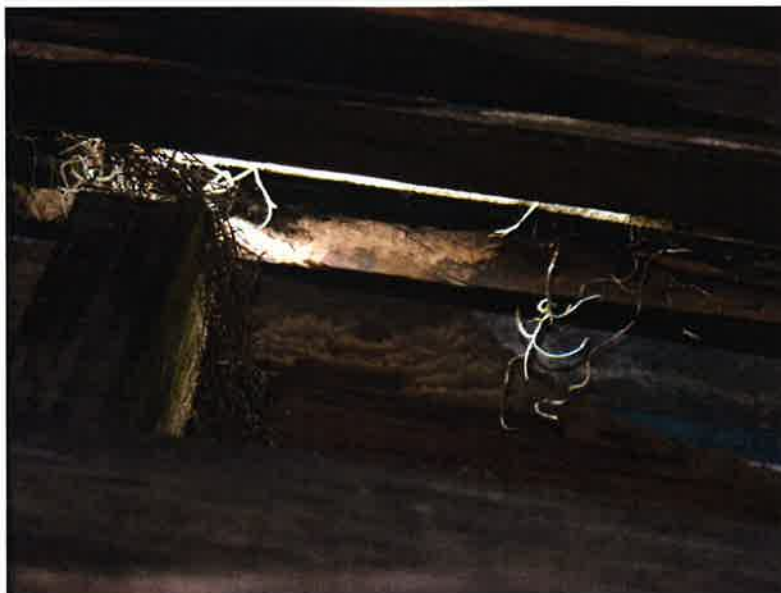
PHOTOGRAPH #6

Location:
1227 NW 4th Ave
Gainesville, FL 32609
Opening in roof on West side

Description:
In this location the hole in
the roof is so big daylight
shines through easily and
vegetation has entered the
structure

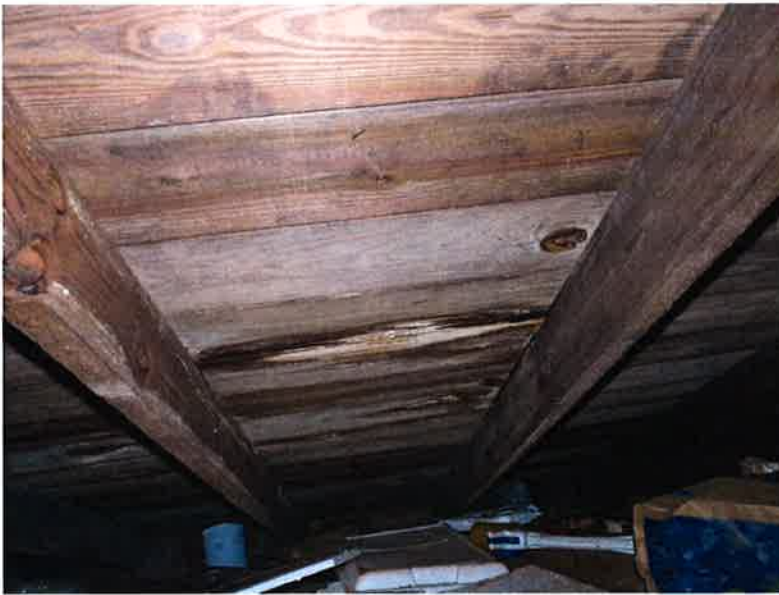
PHOTOGRAPH #7

Location:
1227 NW 4th Ave
Gainesville, FL 32609
Look leak Southwest area

Description:
There is also a newer roof leak here and the roofing materials are showing signs of damage. Also note the garbage left behind by trespassers and vandalism.

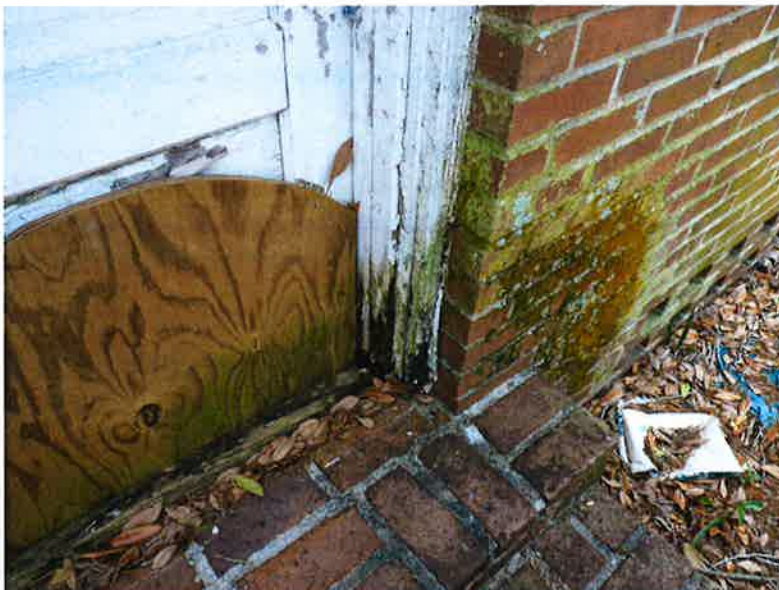
PHOTOGRAPH #8

Location:
1227 NW 4th Ave
Gainesville, FL 32609
West Side Entrance

Description:
Typical of most exterior doors. Lots of moisture intrusion. Large gaps between the door frame and the walls. Algae stains on the brick veneer

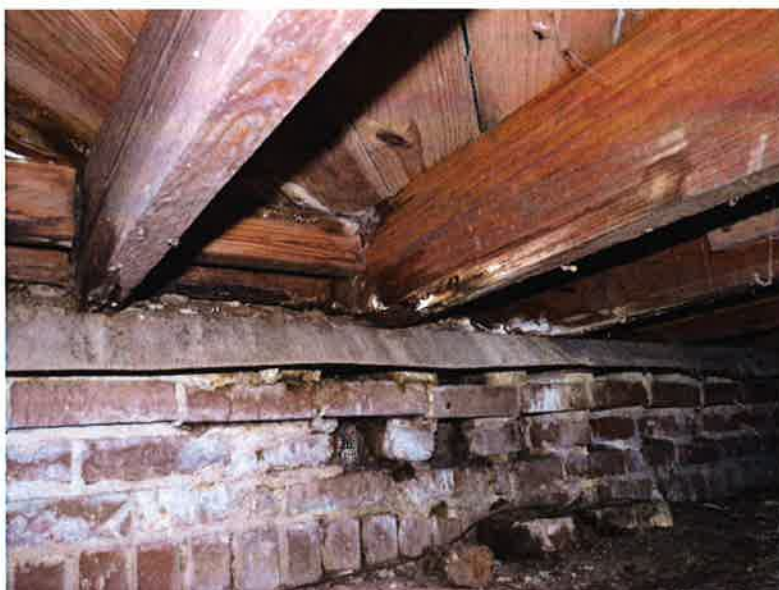
PHOTOGRAPH #9

As noted above, all of the major components and systems of the building have sustained significant damage due to water intrusion and high humidity levels. This is no different for the structural systems. In five places the roof rafters and planking have sustained significant damage due to roof leaks as seen in photographs #1 through #7. The floor system has also taken on damage due to water intrusion into the crawl space. These leaks are most likely caused by poor grading around the house and build up of debris. Please refer to photographs 9 through 13 for description of the damage.

Location:
1227 NW 4th Ave
Gainesville, FL 32609
West side

Description:
Ends of Floor joist damaged by water intrusion into the crawl space and damaged stem wall.

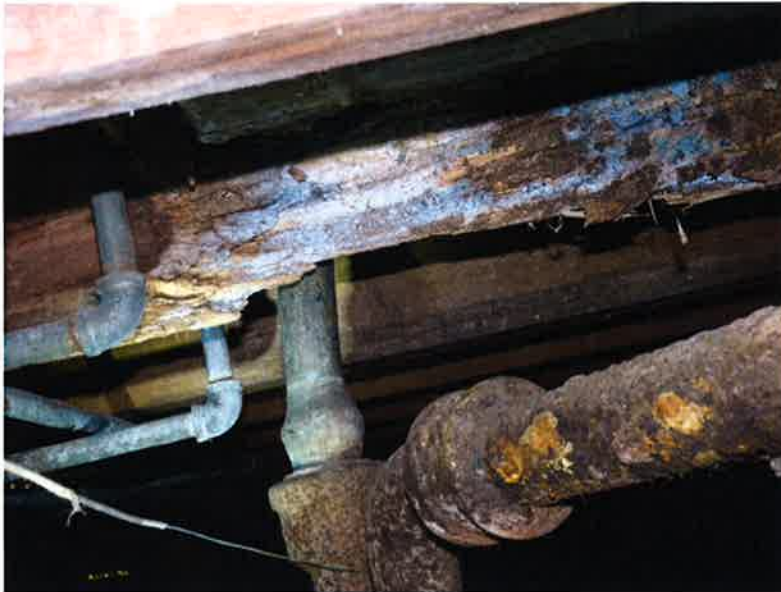
PHOTOGRAPH #10

1227 NW 4th Ave
Gainesville, FL 32609
Under East side bathroom

Major damage to two floor joist where the plumbing at the bathroom tub has been leaking

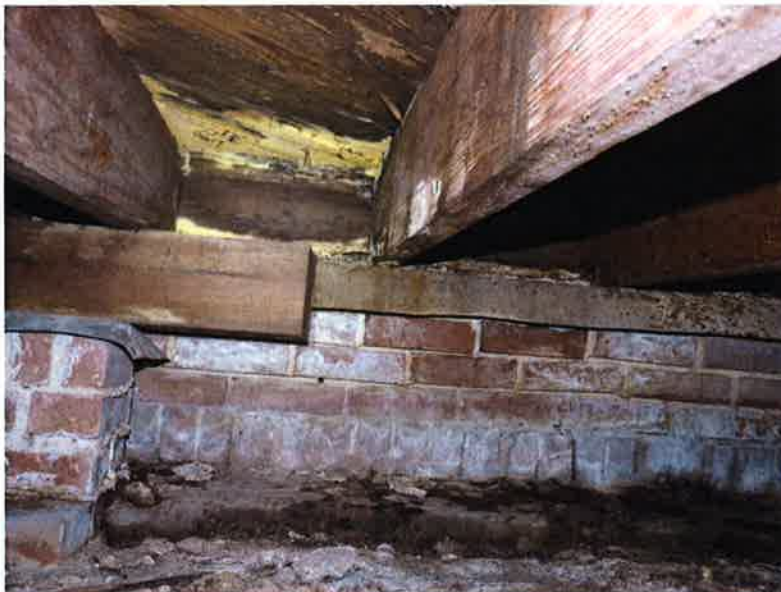
PHOTOGRAPH #11

1227 NW 4th Ave
Gainesville, FL 32609
East side stem wall

Another spot where the ends of the floor joist have been damaged due to water intrusion into the crawl space. Mold and efflorescence is on the stem wall.

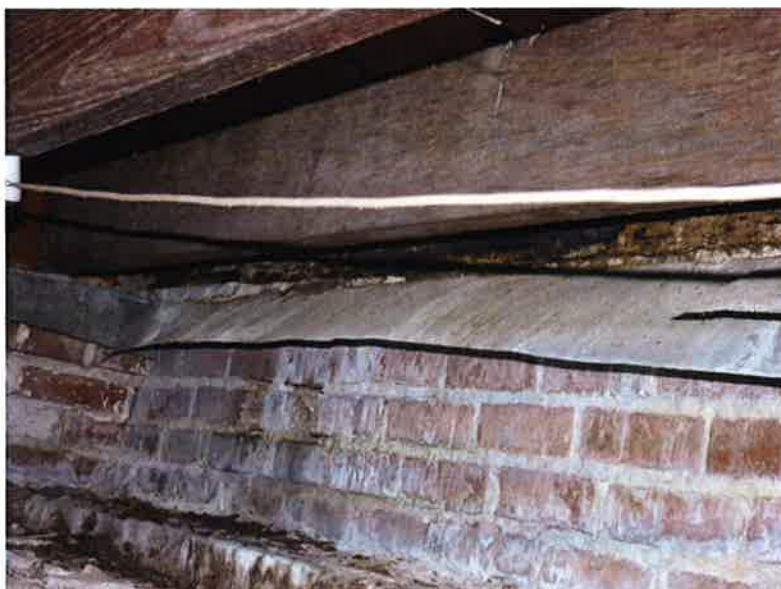
PHOTOGRAPH #12

1227 NW 4th Ave
Gainesville, FL 32609
Southeast stem wall

Here the rim joist has been sustained major damage caused by water intrusion into the crawl space. Efflorescence is on the stem wall.

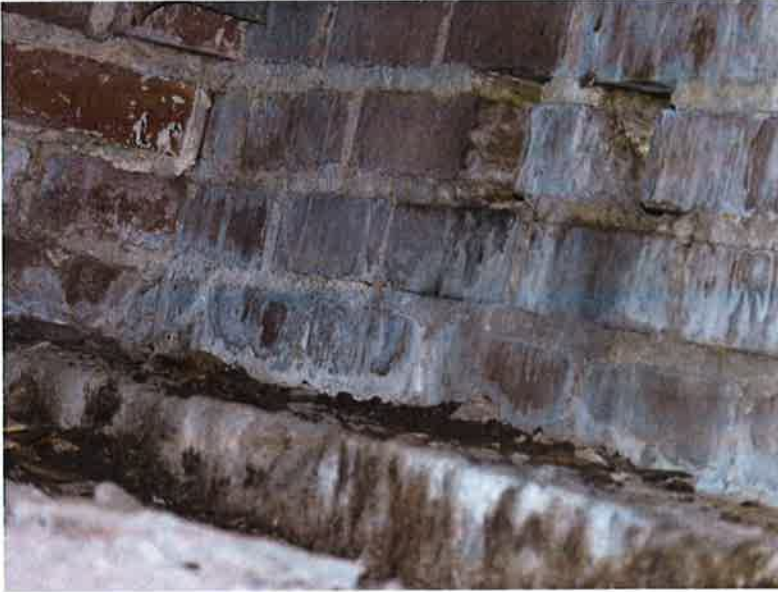
PHOTOGRAPH #13

It should also be noted just how bad the efflorescence build up on the brick stem walls and veneer is. This is a sign that the brick has been exposed to lots of trapped water which has traveled through the brick depositing salts on the surface of the brick. It is likely this means the brick ties, which attach the brick to the building, have also been damaged and are probably severely corroded. There are about four to five roof areas and four to five floor areas where structural repairs need to be made just to make the building habitable. And as mentioned before, the rest of this building's components are in worse shape. There is little to none of the building's interior that can be preserved.

Location:
1227 NW 4th Ave
Gainesville, FL 32609
Southeast stem wall

Description:
Efflorescence stains as bad as I've ever seen on brick veneer. Signs of major water intrusion area into crawl space

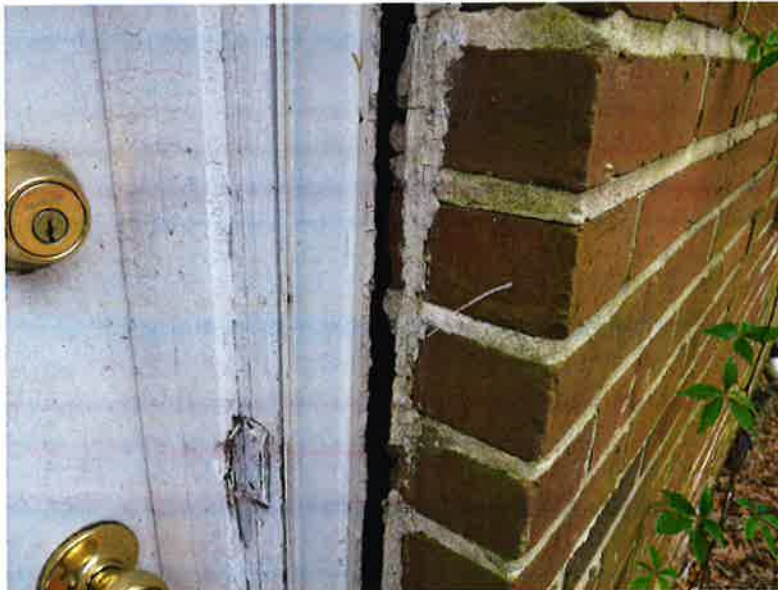
PHOTOGRAPH #14

All of the drywall and ceiling board will need to be completely removed and replaced in their entirety, due to moisture damage from roof leaks and excessive humidity in the house (see photographs 15, 17, 18, 19, 24, 25, 27, 31, and 34). All of the doors and windows show signs of moisture intrusion and other forms of damage (see photographs 14, 21 and 28). All doors and windows will need to be replaced.

Location:
1227 NW 4th Ave
Gainesville, FL 32609
West exterior door

Description:
Here there is a major gap between the walls and the door entry frame

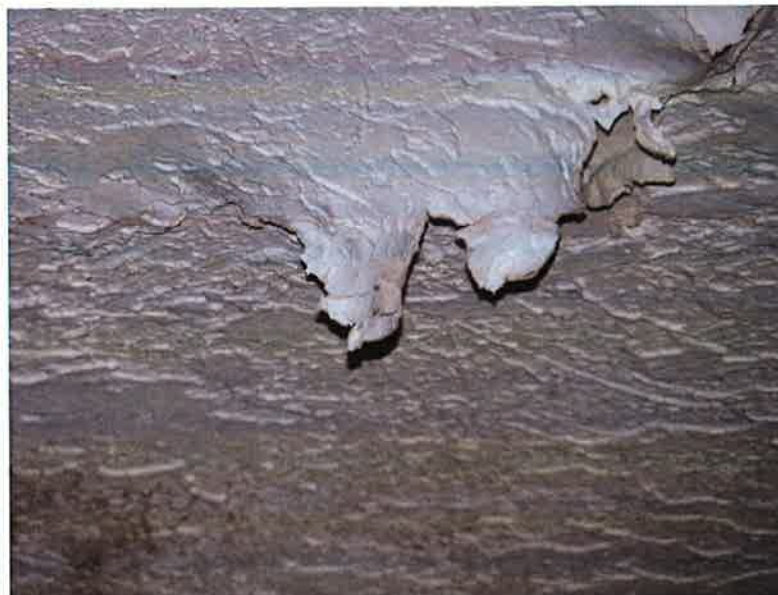
PHOTOGRAPH #15

Description:
Ceiling damage due to water intrusion into the building.

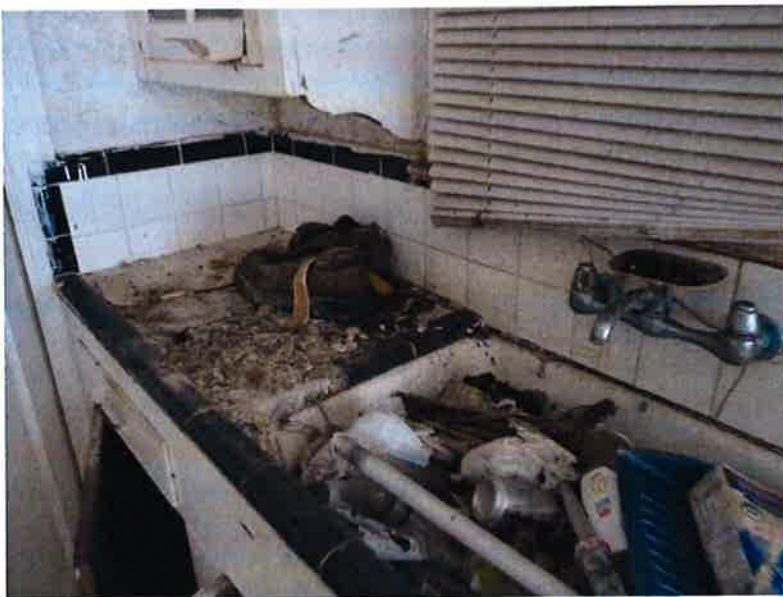
PHOTOGRAPH #16

Location:
1227 NW 4th Ave
Gainesville, FL 32609
Kitchen

Description:
All appliances, sinks, toilets,
interior doors, etc... have
sustained major damage due to
was vandalism.

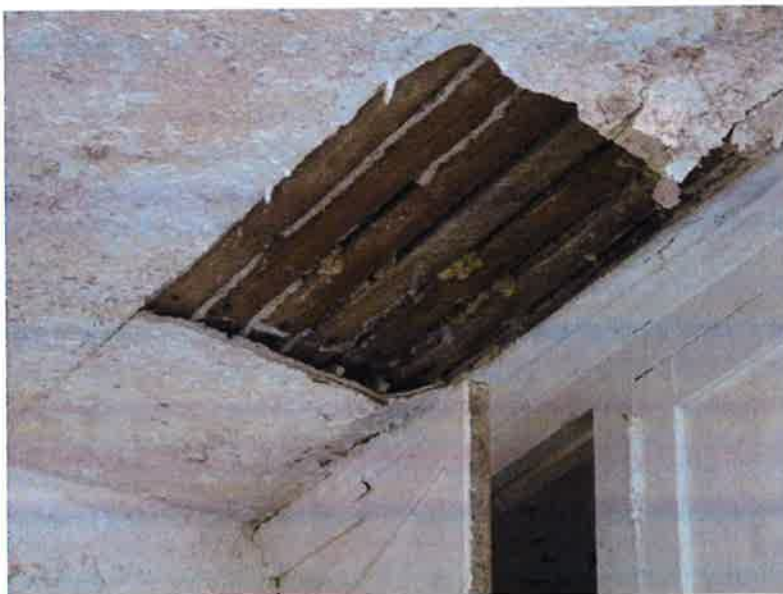
PHOTOGRAPH #17

Location:
1227 NW 4th Ave
Gainesville, FL 32609
Kitchen ceiling

Description:
Damaged ceiling in Kitchen
due to water intrusion into
building from roof

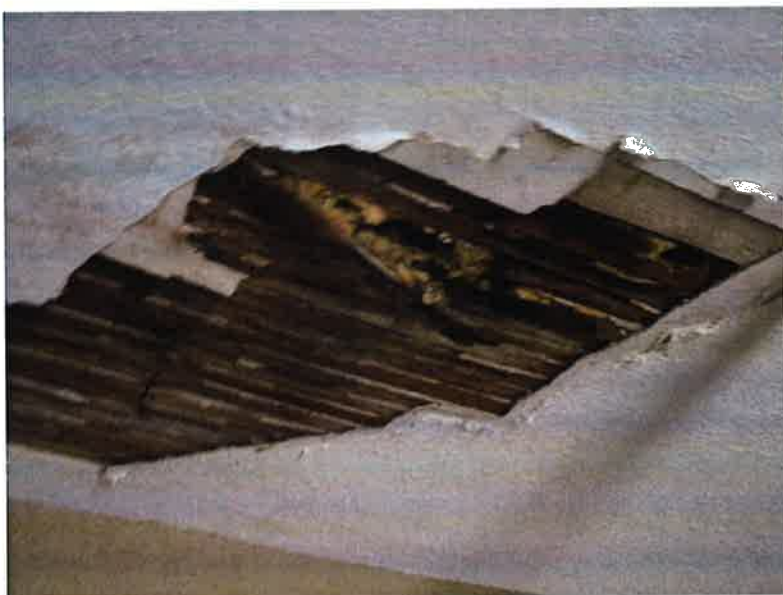
PHOTOGRAPH #18

Location:
1227 NW 4th Ave
Gainesville, FL 32609
Kitchen ceiling

Description:
Another damaged ceiling
area due to water intrusion
into the building.

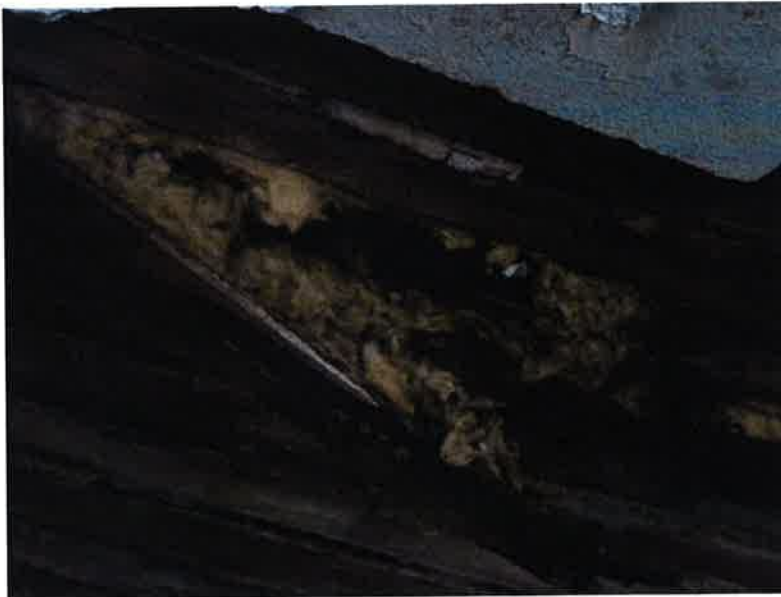
PHOTOGRAPH #19

Location:
1227 NW 4th Ave
Gainesville, FL 32609
Kitchen ceiling

Description:
Close up of damage to ceiling.

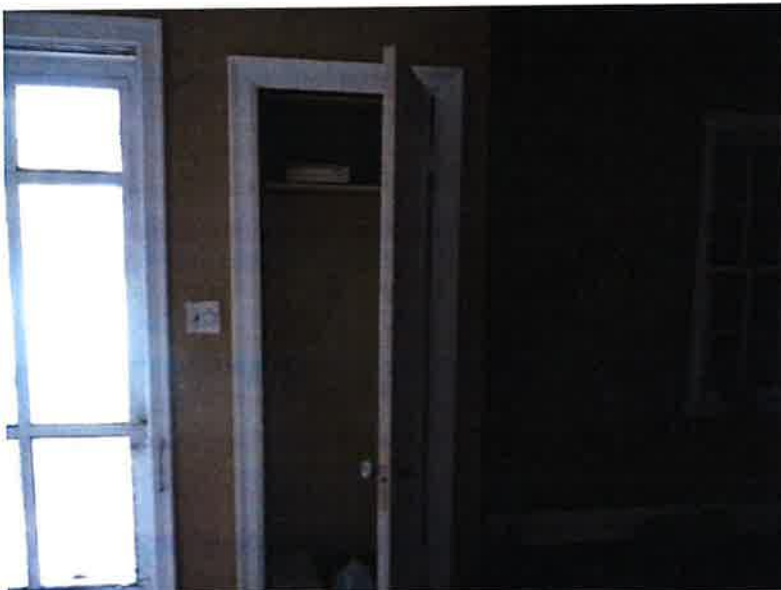
PHOTOGRAPH #20

Location:
1227 NW 4th Ave
Gainesville, FL 32609
Front entrance closet

Description:
Closet door next to front entrance will not close. Most likely due to settlement of the foundation

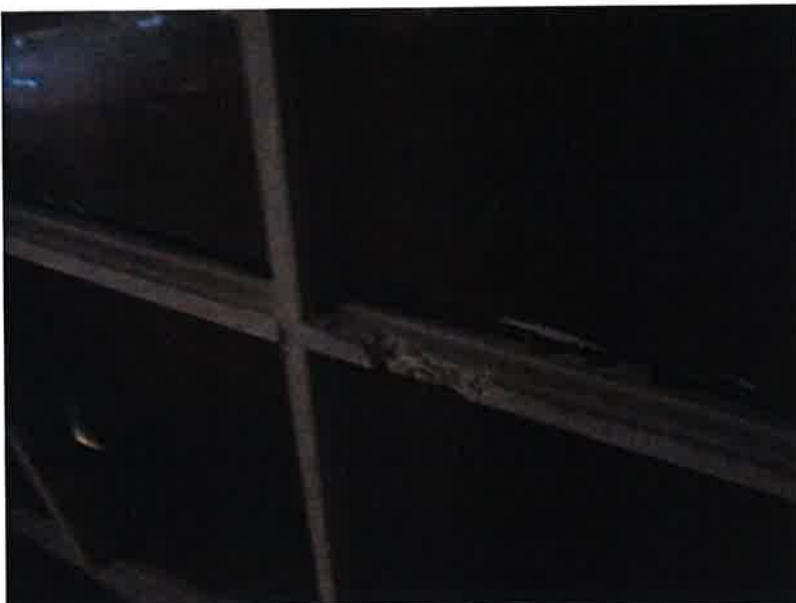
PHOTOGRAPH #21

Location:
1227 NW 4th Ave
Gainesville, FL 32609
Northeast window

Description:
Typical damages sustained to windows

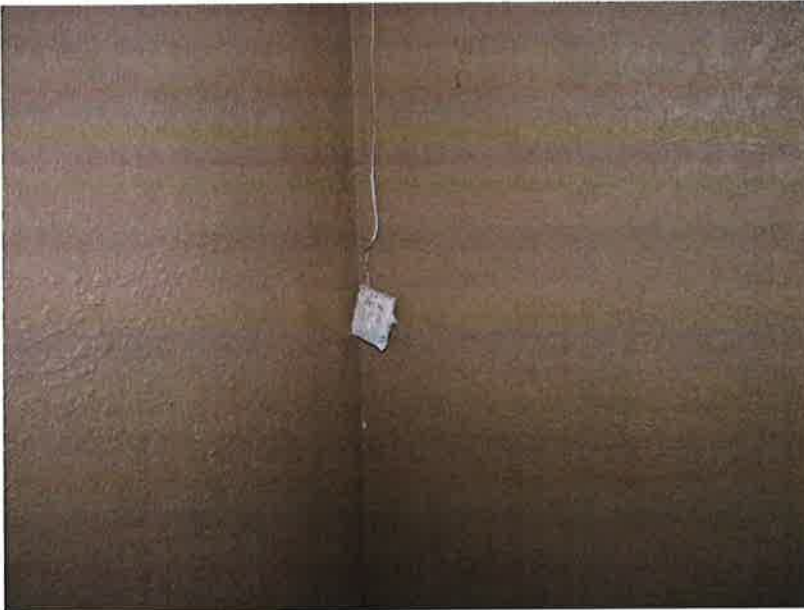
PHOTOGRAPH #22

Location:
1227 NW 4th Ave
Gainesville, FL 32609
Northeast corner

Description:
Damage to electrical system. This could be the door bell chime.

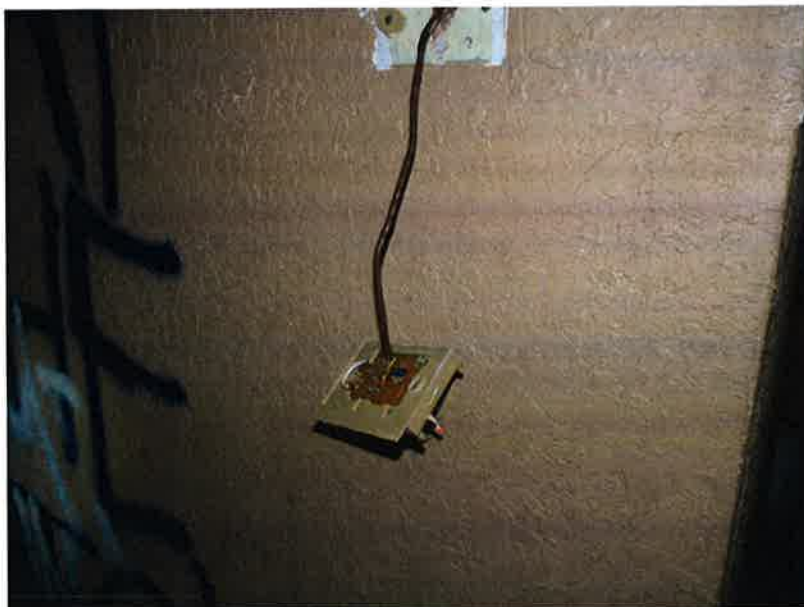
PHOTOGRAPH #23

Description:
More damage to electrical system

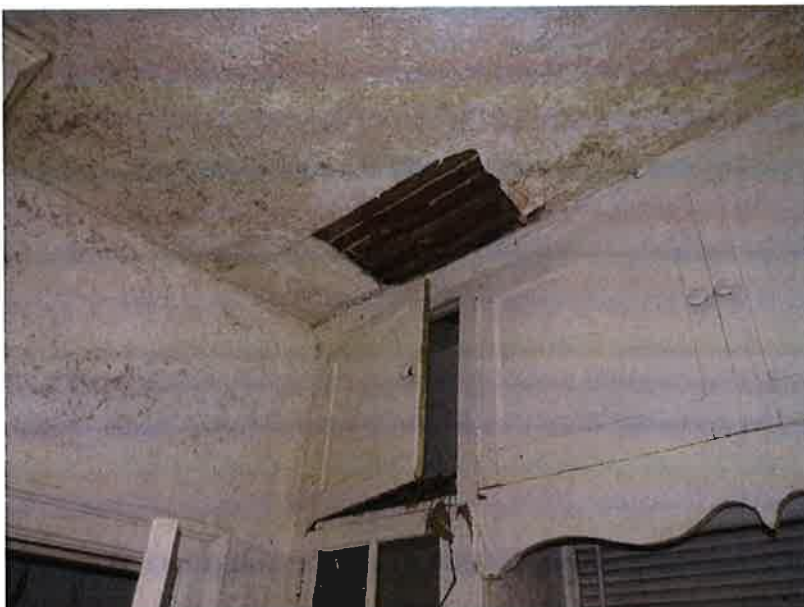
PHOTOGRAPH #24

Location:
1227 NW 4th Ave
Gainesville, FL 32609
Kitchen ceiling overall

Description:
Overall photo of damage to ceiling in the kitchen area due to water intrusion and long periods of excessive humidity in the building

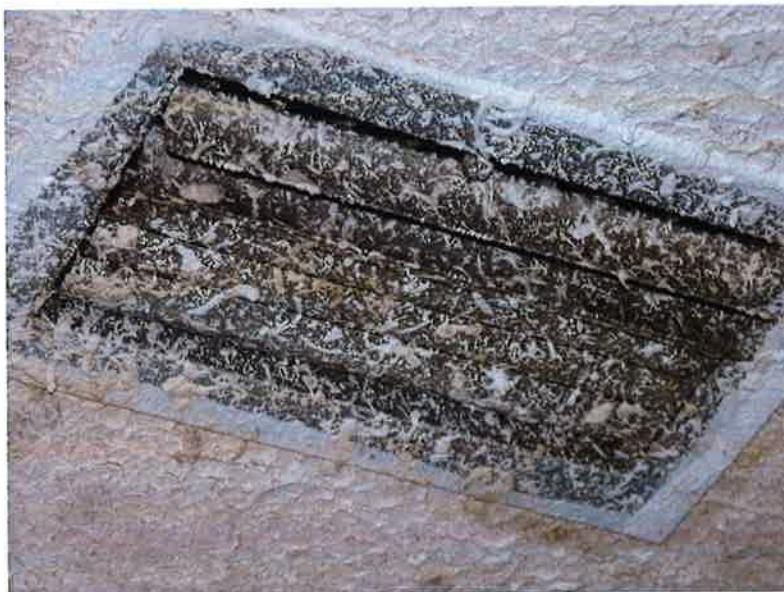
PHOTOGRAPH #25

Description:
Typical of damage sustained to air vents of the mechanical system. Mold and paint and stucco over spray.

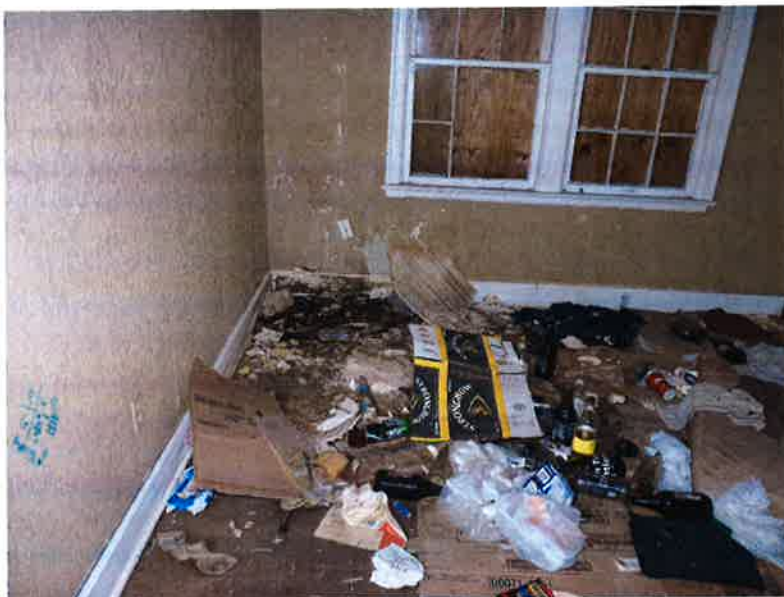
PHOTOGRAPH #26

Description:
Typical example of how each room as been literally trashed

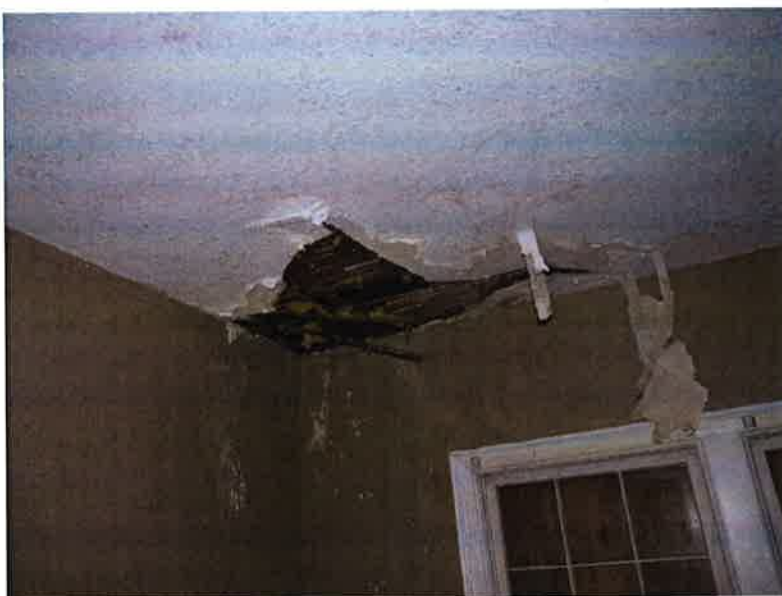
PHOTOGRAPH #27

Description:
More ceiling damage

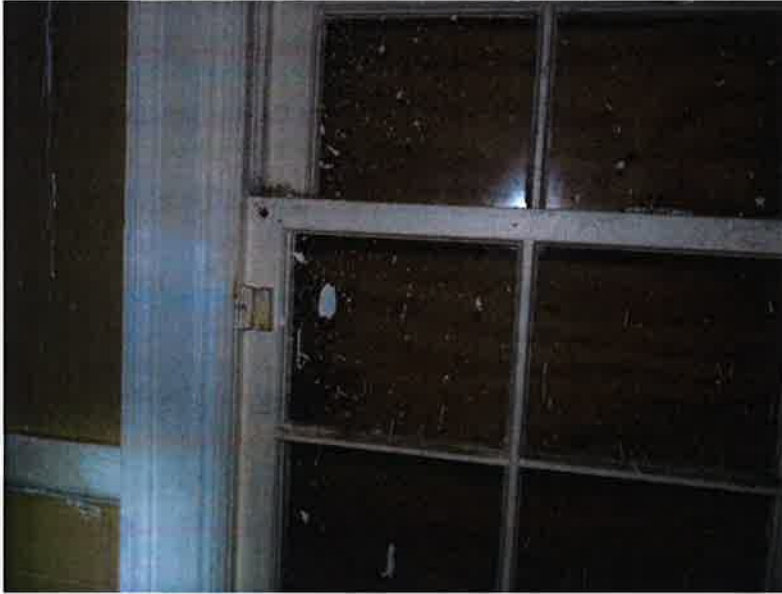
PHOTOGRAPH #28

Description:
More window damage

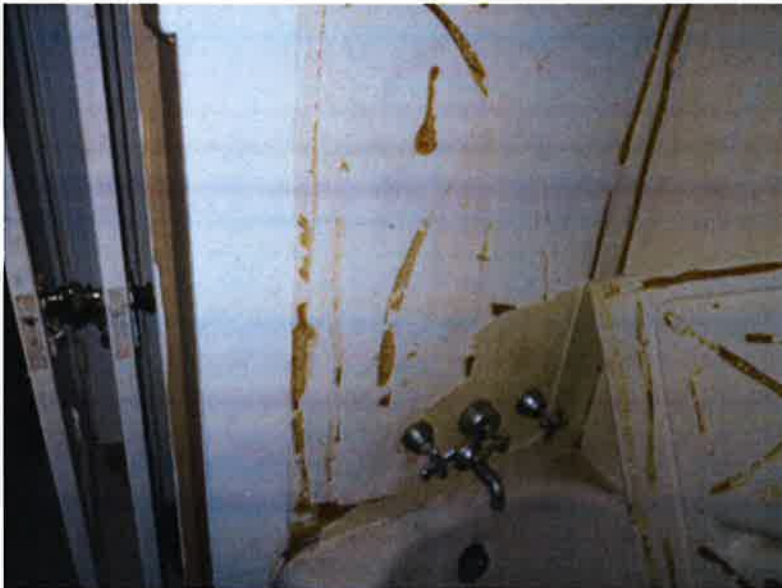
PHOTOGRAPH #29

Location:
1227 NW 4th Ave
Gainesville, FL 32609
Interior bathroom

Description:
This is the bathroom that has been leaking causing damage to the floor system. Here the bathtub surround has been destroyed.

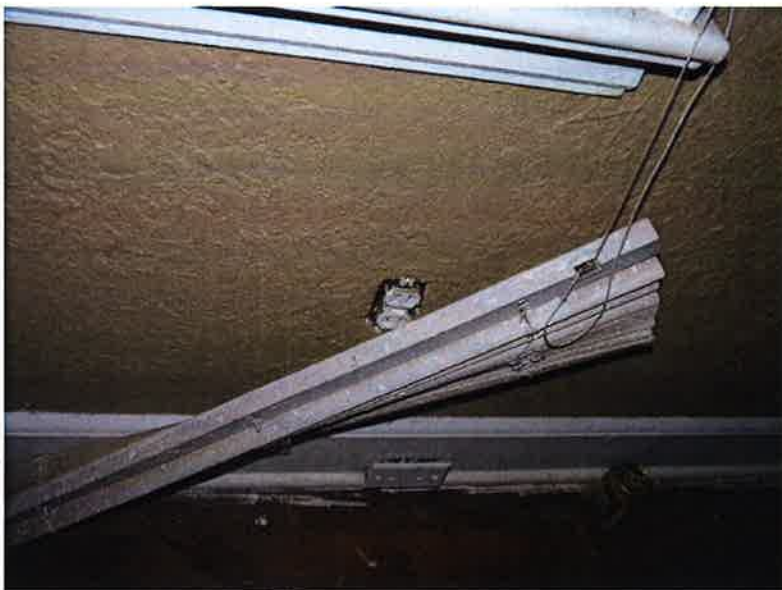
PHOTOGRAPH #30

Description:
Blinds and electrical outlet have sustained major damage

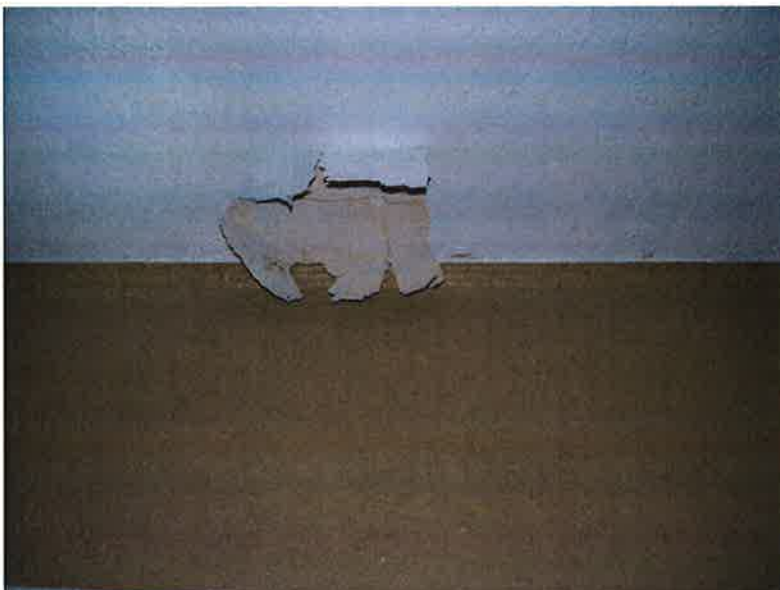
PHOTOGRAPH #31

Description:
Beginnings of a new roof leak causing damage to the ceiling

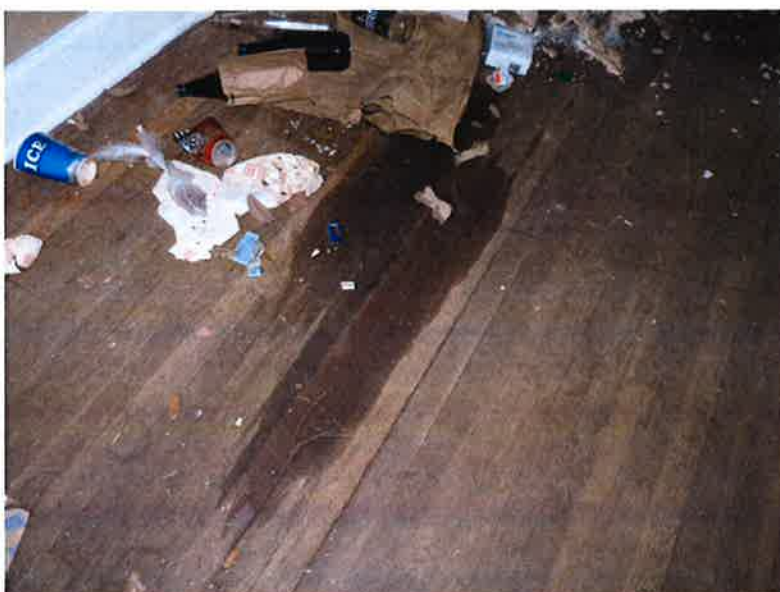
PHOTOGRAPH #32

Location:
1227 NW 4th Ave
Gainesville, FL 32609
Living room

Description:
Floor has been stained most likely from the formation of a new roof leak or perhaps urination.

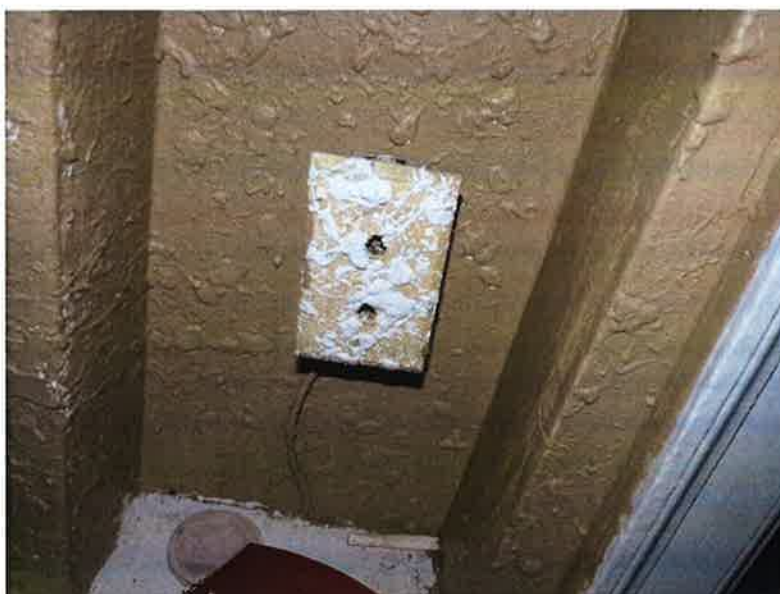
PHOTOGRAPH #33

Location:
1227 NW 4th Ave
Gainesville, FL 32609
Corridor 6-004

Description:
Damage to phone outlet due to excessive humidity and moisture.

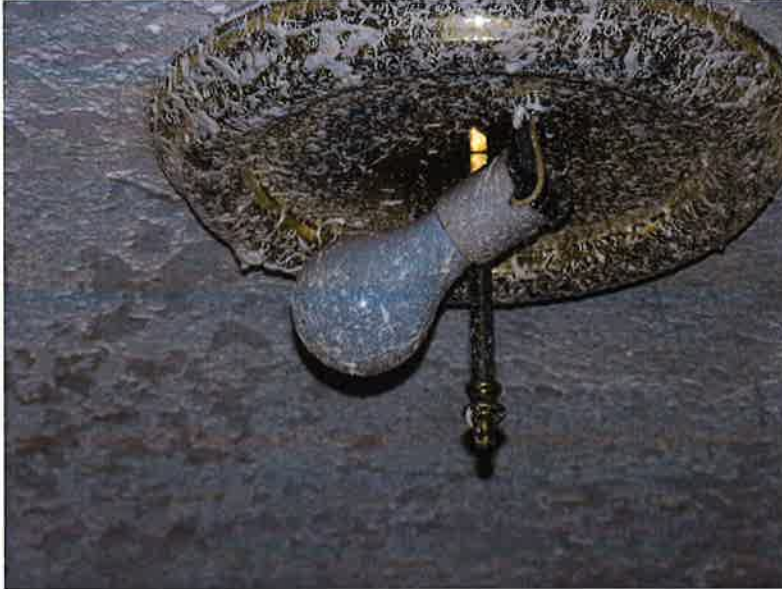
PHOTOGRAPH #34

1227 NW 4th Ave
Gainesville, FL 32609
North Exterior Wall

Typical of damage to light fixtures due to excessive humidity and moisture.

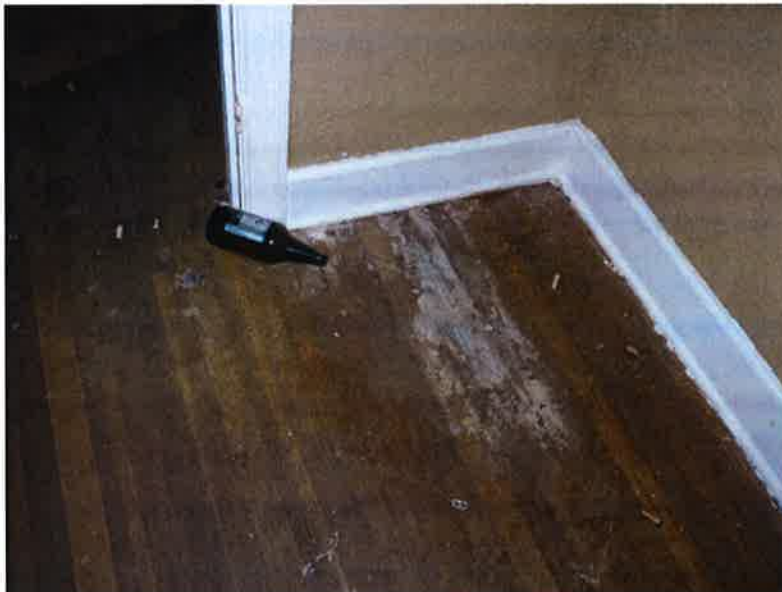
PHOTOGRAPH #35

1227 NW 4th Ave
Gainesville, FL 32609
North Exterior Wall

The flooring planking in this area feels a bit soft. Most likely cause be degradation due to moisture related damage
