## **POWER GENERATION MACHINERY RISK ASSESSMENT**

**City of Gainesville, Gainesville Regional Utilities  
J. R. Kelly Generating Station  
515 S. E. 5<sup>th</sup> Avenue  
Gainesville, FL 32614**

July 28, 2014

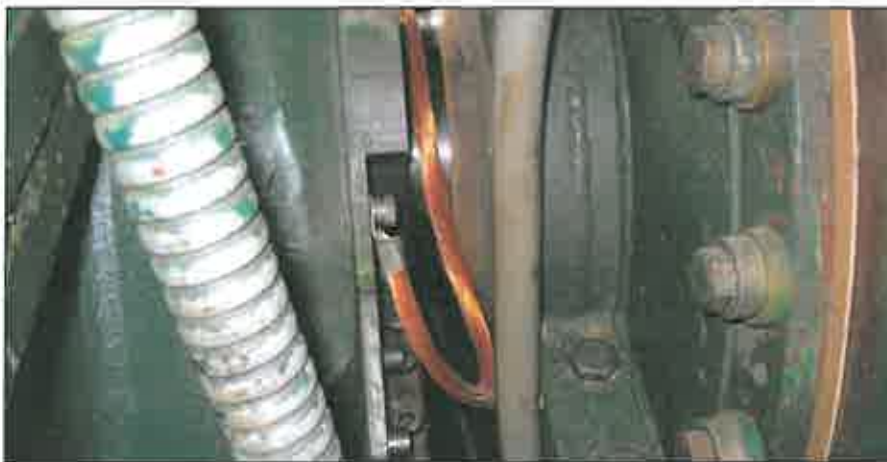
**Unit 8 Generator Shaft Ground Device**

The LP turbine has water seals but as a precaution from stray voltages and currents the plant has installed shaft grounding devices.

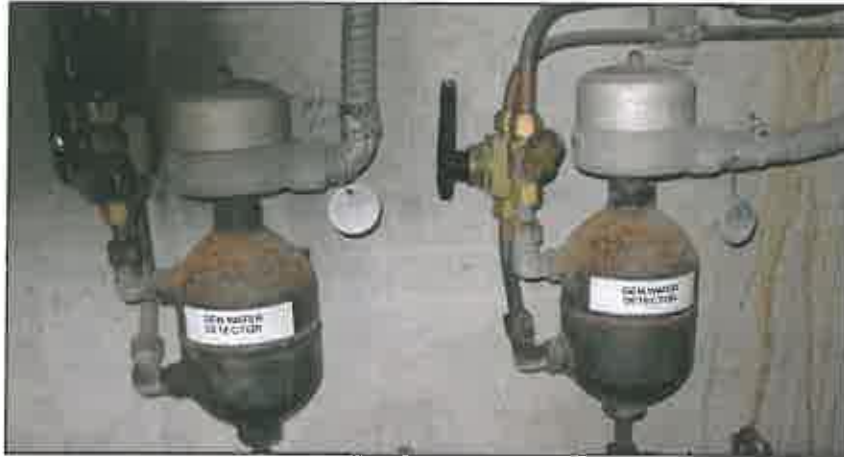
**Liquid Level Detector showing valves for functional testing**

Steam generator liquid detectors are tested monthly by pouring a liquid into the device until it activates the alarm.
