Asbestos Survey Update Report

**C.R. Layton U.S. Army Reserve Center (FL005)
1125 Northeast 8th Avenue
Gainesville, Florida**

June 2013

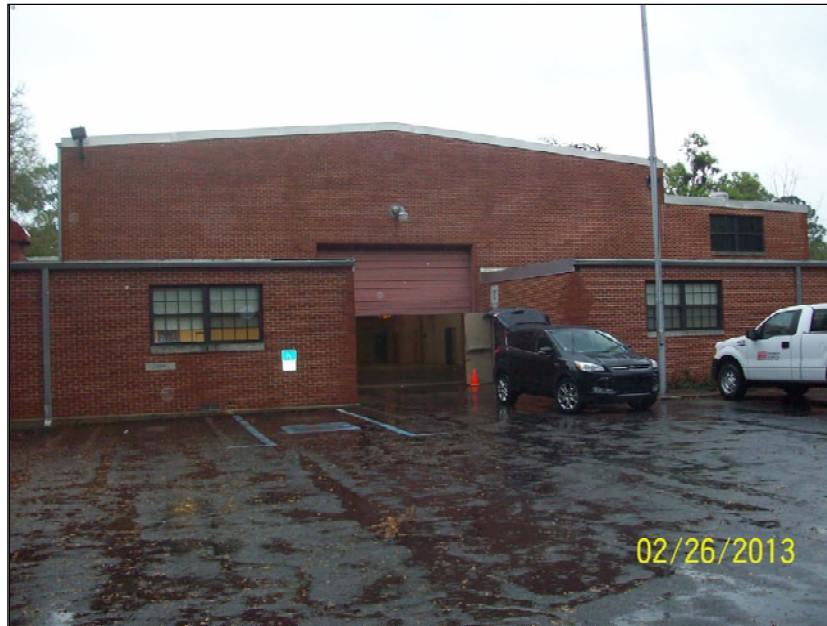
Photo 1: Front of USARC Building. Confirmed ACM: roof flashing material

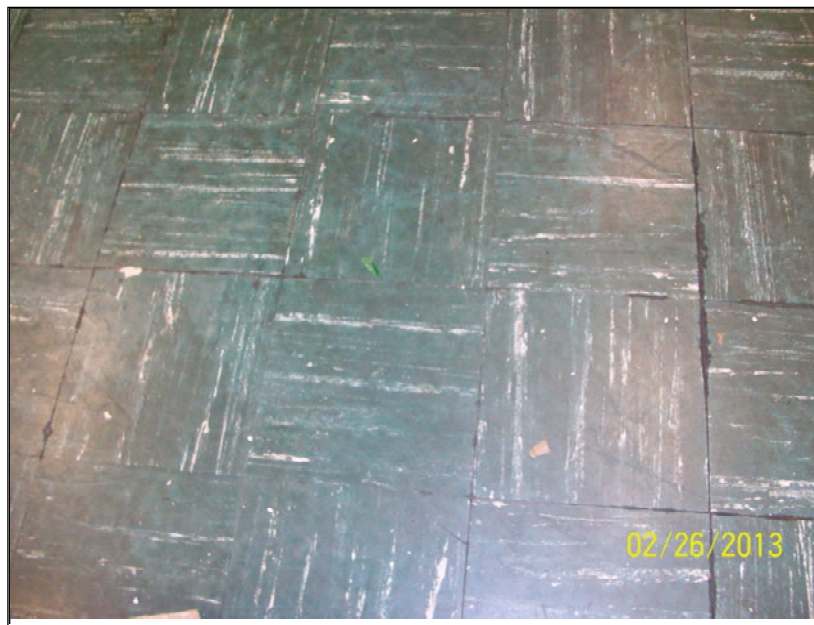
Photo 2: Confirmed ACM: 12-inch by 12-inch green floor tile and mastic

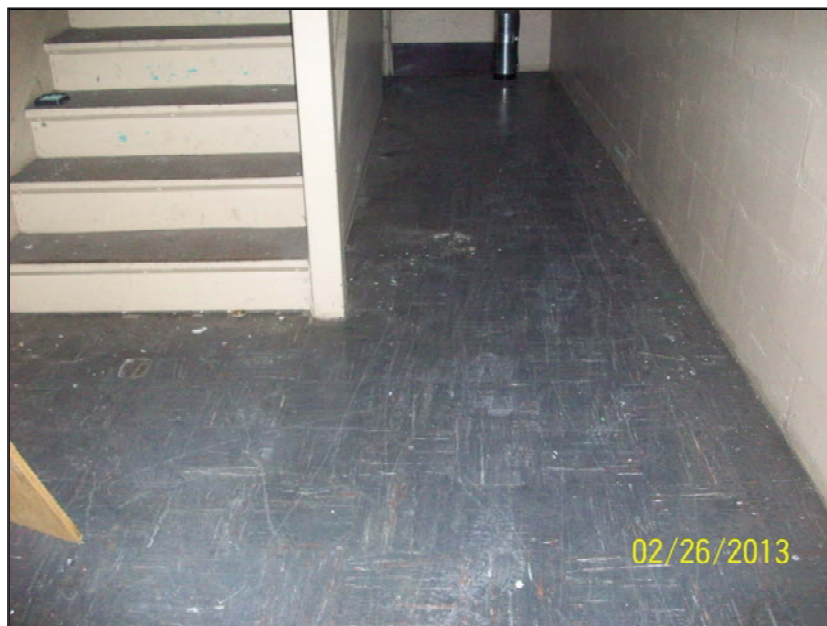
Photo 3: Confirmed ACM: 9-inch by 9-inch black floor tile and mastic

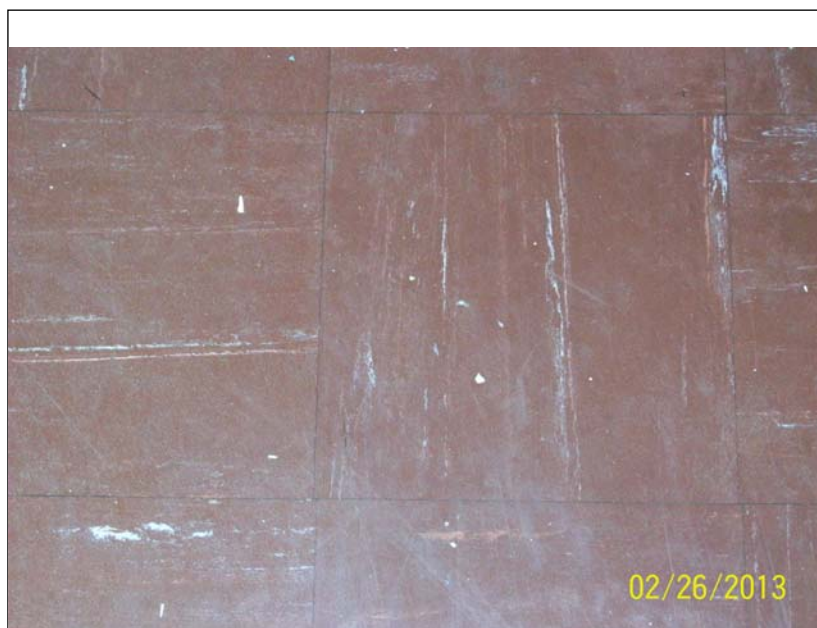
Photo 4: Confirmed ACM: 9-inch by 9-inch brown floor tile and mastic

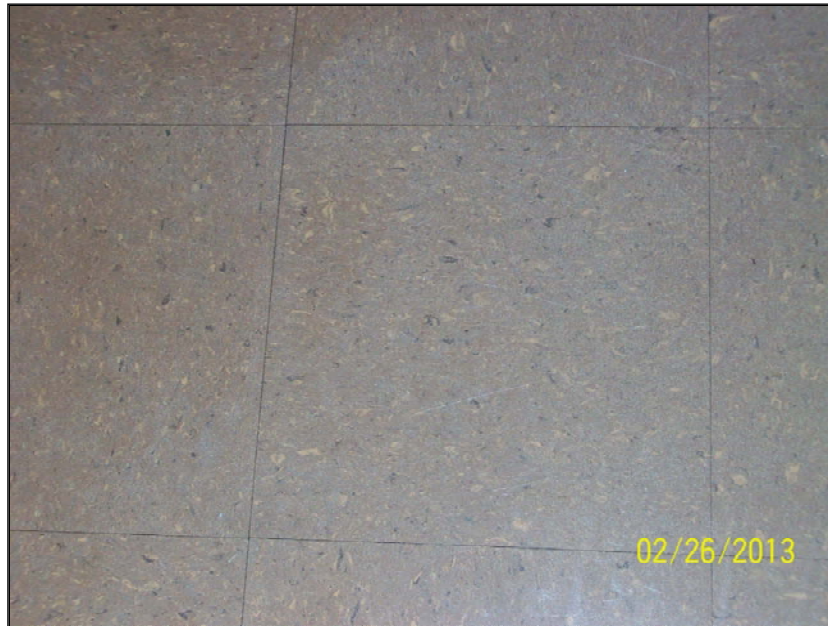
Photo 7: Confirmed ACM: mastic underneath 12-inch by 12-inch tan floor tile

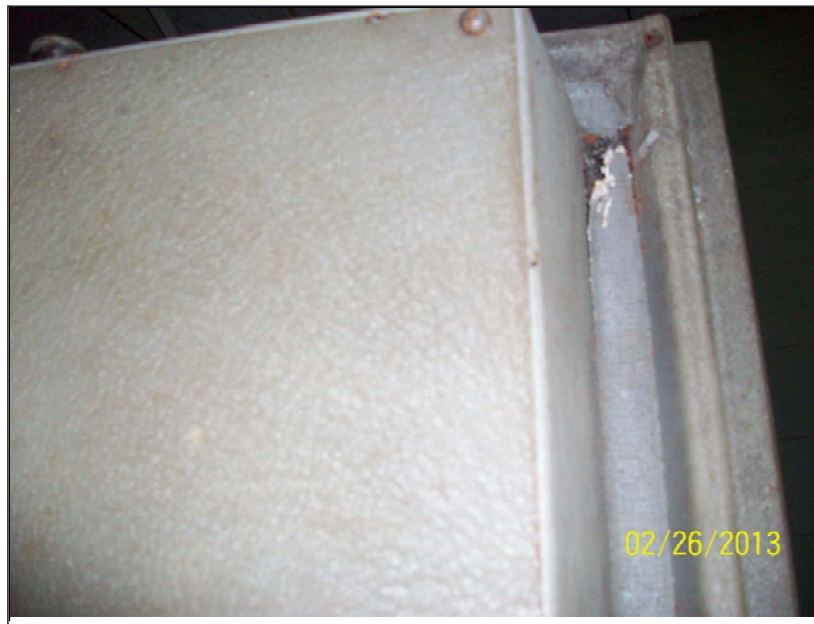
Photo 8: Confirmed ACM: woven gasket adhered to the seal of the arms vault door

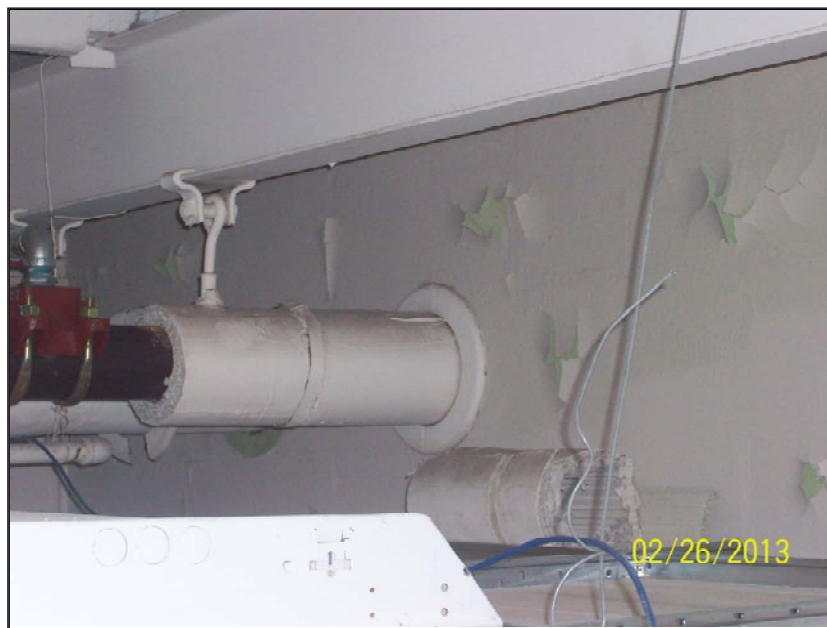
The confirmed or assumed ACMs were observed to be in good to fair condition at the time of the survey update field inspection. Approximately 1 percent total of the ACM pipe insulation has been damaged in rooms 101, 102, 110, and the firing range.

Photo 9: Confirmed ACM: pipe insulation (please note dislodged section)

- Approximately 1 percent total of the ACM pipe insulation has been damaged in rooms 101, 102, 110, and the firing range 124. PSI recommends repairing the damaged pipe insulation. ACM's should be maintained in a good, non-damaged condition through use of an Operations and Maintenance (O&M) program. Regulated ACM (RACM) must be properly removed by a licensed asbestos abatement contractor prior to renovations or demolition that would disturb the

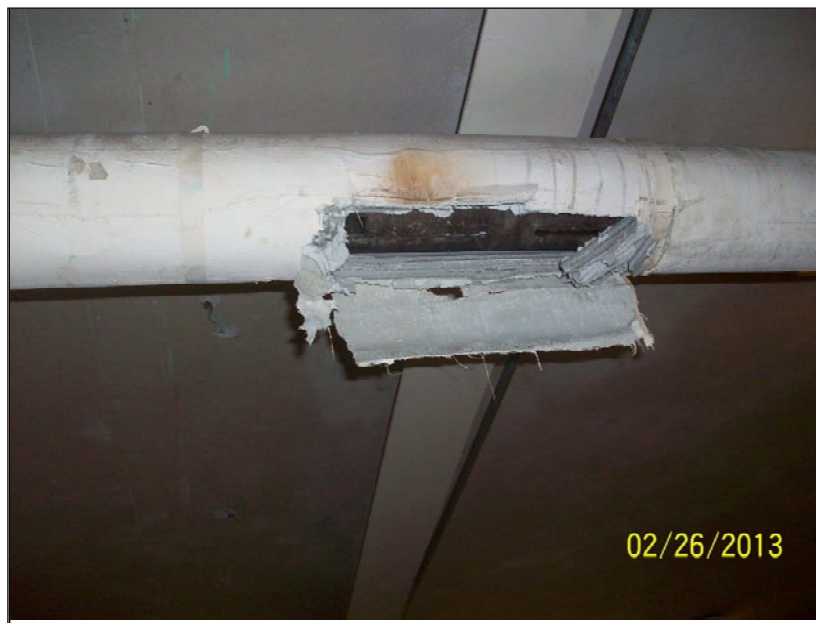
Photo 10: Confirmed ACM: pipe insulation. (Please note damage)

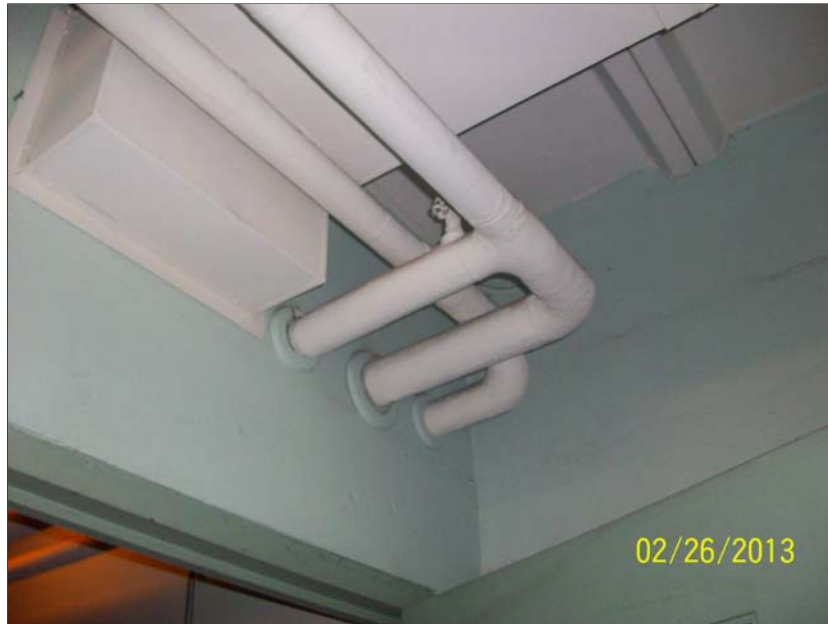
Photo 11: Confirmed ACM: pipe fitting insulation
