# POWER DISTRICT BUILDING NEEDS ASSESSMENTS

May 2015

Gainesville  
Community  
Redevelopment  
Agency

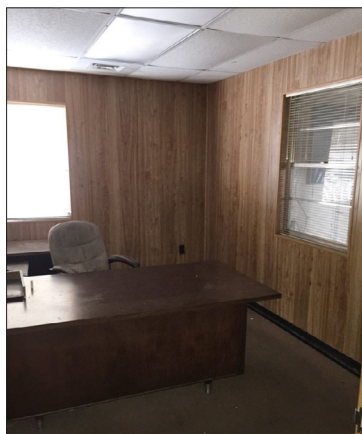
Office With Sagging Ceiling Tiles And Worn Carpeting

<p>The office areas should be completely renovated if they are to be reused.</p>
Ceiling System	Type 1: Lay-in acoustic ceiling tile. Most of the existing ceiling system is in poor condition and replacement is recommended. Batt insulation is present on top of the ceiling tile system.  Type 2: Warehouse spaces are exposed to the building structure.

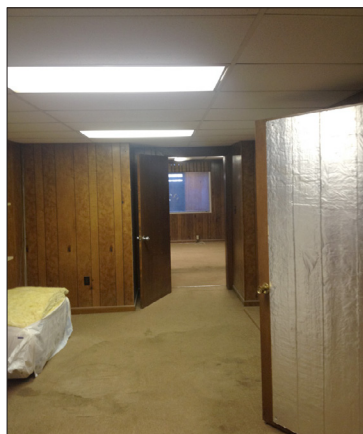
Office Area With Worn Carpeting

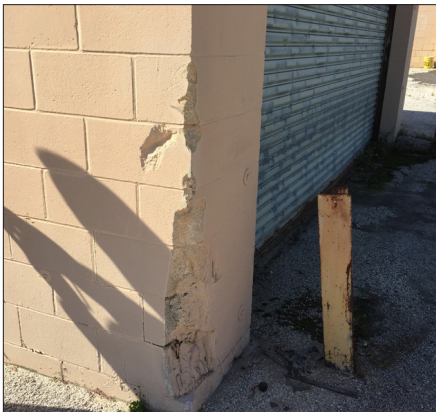
Wall Systems	Exterior Type 1 - CMU. Moderate exterior cracks were observed.

Broken CMU

Repair cracks.
	Interior Type 1 - Paint on CMU. Observed wall cracking was mostly mortar separation, but daylight is visible through the cracks.	
Floor System	First Floor - Poured-in-place concrete slab (slab on grade) Vehicle lift is in place, but does not appear to be functional at this time.

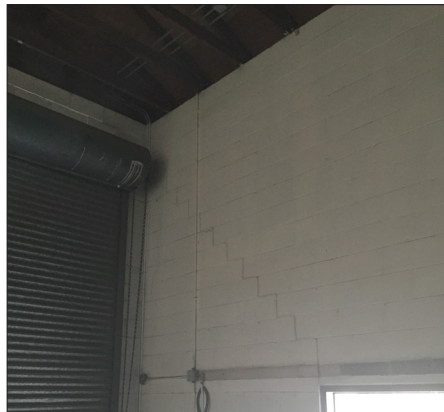
Wall Cracking

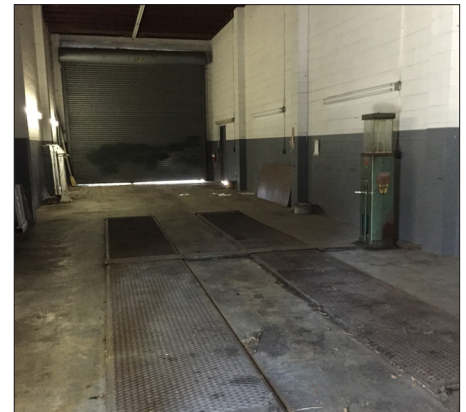
Slab With Vehicle Lift

Concrete slab may be reused. Remove or repair vehicle lift.
Roof	Existing roof system is asphalt shingles on plywood decking on wood trusses. Shingles appear to be in good condition. Installation date is unknown.

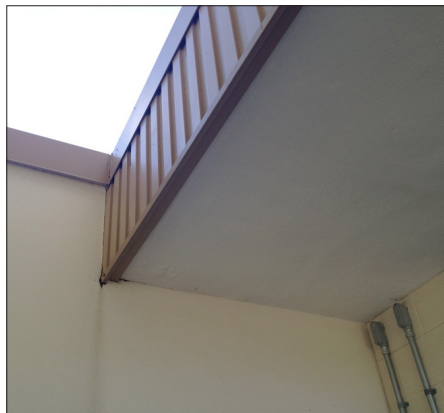
Possible Roof Leak

Repair roof leaks.
	Some water damage was observed on the exterior soffit which indicates a roof leak may be present. No other evidence of roof leaking was observed.

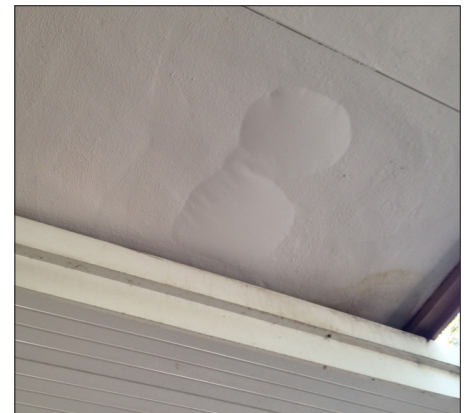
Damage Indicating Possible Roof Leak

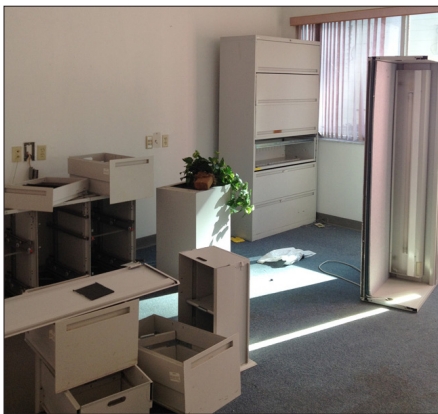
Office With Worn And Dirty Carpet

Replace all finishes.
	System 2: Ceramic Tile. Varied sizes and colors and in fair condition. (Toilet rooms and lobby areas)	
Ceiling System	Type 1: Office spaces have standard sound absorbent 2x2 or 2x4 acoustic ceiling tile. There has been some exposure to moisture which is evidenced by the sagging tiles.

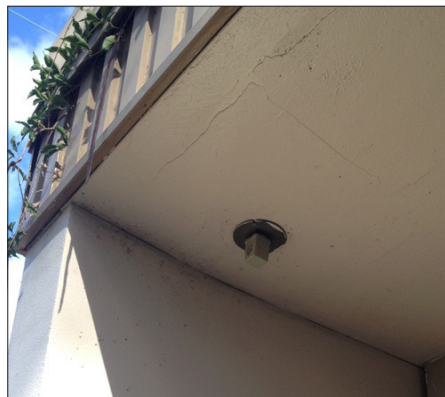
Some water damage was observed on the exterior soffit which indicates a roof leak may be present. No other evidence of roof leaking was observed.	
	System 2: Modified bitumen roof on metal deck.

Water Damage

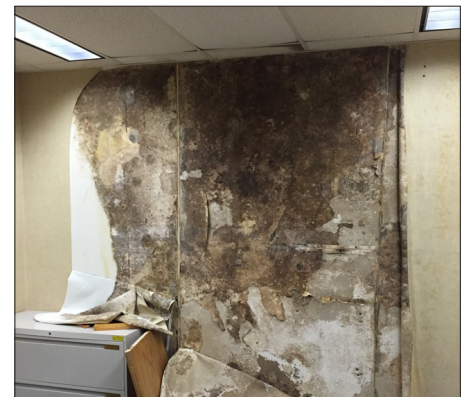
Mold Beneath Wall Coverings

In order to prevent further decline, immediately mitigate mold and repair the roof.

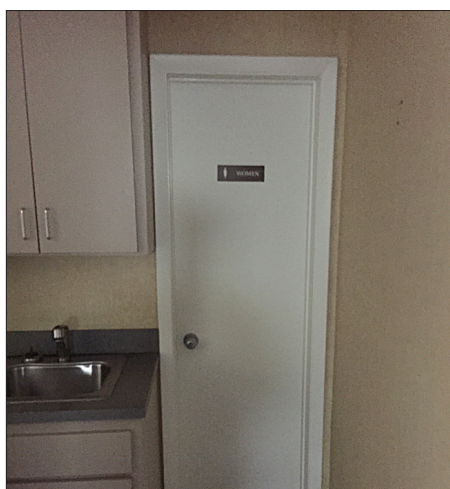
Toilet Room With Exterior Sink

Demolish plumbing stub-outs in existing offices.
Hot Water Systems	No hot water system was located during the survey.	
Other	There is a sink just outside of the restrooms in the main corridor. The sink is in poor condition.	Demolish existing sink. Install new sink to serve new tenant layout.

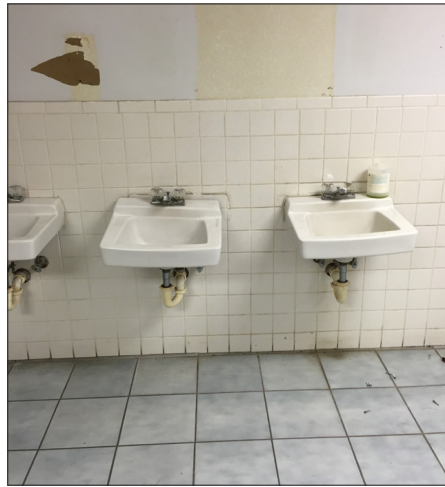
Water Damage At Sinks

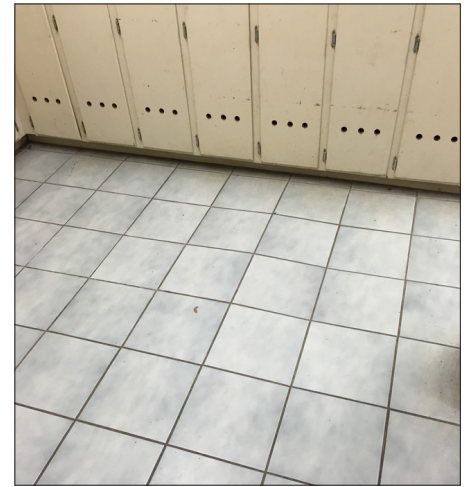
Water Damaged Locker Room Floor

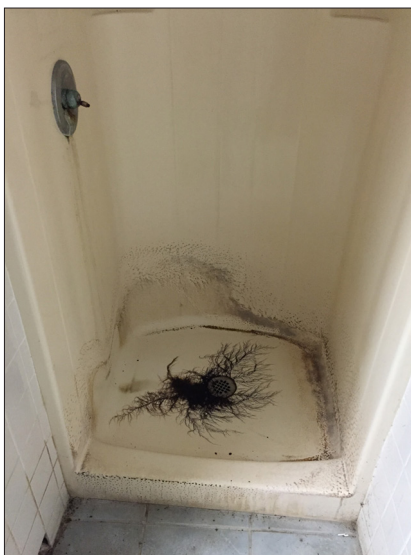
Extreme Mold Growth In Locker Room Shower

<p>Demolish existing plumbing fixtures and piping in locker rooms back to utility connections. Install new fixtures to meet current code requirements</p> <p>Demolish existing water heater. Install new water heater to serve new tenant layout.</p> <p>Demolish existing water cooler. Install new water cooler to serve new tenant layout.</p>
Piping	Existing water and waste piping is concealed and is likely unusable.	
Hot Water Systems	An existing 4,500 watt A.O. Smith water heater was installed in 2008. The casing of the existing water heater is rusted.	
Other	There is an existing water cooler in the front room that is in poor condition.

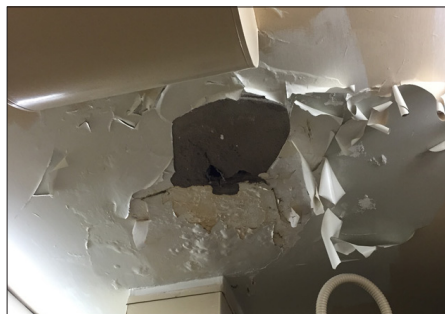
Water Damage Due To Roof Leak

In order to prevent further decline, immediately replace the roof and cap all plumbing.

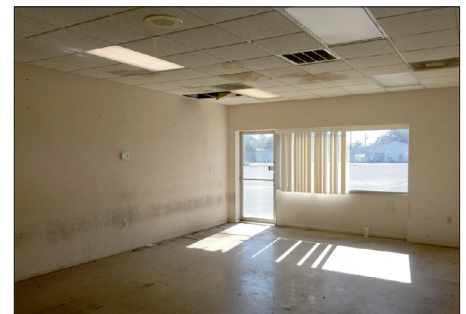
Water Damage And Mold Growth

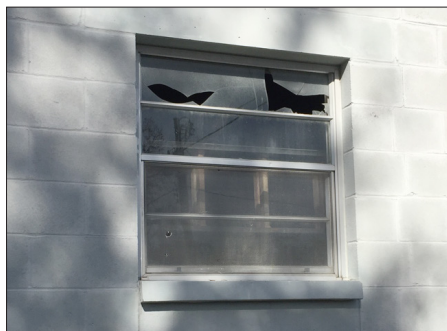
Broken Window Glass

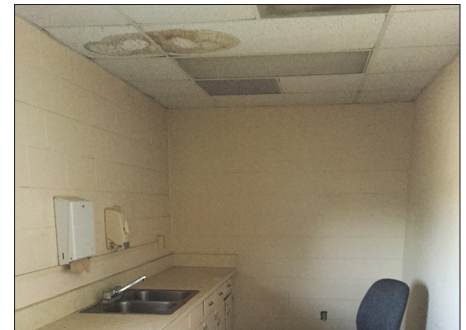
Water Damaged Ceiling Tiles

Remove and replace ceiling tiles.

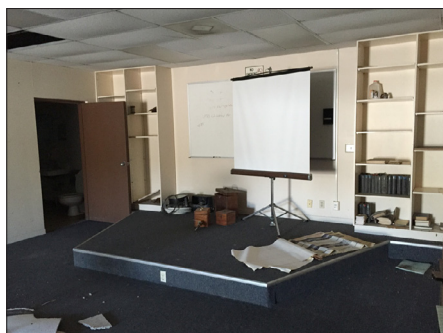
Sagging Ceiling Tiles And Worn Carpet

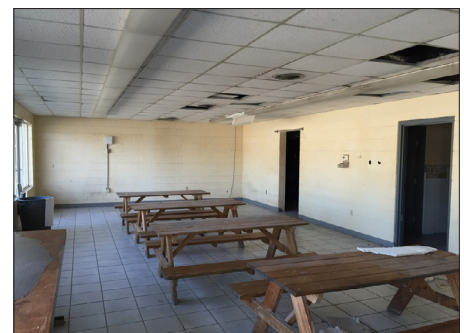
Break Area With Sagging Ceiling Tiles

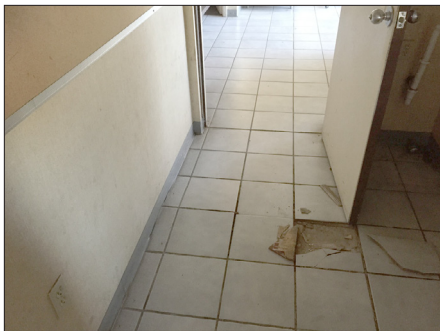
Broken Tile
