# NW Gainesville Finding of Necessity Study

# 1.0 - Introduction

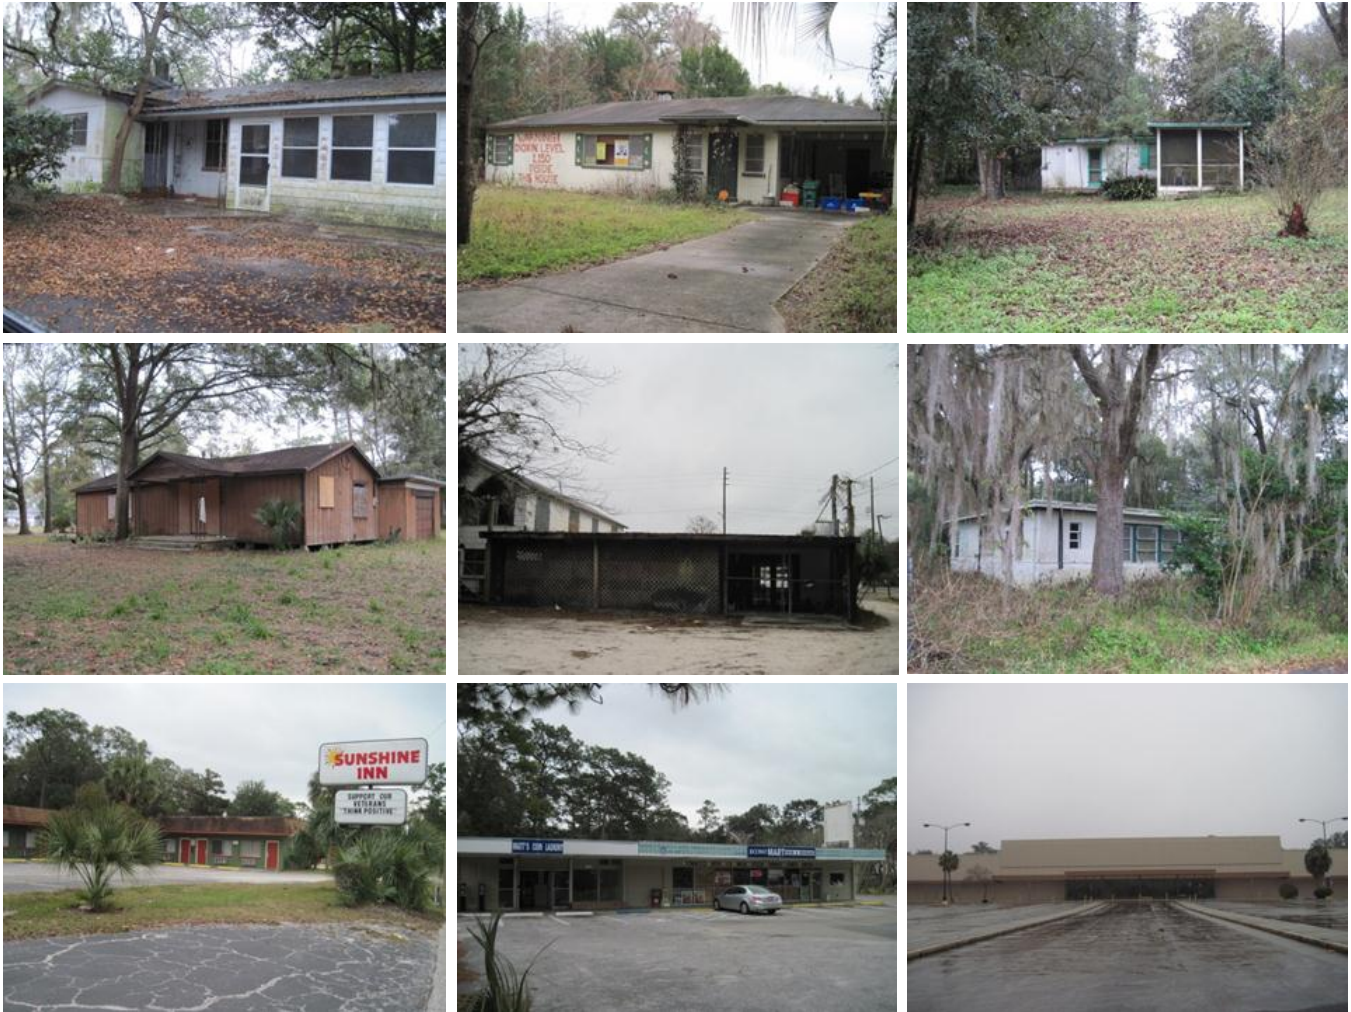
Figure 2-2: Examples of Deteriorating Structures and Unsanitary and Unsafe Conditions

A summary of this fieldwork is included in Table 2-1, and some representative examples of structural and unsanitary conditions are shown in Figure 2-2. This data shows that there are a significant percentage of deteriorating structures, unsanitary conditions, and outdated density patterns within the Study Area, Subarea 1 and Subarea 2.

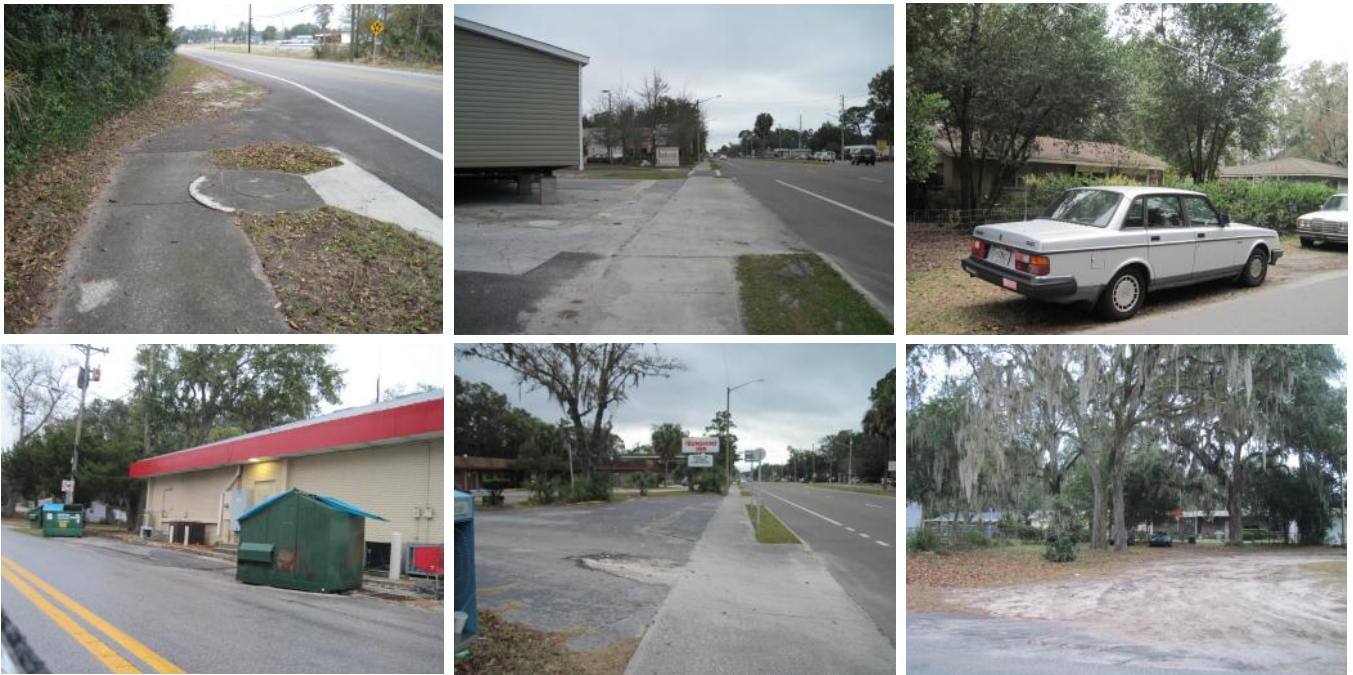
Figure 2-4: Examples of Unsafe Roadways

The documented traffic congestion and concentration of vehicular accidents demonstrate unsafe conditions along the commercial corridors, which include major arterial roadways along NW 13th Street (Subarea 1), 39th Avenue (Subarea 1 and Subarea 2), 23rd Avenue (Subarea 1 and Subarea 2), and NW 6th Street (Subarea 2). Field observations and analysis confirm that existing access management and roadway conditions are inadequate or defective and contribute to unsafe conditions. Inadequate parking and accessibility problems due to faulty lot layout and outdated building patterns may be a deterrent to future development until parcels are acquired.

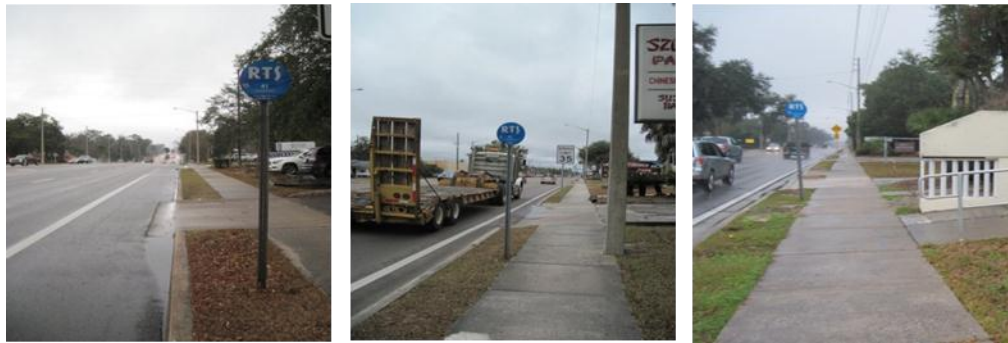
Figure 2-6: Examples of Inadequate Public Transit Facilities

As shown in Figure 2-6, public transit facilities are somewhat limited in the Study Area, though not inconsistent with the overall system as a whole (See Table 2-8).

The existing RTS stops in most cases are a pole sign adjacent to a sidewalk. Enhancements to public transit facilities and amenities that ensure ADA compliance are essential to create a safe and inviting waiting area. In addition, many of the transit stops along commercial corridors are lacking sidewalk connections and ADA access. The defective or inadequate public transportation facilities serve as another qualifying condition for blighted area.

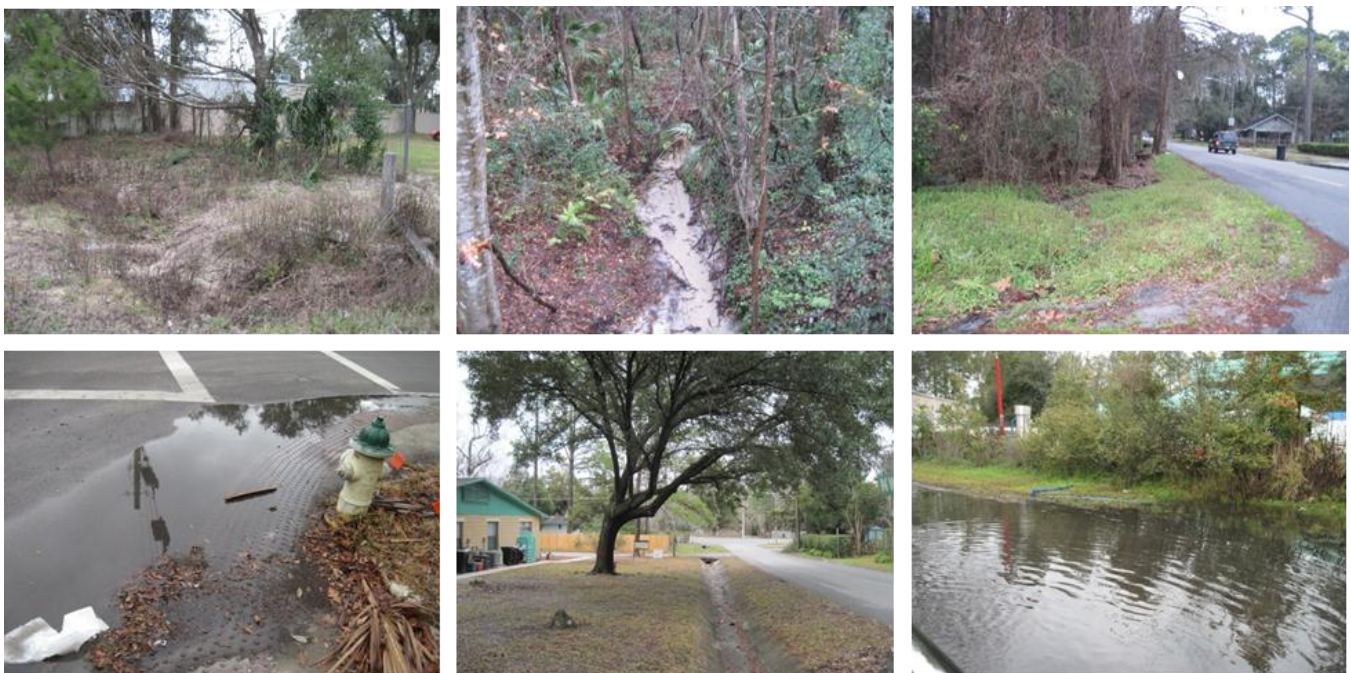
Figure 2-8: Examples of Inadequate Stormwater Facilities

Inadequate stormwater facilities are common throughout the Study Area including Subarea 1 and Subarea 2, as can be seen in the images in Figure 2-8. Most streets do not have curbs or gutters and have collections of water along roads and at intersections. On streets that do have curbs and gutters, adequate drainage does not exist in many areas. Additionally, the condition of stormwater facilities on many of the large commercial properties varies greatly due to development age, etc. Many of the large commercial properties are over 30 years old, which likely means that redevelopment will require the installation or significant upgrade of stormwater facilities.

Redevelopment along commercial corridors for retail and multi-family redevelopment can benefit from a master stormwater management plan and system that can significantly aid in supporting new construction and rendering parcels more easily developable.

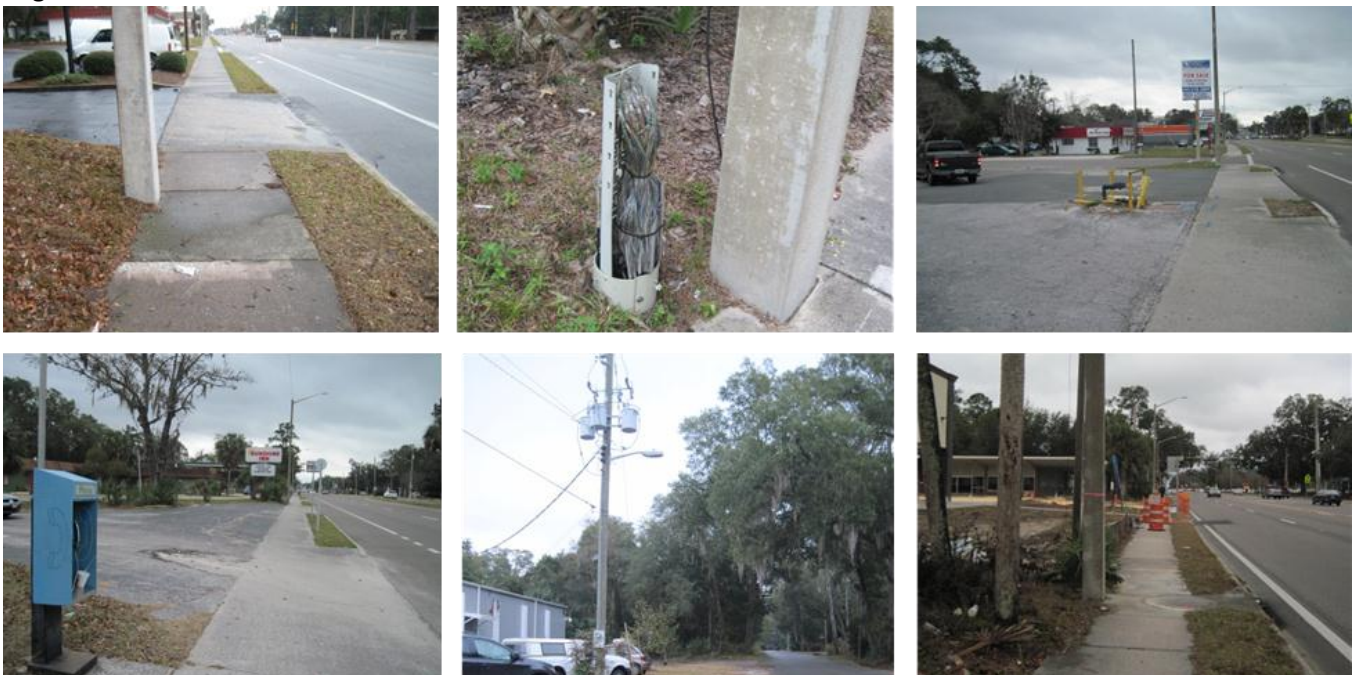
Figure 2-9: Condition of Utilities

During fieldwork, observable issues/concerns with aboveground utilities were documented. Several issues were the most prevalent within the Study Area including Subarea 1 and Subarea 2, consisting of outdated utilities, facilities within pedestrian areas, or poorly protected utilities (See Figure 2-9).

The existing overhead utilities create additional support for unsafe conditions and defective roadways, which contributes to physical and visual blight. Undergrounding overhead utilities improves roadway safety by preventing roadway obstacles during hurricanes and reducing the chance of motorists striking poles, and fire hazards due to downed lines.
