**WALDO ROAD CORRIDOR
PRELIMINARY BLIGHT FINDINGS REPORT
FOR THE EXPANSION OF THE EASTSIDE COMMUNITY REDEVELOPMENT AREA**

Prepared by:
Asset Property Disposition, Inc. (APD)

**DRAFT
July 2, 2007**

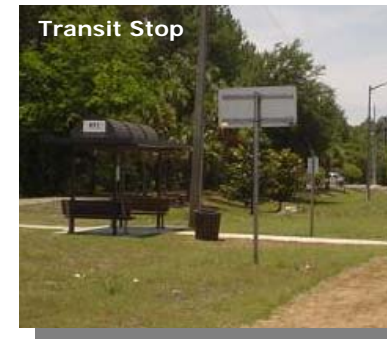
The transit amenities provided at the stops along Routes 15 and 24 are limited to 7 wooded and concrete benches in various conditions and 2 metal shelters. Despite having a large ridership, pedestrian safety is compromised due to limited amenities that are designed

to protect pedestrians from environmental elements and vehicular movements while commuting.

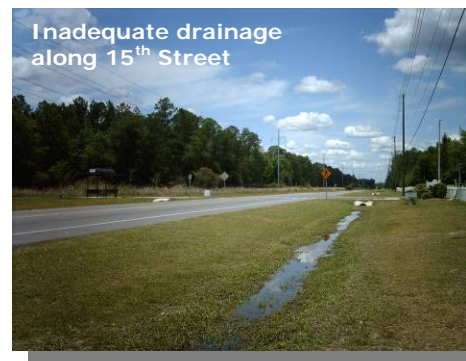
Pedestrian facilities within the study area are incomplete, inadequate or non-existent. Missing sidewalks are internal to the residential blocks and along the corridors of the of the Waldo Road Corridor study area. This lack of consistent and reliable pedestrian facilities fails to provide adequate connections to surrounding residential neighborhoods, public facilities, commercial and employment generators located in the area. Although there are formal trails and bike paths along the perimeter arterials that offer alternative modes of transportation, the lack of continuous sidewalk connection compromises the safety of pedestrians to utilize these facilities.

In addition to the incomplete pedestrian facilities, there are also limited pedestrian amenities including lighting, benches and buffering from

vehicular movements. Streetscape improvements and the installation of such amenities increase the functionality of and safety of the overall pedestrian infrastructure. The incomplete pedestrian facilities are identified on the figure 3.2.

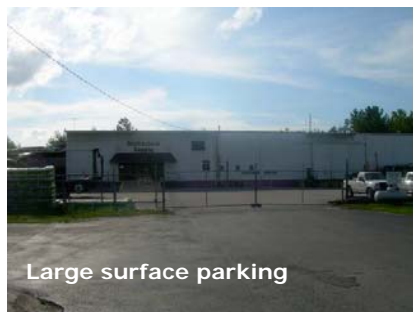
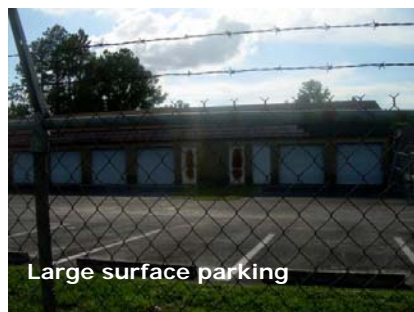
The industrial uses along Waldo Road contain an abundance of parking creating a more than adequate parking environment, but contributing to the lack of usefulness of the site. These aging properties are positioned on the rear of the site with parking located in front along Waldo Road. These parking facilities also lack efficient landscaping to assist with runoff due to the abundant amount of asphalt or concrete. Ultimately this underutilization of land contributes to the lack of usefulness of the facilities and overall economic viability and sustainability of Waldo Road.

Large surface parking

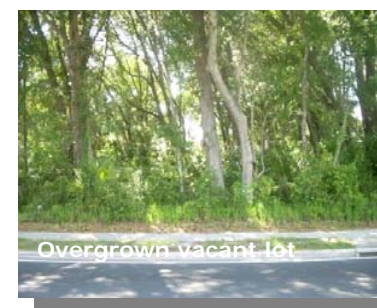
Also contributing to the blight and deterioration in the area are the vacant and overgrown lots. These lots, although scattered throughout the single family neighborhood of Carol Estates and along Waldo Road, illustrate lack of investment and underutilization. As shown on the following images, the haphazard location of these vacant lots contributes to the perception of crime, loitering, and nuisance behavior which make future development within the corridor difficult. Vacant lots and unsanitary conditions contribute to an unstable environment ultimately leading to the decline in the market value of the newly constructed housing and commercial development within the study area. This condition results in a high hurdle for private developers

Overgrown vacant lot

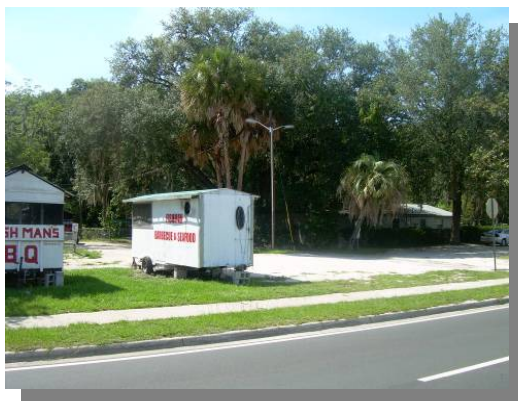
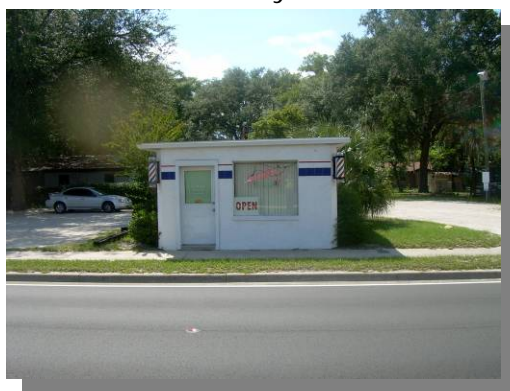
The Waldo Road Corridor study area is characterized by a lack of planning and disjointed uses which have inhibited growth in the study area. With this disparity in character comes an outdated

building density pattern evident by adjacent low and medium density structures and the lack of inter-parcel connectivity, shared driveways and parking facilities. Inconsistent build patterns in the study area show a disconnect

between land uses and a lack of uniformity which are key elements in urban design.

These density pattern factors contribute to an overall impression of degradation, deterioration, and economic distress while compromising future investment in the area.
