Vehicle Speed Evaluation
Porters Neighborhood
Gainesville, Florida

Prepared For:
City of Gainesville
Public Works Department

Prepared By:
George F. Young, Inc.
Transportation Consultants
Gainesville, Florida

Append
August 26, 2015

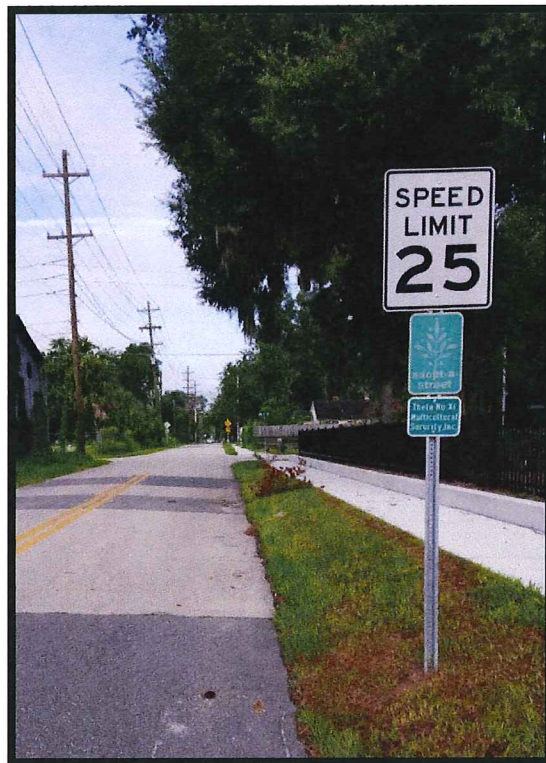
a. Speed limit postings:

1. The area-wide inventory demonstrated very limited postings.
2. The postings are consistent at 25 miles per hour.
3. The postings do meet City and State standards and guidelines.

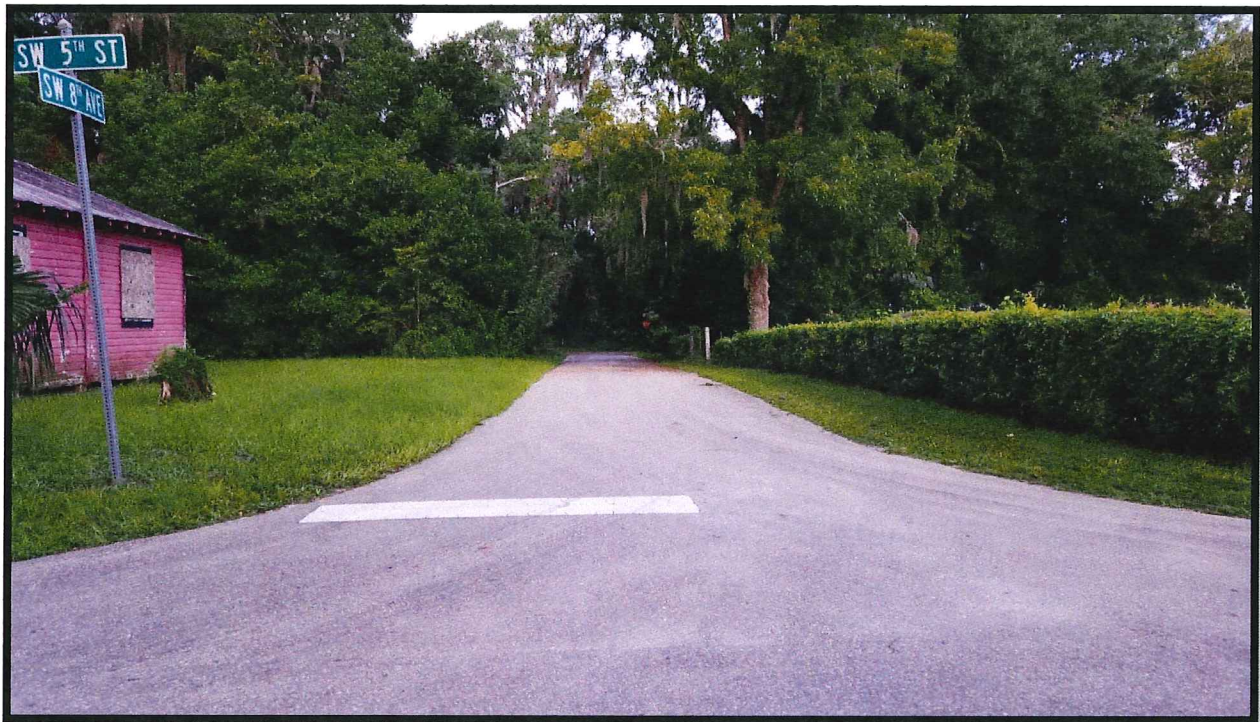
1. Sub-standard roadway conditions – the definition of a sub-standard roadway may be defined as a “windshield survey” supplemented with field measurements or ground observations to determine if a section of roadway meets City standards, while providing a general description of the physical constraints that may prevent upgrading the sub-standard condition, with a detailed description of the proposed improvements. The National Highway Safety Standards considers travel lanes less than 9 feet wide sub-standard and mitigation measures should be considered.

Sample of a sub-standard roadway

National, State and City regulations – Although the neighborhood roadway posted speed limits follow National, State and City guidelines, **this review has found sub-standard roadway conditions.** As illustrated under the existing condition sections, sub-standard roadways typically advocate a reduction in the current posted speed limits.

Recommendation – The current posted speed limit of 25 miles per hour appears to be effective and accepted on S.W. 5th Avenue and S.W. 3rd Street which are standard applied roadways. However, the internal grid system roadways are primarily sub-standard and should be considered for a reduction in the posted speed limit to 20 miles per hour. Although, there are substandard roadways within the neighborhood, it would not be financially feasible to make all necessary improvements.

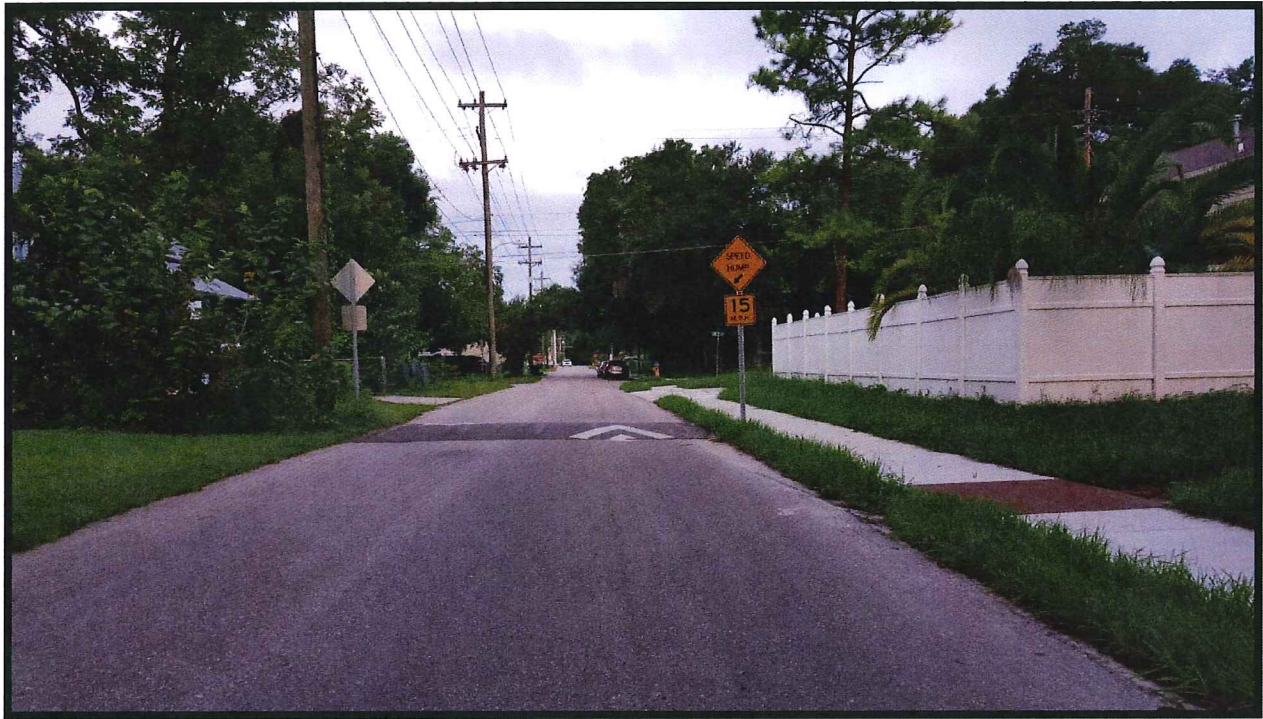
d. Traffic calming features:

1. Several roadways within the area have traffic calming devices and notifications in place.

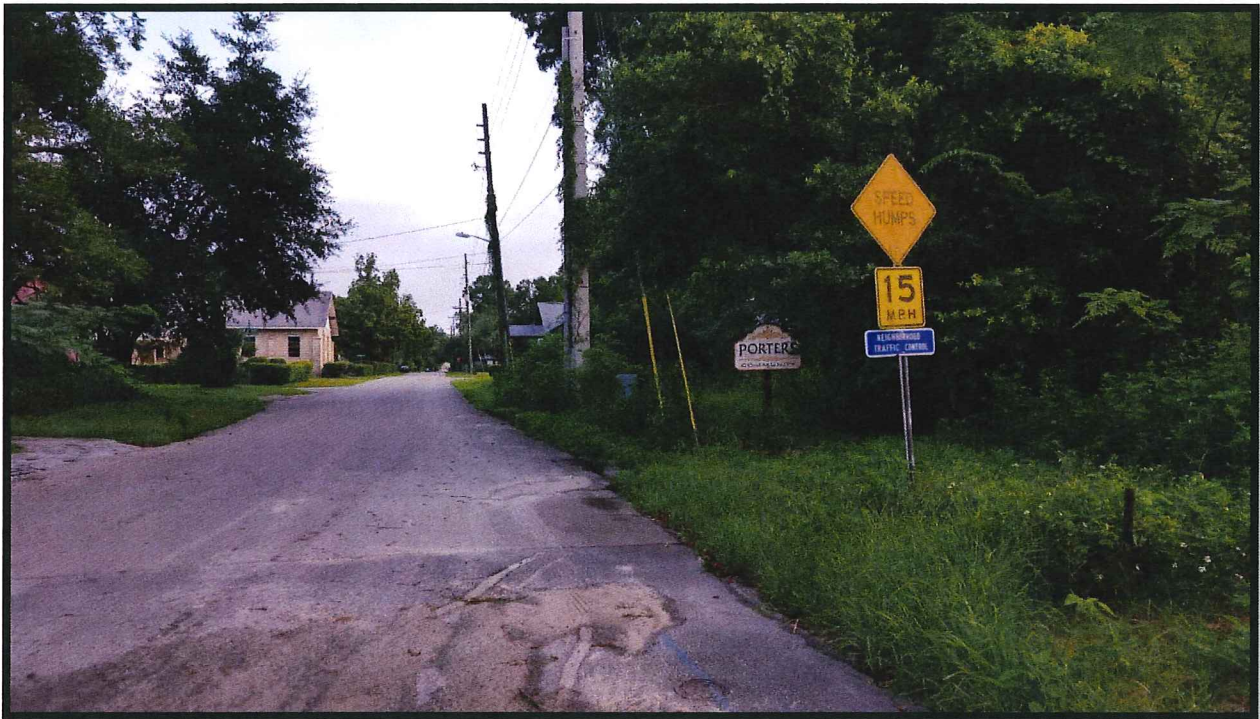
g. Visual restrictions/hazards:

1. There are several roadways with site restrictions which are hazardous (sub-standard). Vegetation has grown to a mature state that signs are being blocked of the intended messages.

1. There are several roadways, as illustrated above, that the clear zone is sub-standard. The vegetation is within four (4) feet of the edge of the roadway as suggested for local urban roadways.

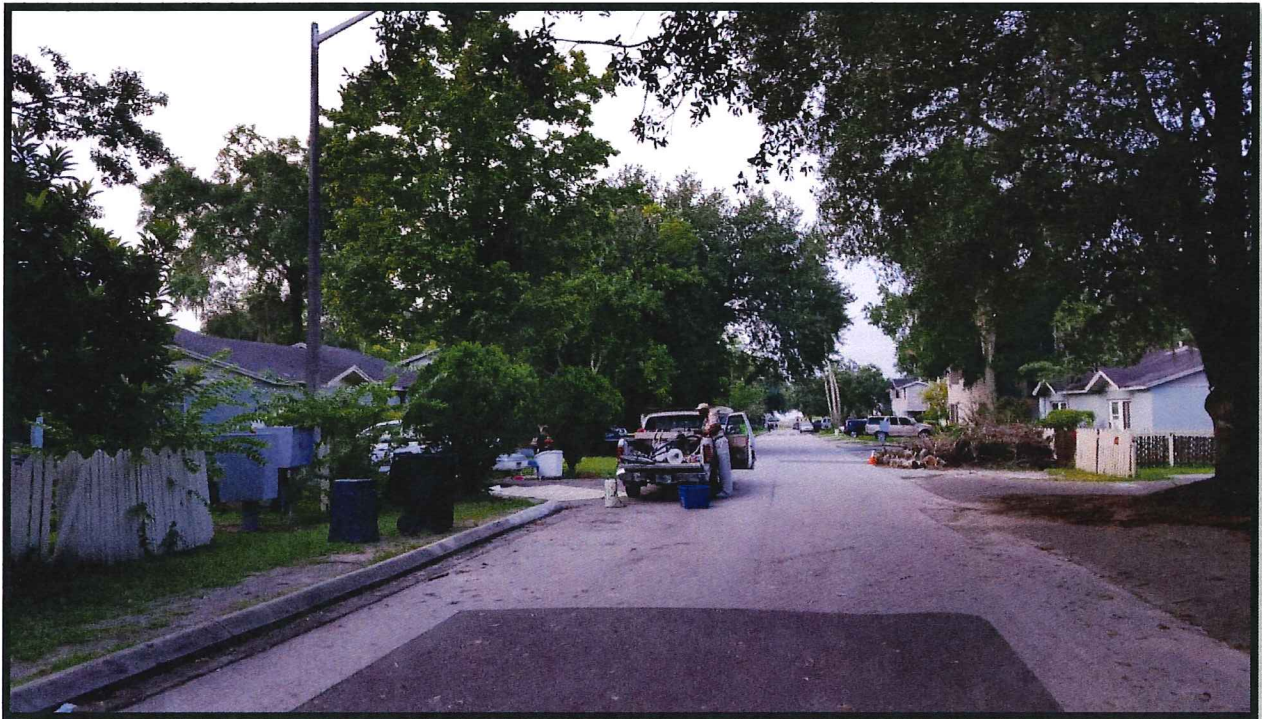
i. Vehicle types:

1. The area is utilized by several means of vehicle types from cars, mini-vans, pick-up trucks and bicycles. On several occasions, lawn maintenance crews with trailers and delivery vehicles use the streets within the neighborhood for parking. On occasion, outside large trucks will use the neighborhood as a short-cut to avoid the adjoining busy major roads. This is discouraged by the City.

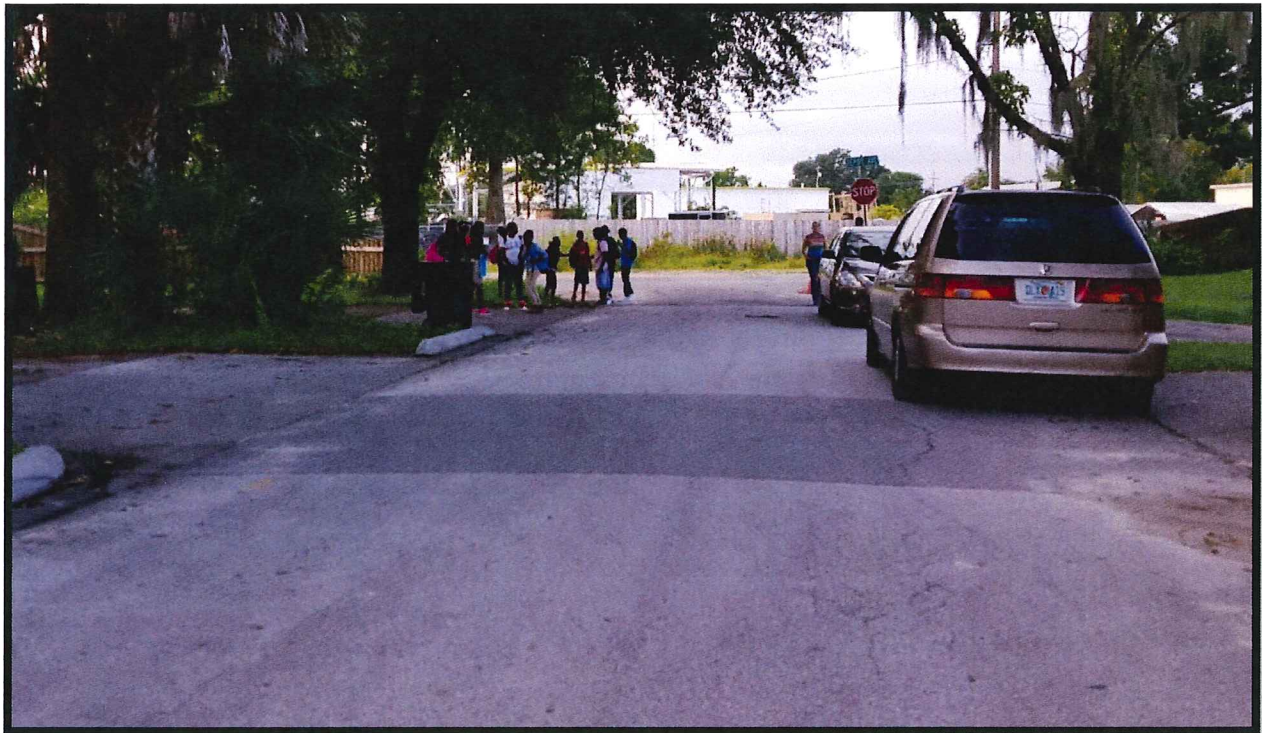
J. Pedestrian/Bicycle movements:

1. There are extensive amounts of pedestrians and bicycle activity throughout the neighborhood.
