City of Gainesville Eastside CRA Expansion Area Analysis

Finding of Necessity (Chapter 163, Florida Statutes)

WilsonMiller Stantec
2205 North 20th Street
Tampa, Florida 33605

August 2011

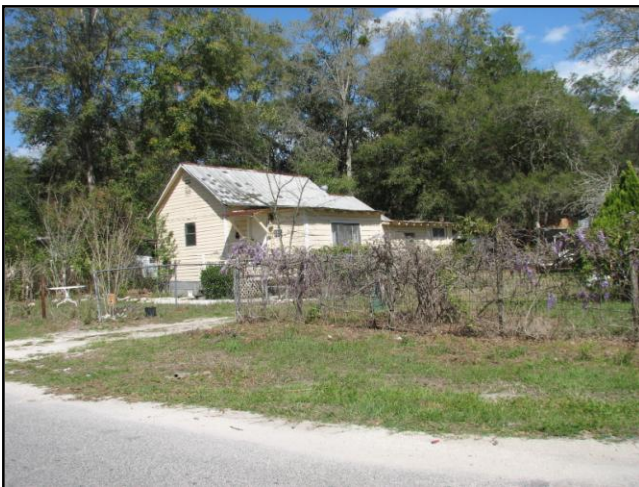
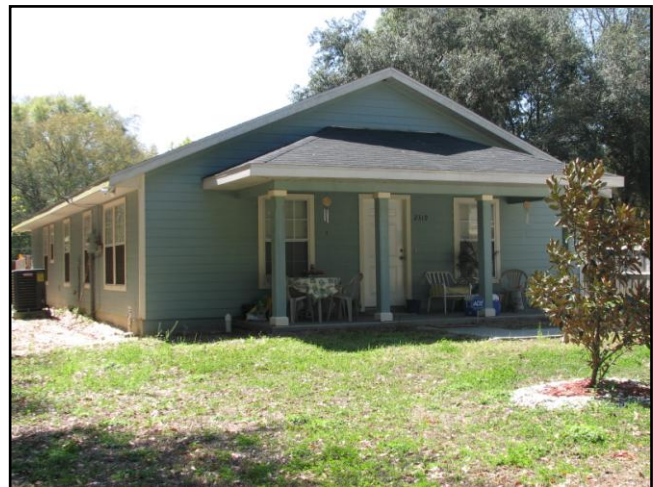
Figures 4.1 and 4.2 Typical Single Family Housing

Site visit observations indicated that many properties and structures in the study area show signs of lack of property maintenance and of aesthetic deterioration. This observation is supported by photo documentation, and is discussed in more detail in the following section. Figures 4.1 and 4.2 show typical single family housing and Figure 4.3 shows the single commercial parcel within the Study Area

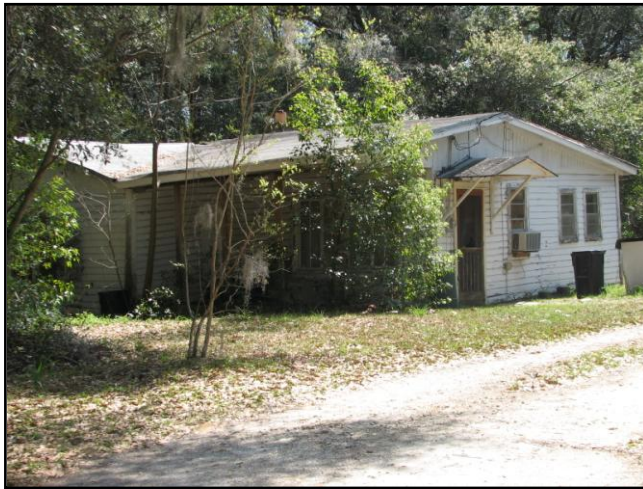
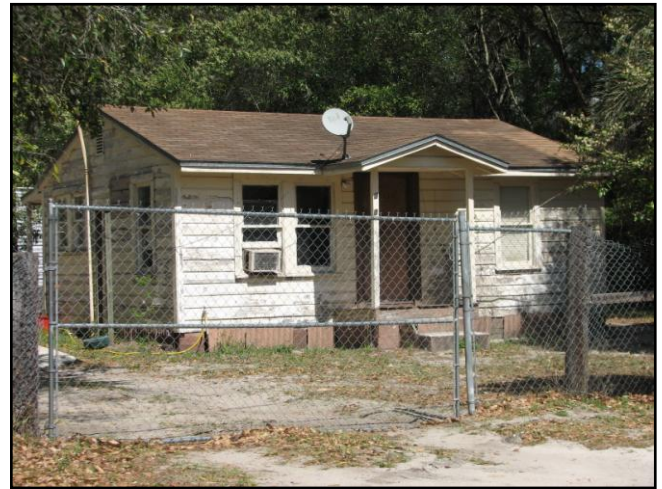
Figures 4.4 and 4.5: Examples of Deteriorating Structures

The documented percentages of deteriorating/deteriorated structures within the Study Area is consistent with what has typically been documented as substantial in other jurisdictions, and is higher than those percentages observed in previous expansions within the City of Gainesville (2009 and 2010).

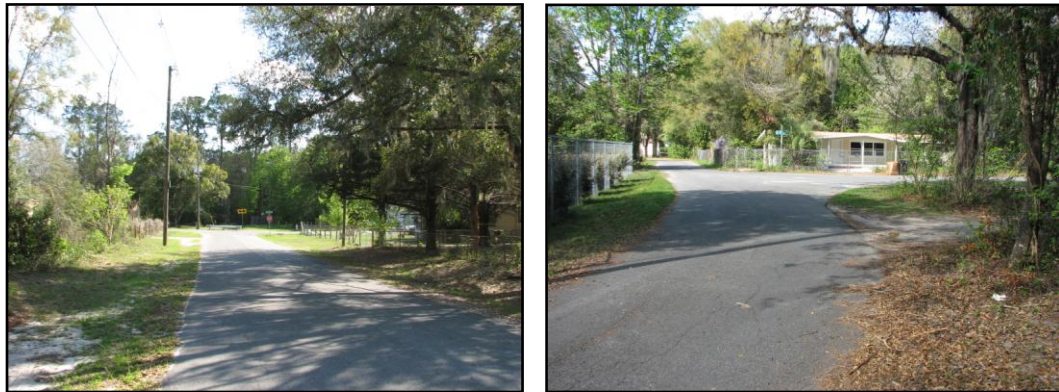
Figures 4.6 and 4.7: Typical Study Area Roadways

sidewalk (3.4%). The only sidewalk within the Study Area is located on the western side of SE 23rd Street and runs from SE 24th Street to SE 8th Place. This condition could create a potentially dangerous pedestrian environment with little space to maneuver out of the way of oncoming cars. Figures 4.6 and 4.7 illustrate the typical roadway conditions within the Study Area.

While the findings show some evidence of a defective or inadequate street layout, particularly as it relates to pedestrian facilities within the Study Area, sufficient evidence is not available to identify this as a condition of blight.

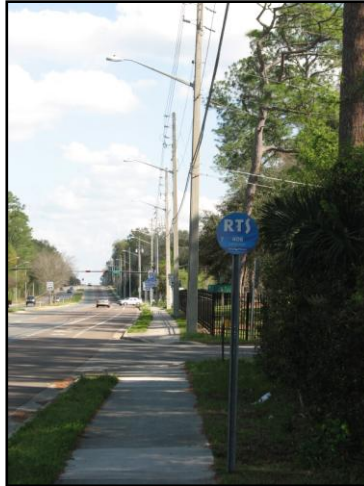
Figure 4.8 Existing RTS Stop Adjacent to Study Area

The Study Area is served with bus service from Gainesville RTS. There are two routes easily accessible from the Study Area. The first of these is Route #2 which connects the nearby Health Department to the Rosa Parks Station in Downtown, and runs on one hour headways. Transit stops for Route #2 are available at the Gainesville Technology Enterprise Center (GTEC) near the intersection of SE Hawthorne Road and SE 24th Street. In addition, there are also bus stops available immediately adjacent to the Study Area that serve Route #7, which connects the Rosa Parks Station to Eastwood Meadows. Service along Route #7 runs on one hour headways, and a bus stop is available near the intersection of SE Hawthorne Road and SE 26th Street. The bus stop is marked by a sign along the sidewalk, and no additional amenities are provided. Figure 4.8 below shows the existing bus stop.

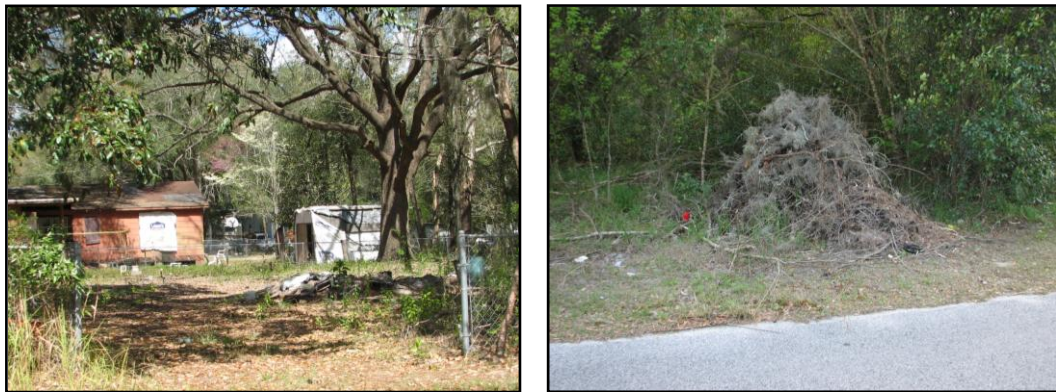
Figures 4.9 and 4.10: Examples of Public Dumping/Debris

In a March 2011 visit to the Study Area, conditions considered unsanitary and unsafe were observed and photographed. The primary evidence of these conditions was debris and dumping on some of the vacant lots within the Study Area. Public dumping

not only reduces the aesthetic appeal, it often leads to the perception that the area is in decline. Public dumping also can attract rodents and other pests, which can have the potential to cause safety/health issues.

Figures 4.9 and 4.10 illustrate some areas where dumping of trash and debris were found within the Study Area.

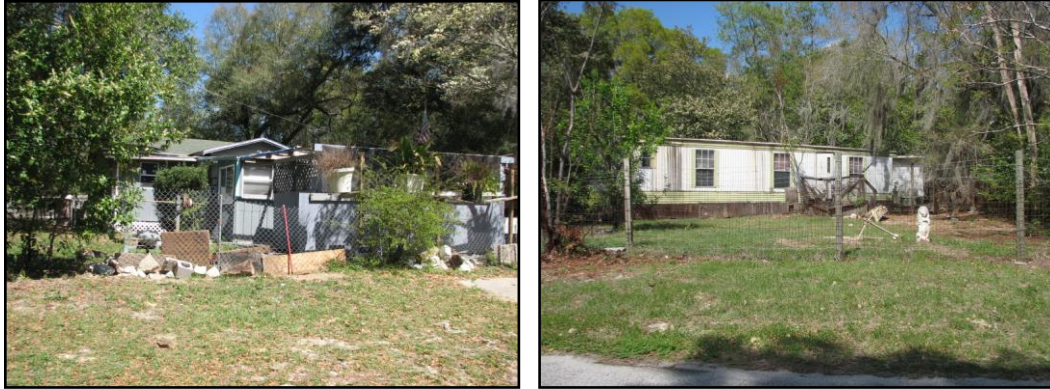
Figures 4.11 and 4.12: Examples of Properties with Poor Upkeep and Potential Safety Issues

In addition, a lack of general property upkeep within the Study Area was also observed. Several properties were poorly maintained, as demonstrated by deteriorating paint and cluttered areas outside. Examples of these conditions are illustrated in Figures 4.11 and 4.12 below. These observations are consistent with the code enforcement data that was collected and is summarized in Section 4.2.1 of this report.

Overall, the findings, as documented above, adequately meet the criteria for unsafe or unsanitary conditions to be considered a condition of blight.

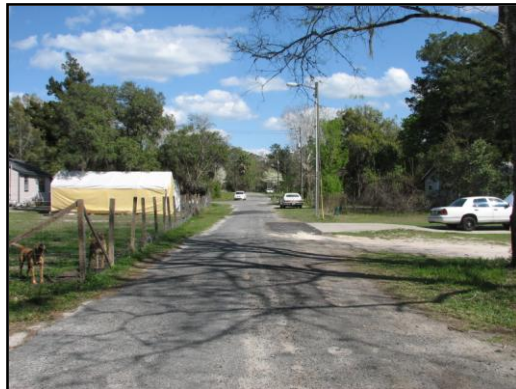
The pavement condition of the roadways within the Study Area is generally good, though there are areas of concern that should be addressed. As noted in the stormwater discussion above, SE 8th Place and SE 9th Avenue are in poor condition at their eastern termini. The pavement on SE 11th Avenue is also in poor condition and in need of repair. See Figures 4.15-4.16 below.

Figures 4.15-4.16 Examples of Poor Paving Conditions

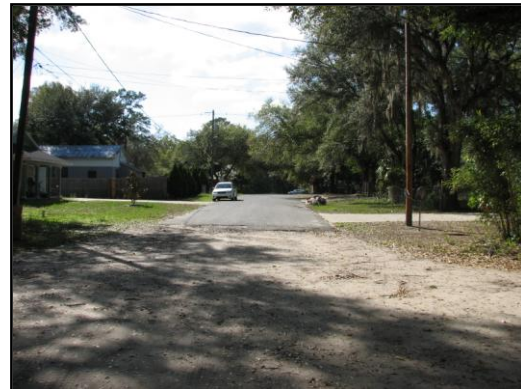
infrastructure. In addition SE 8th Place and SE 9th Avenue are both in poor condition at their eastern terminus, which likely exacerbates the problem. See images in the Roadway Conditions section. See Map 4.6 Stormwater Infrastructure.
