**WALDO ROAD CORRIDOR
PRELIMINARY BLIGHT FINDINGS REPORT
FOR THE EXPANSION OF THE EASTSIDE COMMUNITY REDEVELOPMENT AREA**

Prepared by:
Asset Property Disposition, Inc. (APD)

**DRAFT
July 2, 2007**

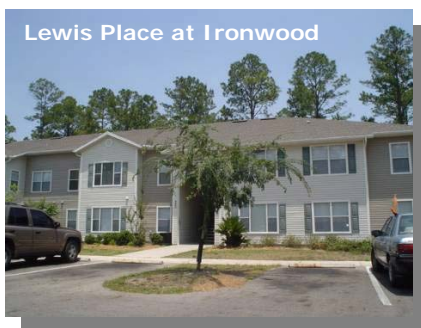
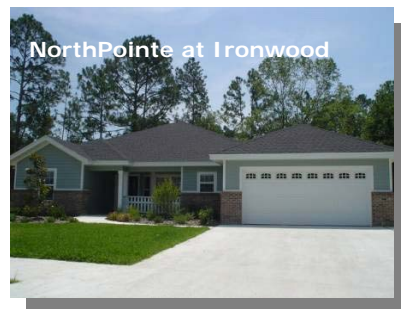
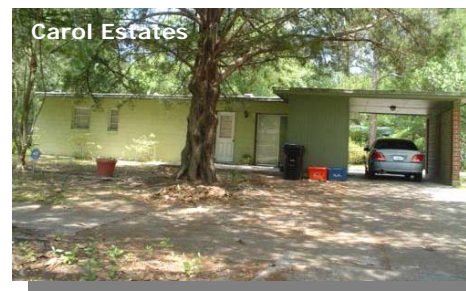
The Waldo Road Corridor study area has a total land area of 1,268 acres. Per the field survey and utilizing the Geographic Information System data derived from the City of Gainesville, the assessment of the study area conclude that the residential land uses account for 26% of the land area in the study area and are in the form of single family and multi-family dwellings. Located in the southern portion of the study area along Waldo Road is Carol Estates, an aging and deteriorating housing stock with scattered duplexes, some trailer homes and several vacant lots. A new single-family development, NorthPointe at Ironwood, is under construction off 15th Street east of the Ironwood Golf Course. To the south of the NorthPointe at Ironwood development are two multi-family residential developments that are aging and showing signs of neglect.

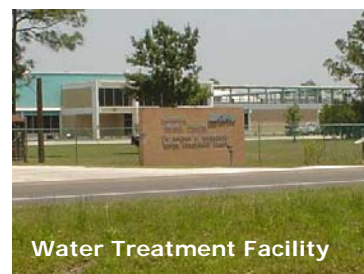
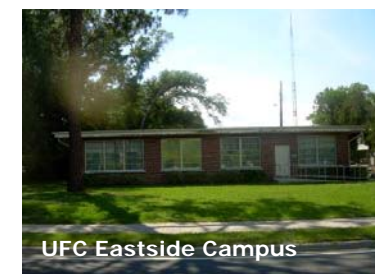
Industrial properties and public facilities including the Airport Industrial Park, and diversity of office, supply, manufacturing and warehousing facilities along Waldo Road comprise 51% of the study area. These uses are in various degrees of density and condition, but have excellent access and visibility. Public facilities that are included in or immediately adjacent to the study area are the Gainesville Airport, Gainesville Regional Utility's water treatment facility, Taccachale, several correctional facilities and University of Florida campus buildings. Like the industrial, public facilities are an important employment center and provide needed community services.

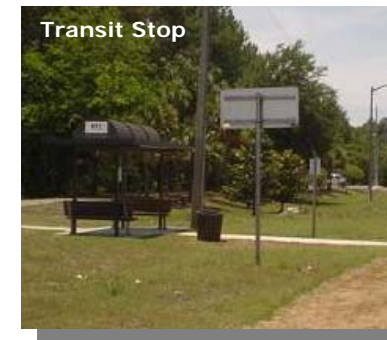
The transit amenities provided at the stops along Routes 15 and 24 are limited to 7 wooded and concrete benches in various conditions and 2 metal shelters. Despite having a large ridership, pedestrian safety is compromised due to limited amenities that are designed

to protect pedestrians from environmental elements and vehicular movements while commuting.

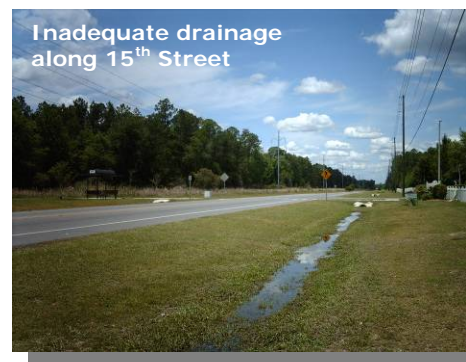
public infrastructure and contribute to problems associated with standing water and periodic flooding within the study area. The streets with insufficient drainage and deficiencies are illustrated on figure 3.2.

vehicular movements. Streetscape improvements and the installation of such amenities increase the functionality of and safety of the overall pedestrian infrastructure. The incomplete pedestrian facilities are identified on the figure 3.2.

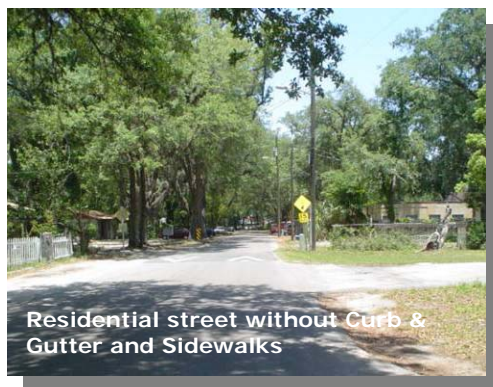
Pedestrian facilities within the study area are incomplete, inadequate or non-existent. Missing sidewalks are internal to the residential blocks and along the corridors of the of the Waldo Road Corridor study area. This lack of consistent and reliable pedestrian facilities fails to provide adequate connections to surrounding residential neighborhoods, public facilities, commercial and employment generators located in the area. Although there are formal trails and bike paths along the perimeter arterials that offer alternative modes of transportation, the lack of continuous sidewalk connection compromises the safety of pedestrians to utilize these facilities.

In addition to the incomplete pedestrian facilities, there are also limited pedestrian amenities including lighting, benches and buffering from

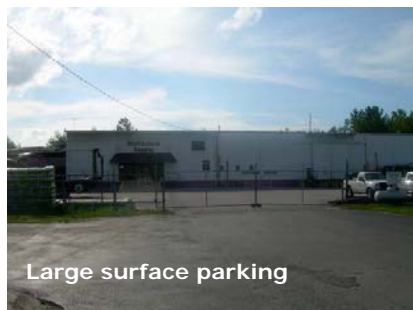
The industrial uses along Waldo Road contain an abundance of parking creating a more than adequate parking environment, but contributing to the lack of usefulness of the site. These aging properties are positioned on the rear of the site with parking located in front along Waldo Road. These parking facilities also lack efficient landscaping to assist with runoff due to the abundant amount of asphalt or concrete. Ultimately this underutilization of land contributes to the lack of usefulness of the facilities and overall economic viability and sustainability of Waldo Road.

Large surface parking

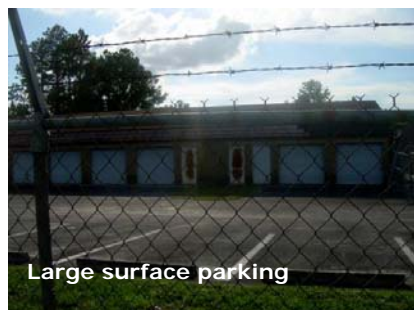
Large surface parking

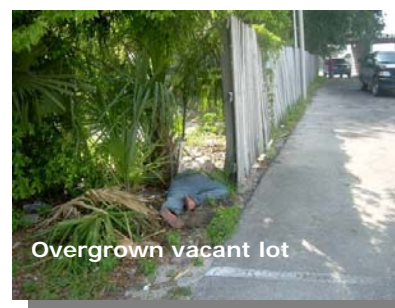
Also contributing to the blight and deterioration in the area are the vacant and overgrown lots. These lots, although scattered throughout the single family neighborhood of Carol Estates and along Waldo Road, illustrate lack of investment and underutilization. As shown on the following images, the haphazard location of these vacant lots contributes to the perception of crime, loitering, and nuisance behavior which make future development within the corridor difficult. Vacant lots and unsanitary conditions contribute to an unstable environment ultimately leading to the decline in the market value of the newly constructed housing and commercial development within the study area. This condition results in a high hurdle for private developers

Overgrown vacant lot

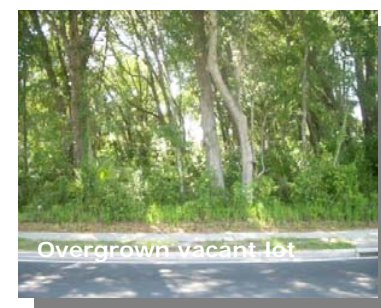
Overgrown vacant lot

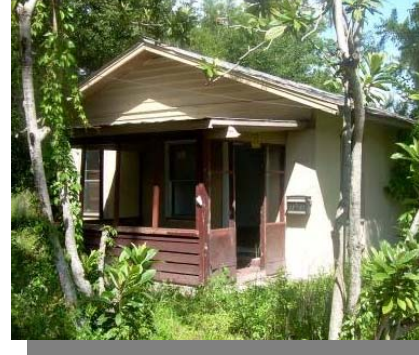
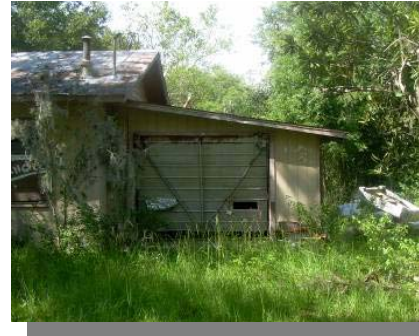
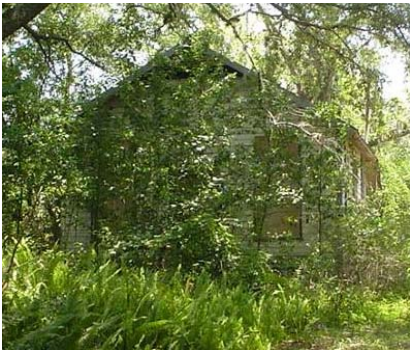
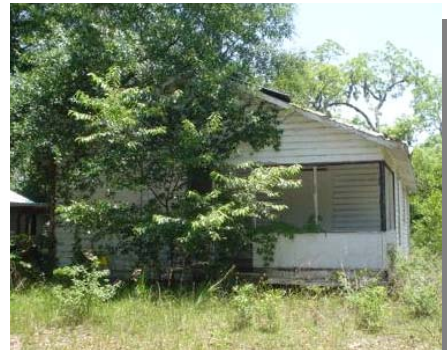
(e) Deterioration of site or other improvements;
Several homes in Carol Estates are unoccupied, severely deteriorated with unkempt yards which contribute to the deterioration of the study area. In addition, the 248 of code violations described in the earlier section negatively impact long-term sustainability and marketability and leads to the impression of abandonment, physical deterioration and lack of investment which can ultimately present a challenge to redevelopment along the Waldo Road corridor.

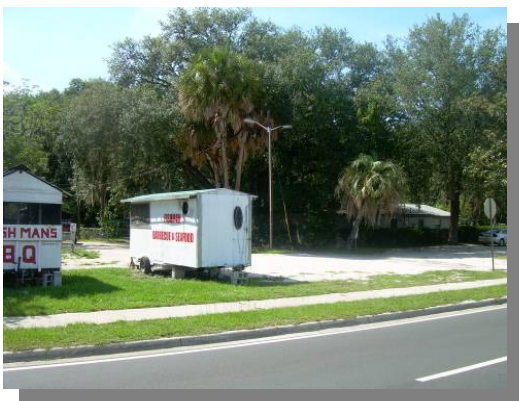
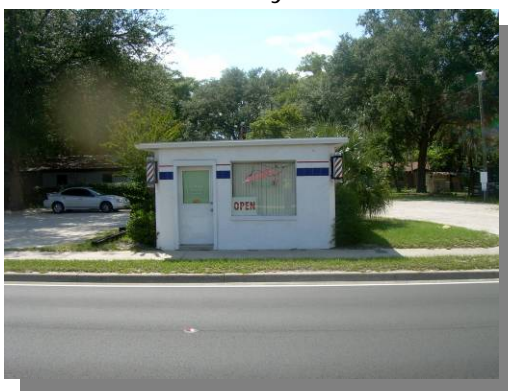
The Waldo Road Corridor study area is characterized by a lack of planning and disjointed uses which have inhibited growth in the study area. With this disparity in character comes an outdated

building density pattern evident by adjacent low and medium density structures and the lack of inter-parcel connectivity, shared driveways and parking facilities. Inconsistent build patterns in the study area show a disconnect

between land uses and a lack of uniformity which are key elements in urban design.
