CERTIFICATE OF APPROPRIATENESS REPORT

TO: Steven Dush, AICP, Planning and Development Services Director PN 13-0515
FROM: Gerry Dedenbach, AICP, LEED AP
DATE: January 5, 2015
RE: Gainesville Mixed Use on NW 13th Street Certificate of Appropriateness (CoA)

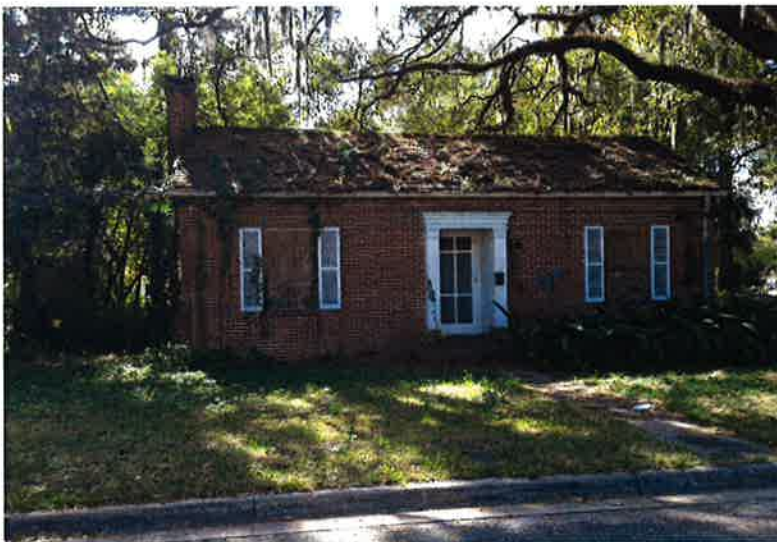
Photo 1. 1227 NW 4th Avenue

The on-site single-family residential home on Parcel 14012-000-000 is shown below. This brick cottage home was a student rental property years ago. Its condition quickly deteriorated due to vandalism and theft, as documented in the attached report.

The approved mixed-use project is a positive infill redevelopment within the City of Gainesville's core area. This request facilitates the construction of the approved project. Specifically the project requires the removal of a residential structure that is structurally compromised from its decaying foundation up to and including roofing members. The structure's exterior and interior sheathing are physically destroyed and all mechanical systems have been stolen, rendering the structure in a dangerous condition (**See Above**). Repeated efforts to secure the property are met with continued trespass and illegal habitation. Such occupancy has further degraded the structural and physical condition beyond practical repair, restoration, and/or rehabilitation.

6. **Whether reasonable measures can be taken to save the building, structure or object from collapse; and**
The building has deteriorated beyond practicable financial measures to save the building. Given the buildings small size, common construction materials and methods, replacement of the structure with a catalyst or transformational project provides greater merit to the City of Gainesville, its residents, and the short- and long-term economic viability so greatly needed in the University Context Area.
