City of Gainesville Eastside CRA Expansion Area

Finding of Necessity Report

July 2010

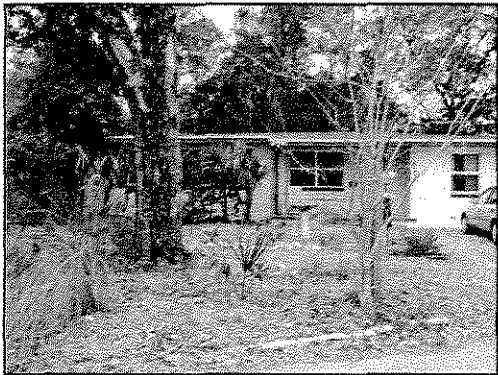
Figures 4.1 and 4.2 Typical Single Family Housing

Site visit observations indicated that many properties and structures in the study area show some signs of lack of property maintenance and of aesthetic deterioration. This observation is supported by photo documentation, and is discussed in more detail in the following section. See Map 4.4 Existing Land Use.

548 NE 12th Street

1228 NE 6th Avenue

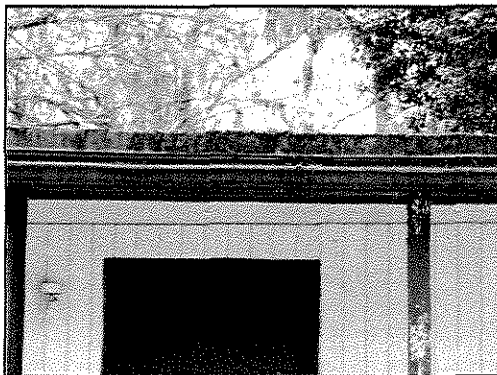
Figures 4.4 and 4.5: Examples of Deteriorating Structures

A second source of data related to the conditions of structures within the Study Area was a field survey, which included photographing and documenting of existing conditions. The conclusion of this fieldwork is documented below in Table 4.2.b and some representative examples in Figures 4.4 and Figure 4.5.

1221 NE 6th Avenue

535 NE 12th Court

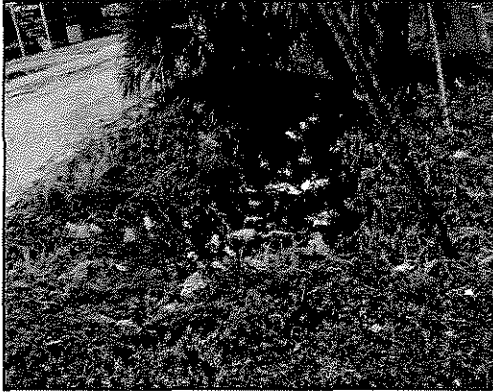
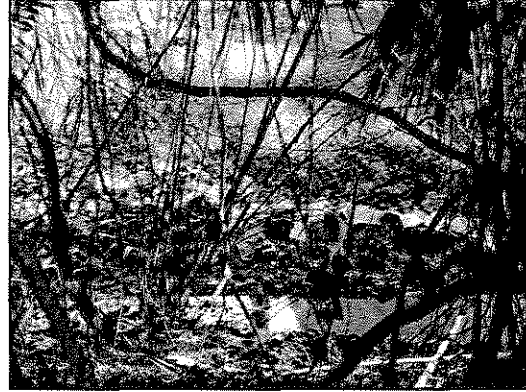
Figures 4.6 and 4.7: Examples of Public Dumping

One factor observed within the Study Area and related to unsanitary and unsafe conditions was dumping. The dumping was primarily found in drainage ditches and the canal associated with Rosewood Branch. Rosewood Branch is a tributary of Sweetwater Branch which ultimately flows to Paynes Prairie.

Public dumping not only reduces the aesthetic appeal, it often leads to the perception that a given neighborhood or area is in decline. Public dumping also can attract rodents and other pests, which can have the potential to cause safety/health issues. The Study Area is small in size, but there were several locations (See Figures 4.6 & 4.7 below) where illegal dumping was found.

Ditch along NE 5th Avenue

Rosewood Branch

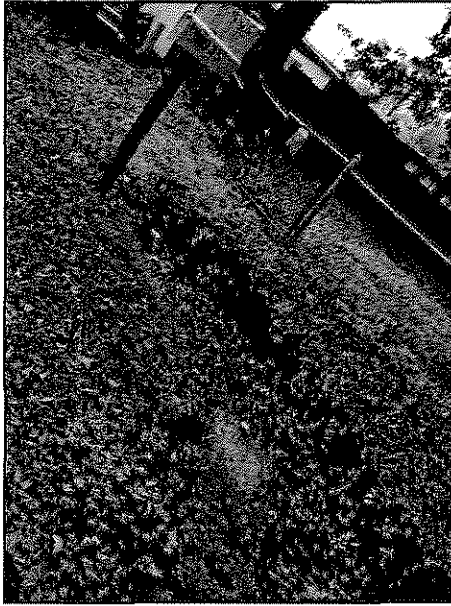
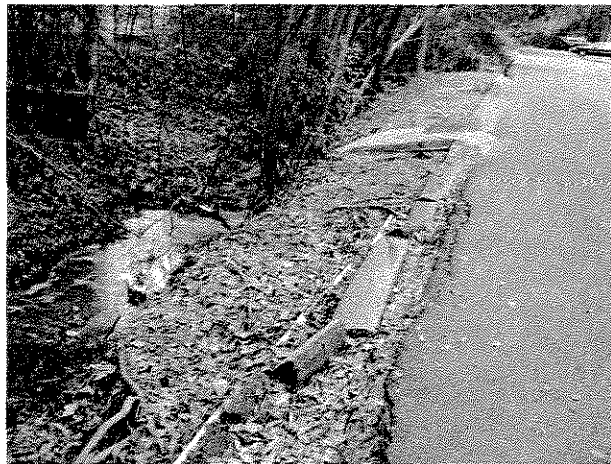
Figures 4.10, 4.11 and 4.12: Examples of Drainage System

In addition to the water/sanitary sewer systems, the stormwater drainage system was also reviewed. Within the area, streets consist of predominantly a two-lane rural cross-section, which lacks curbing and has open ditches for drainage. The area is in need of some roadway and drainage swale maintenance, but no appreciable problems were observed aside from minor ponding and broken concrete driveways (See Figures 4.10-4.12). There is anecdotal testimonial evidence from residents that some flooding occurs during certain rainfall events and that there historically have been some flooding issues from some of the larger drainage ditches. However WilsonMiller was not able to substantiate these issues in discussion with city staff.

NE 12th Court

NE 12th Street

NE 4th Place
