POWER GENERATION MACHINERY RISK ASSESSMENT

City of Gainesville, Gainesville Regional Utilities
South Energy Center
1390 SW 14th Ave.
Gainesville, FL 32614

July 30, 2014

South Energy Center

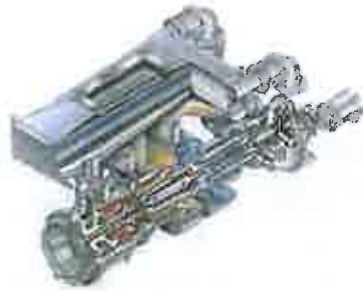
Combustion Turbine

Unit	Year Built	Manu.	MW	Model/ Serial #	Total Fired Hours	Total Starts	EFOR
GT-1	2008	Solar	4.3	Mercury 50/ SNOC07737-10	39,007	179	0.00%

The combustion turbine is equipped with coolers on the air inlet. The coolers are part of the chilled water system.

Power 4.6 MW, Heat rate 9351 kJ/kWh, Exhaust flow 140,000 lb/hr, Exhaust Temperatures 710°F.

It has a “turbotronic 4” control operating system.

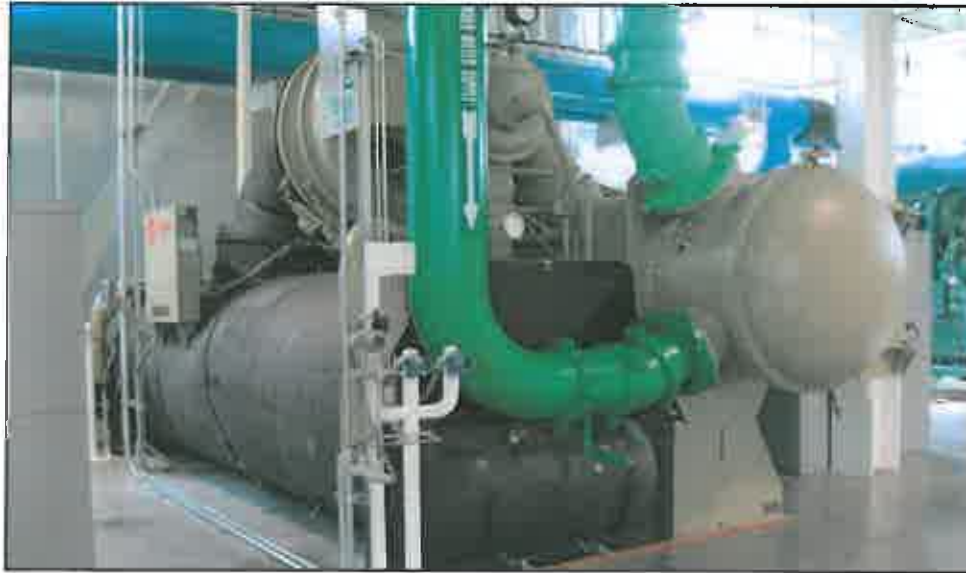
There are three centrifugal 900 kW chillers that have R134 and R123. Two are driven by electric motors and one is steam turbine-driven. The two 1500 ton electric chillers were manufactured by Trane. The 1200 ton turbine-driven unit was manufactured by York.

A contract with a vendor for monthly maintenance inspections is in place for the Trane and York Chillers. Every three years NDE (eddy current) inspections of the condenser and evaporator tubes are performed. In 2012 the chiller tube sheets were epoxied to prevent erosion at the tube ends. The steam turbine driven chiller is scheduled for an annual maintenance inspection and every three years the steam turbine will be disassembled and inspected. This is due again in January 2015.

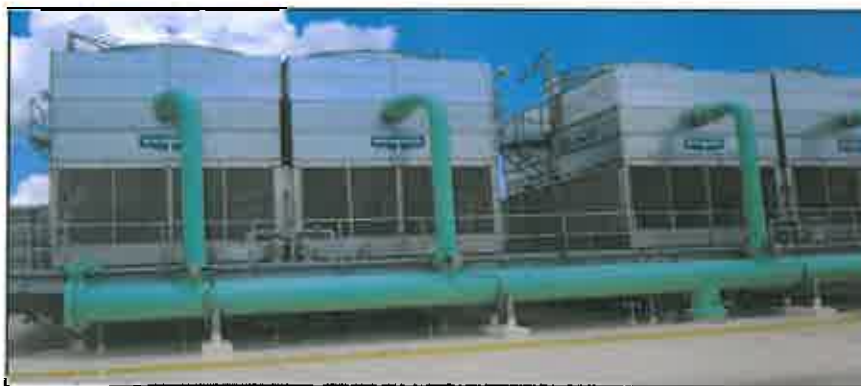
There are four Evapco cooling cells installed at SEC. These are grouped into two logical cooling towers for operational purposes.

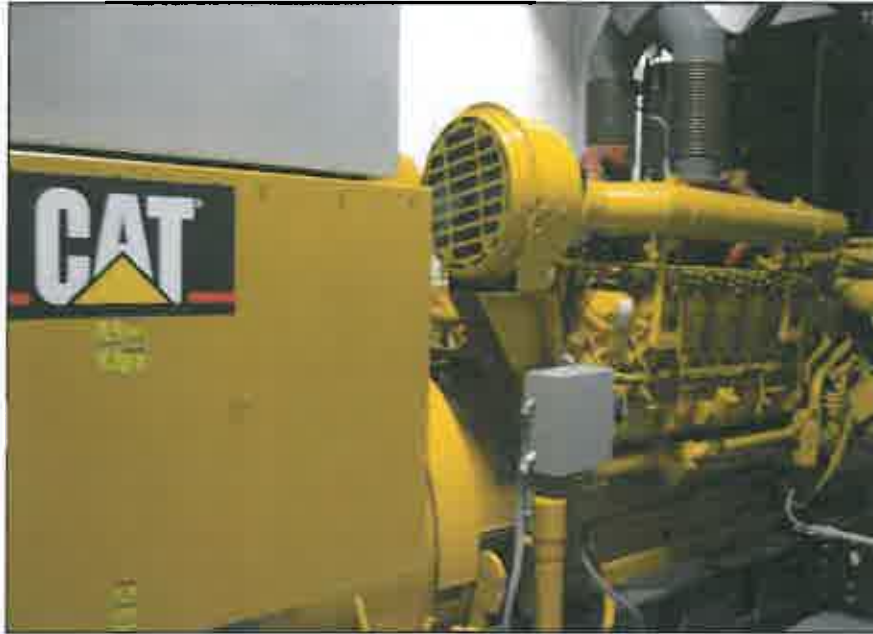
Unit #	MFG	Year Built	Type	Volts	Fuel	Nameplate Rating (kW)
DG 2	Caterpillar	2007	ICE	12.47	Fuel Oil	2,250
DG 1	Caterpillar	2007	ICE	480	Fuel Oil	500

An aggressive inspection criterion from the Caterpillar operation and maintenance manual will be performed as part of annual maintenance on the diesel engines. The DG2 is started monthly and run for a period of at least 30 minutes minimum and with a minimum load of 30%.

As part of the maintenance program, the batteries will be replaced (DG 2 only) every two years. These batteries were replaced in 2012. Every three years the cooling system water temperature regulator will be replaced and the turbo-charger and rotating rectifier will be inspected.
