**City of Gainesville
Department of Doing**

SUBJECT: DB-18-017 Oaks Preserve Design Plat – Resource Conservation Report

Site Description

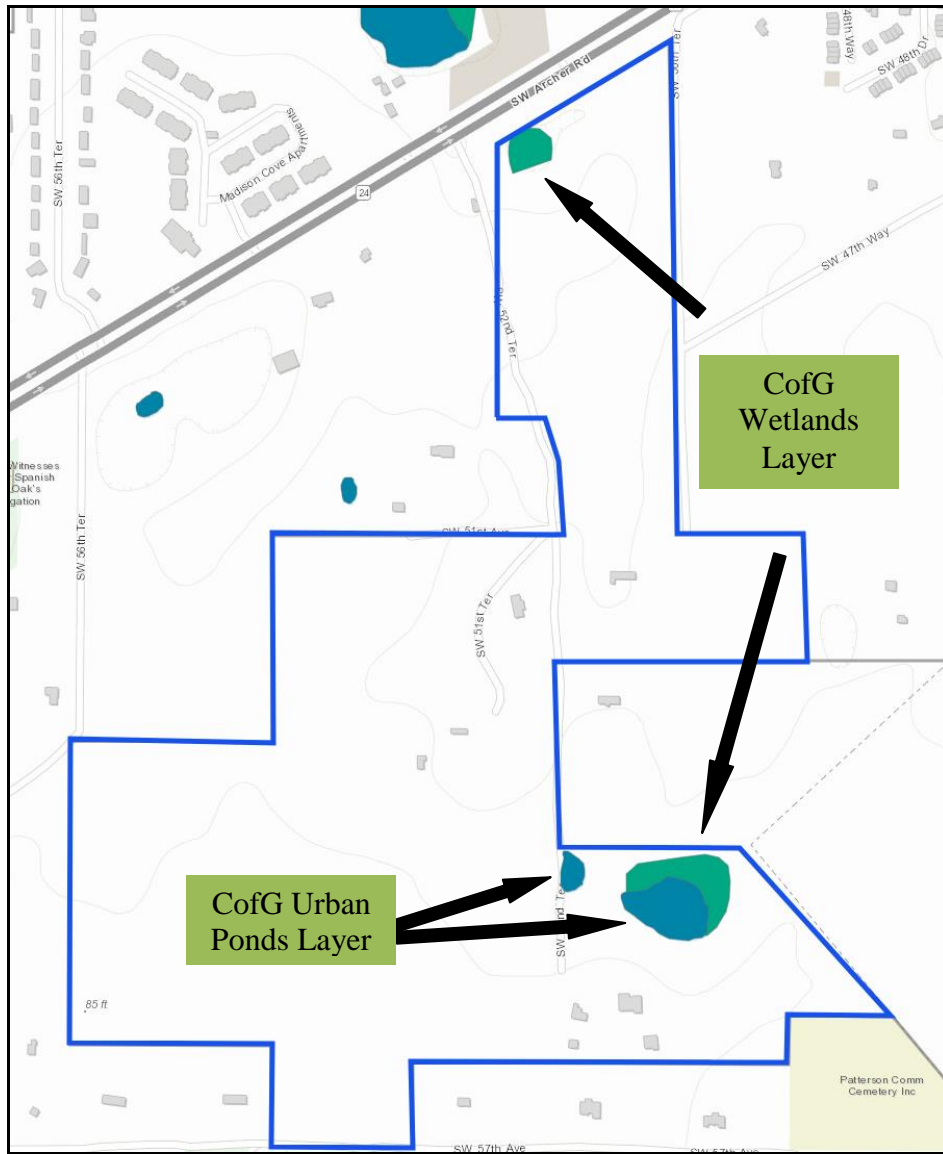
Figure 4: Pre-application Wetland and Urban Pond Data

At the time of application City of Gainesville and Alachua County data indicated two wetland areas and two “urban ponds” (Fig. 4). However, the report submitted by Normandeau Associates identified four wetland areas occurring in the southern portion of the project site (Fig. 5) and did not include the northernmost “wetland.” C of G and Alachua County Environmental Protection Department staff conducted field verifications and concur with Normandeau’s findings. What is shown in C of G data as a “wetland” nearest SW Archer Road is actually a manmade depression with little to no ecological value. The most southeastern and largest wetland is a freshwater pond lined with Cypress, Oak, Cabbage Palm, Cat-tail, and Maidencane. Just to the west is the second largest wetland which is

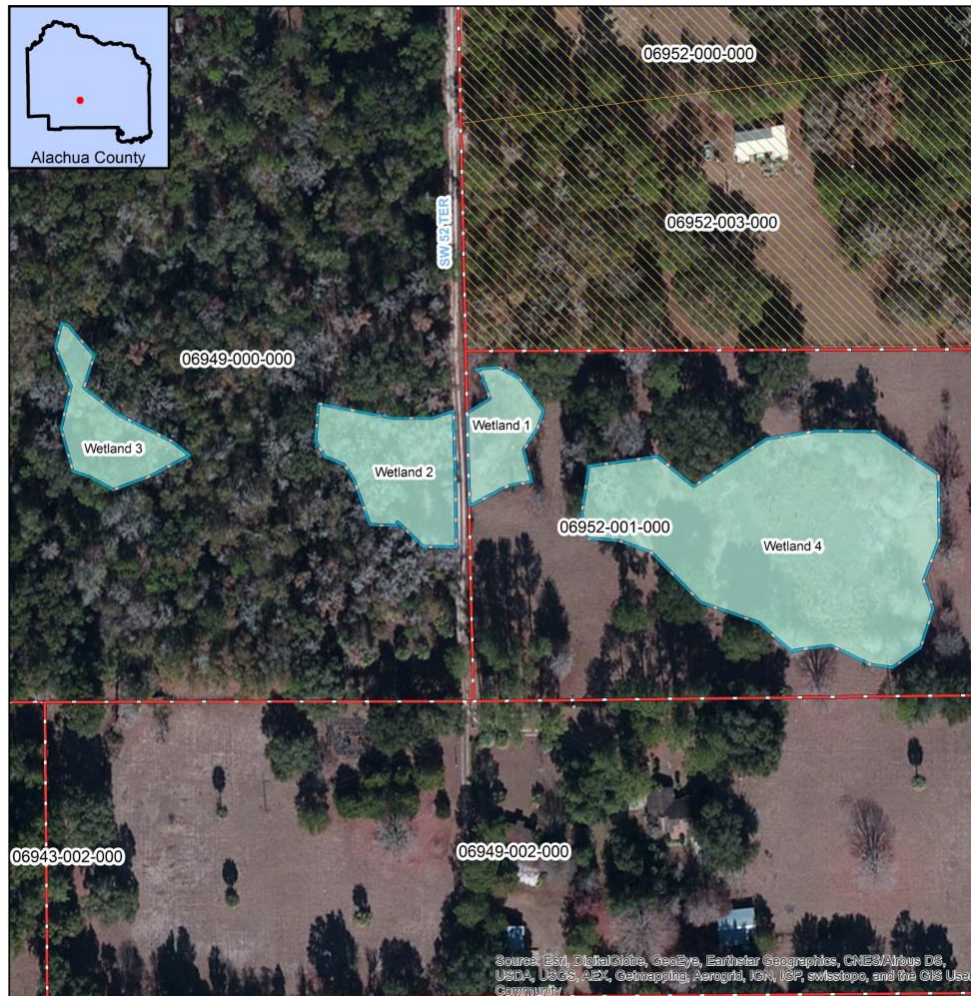
Figure 5: Identified Wetlands (Normandeau Associates, 2018)

currently bisected by an access road. The final wetland is just to the west of the other wetland areas.

- Removal of the existing road that divides the central cypress wetland should be explored to enhance ecological connectivity.

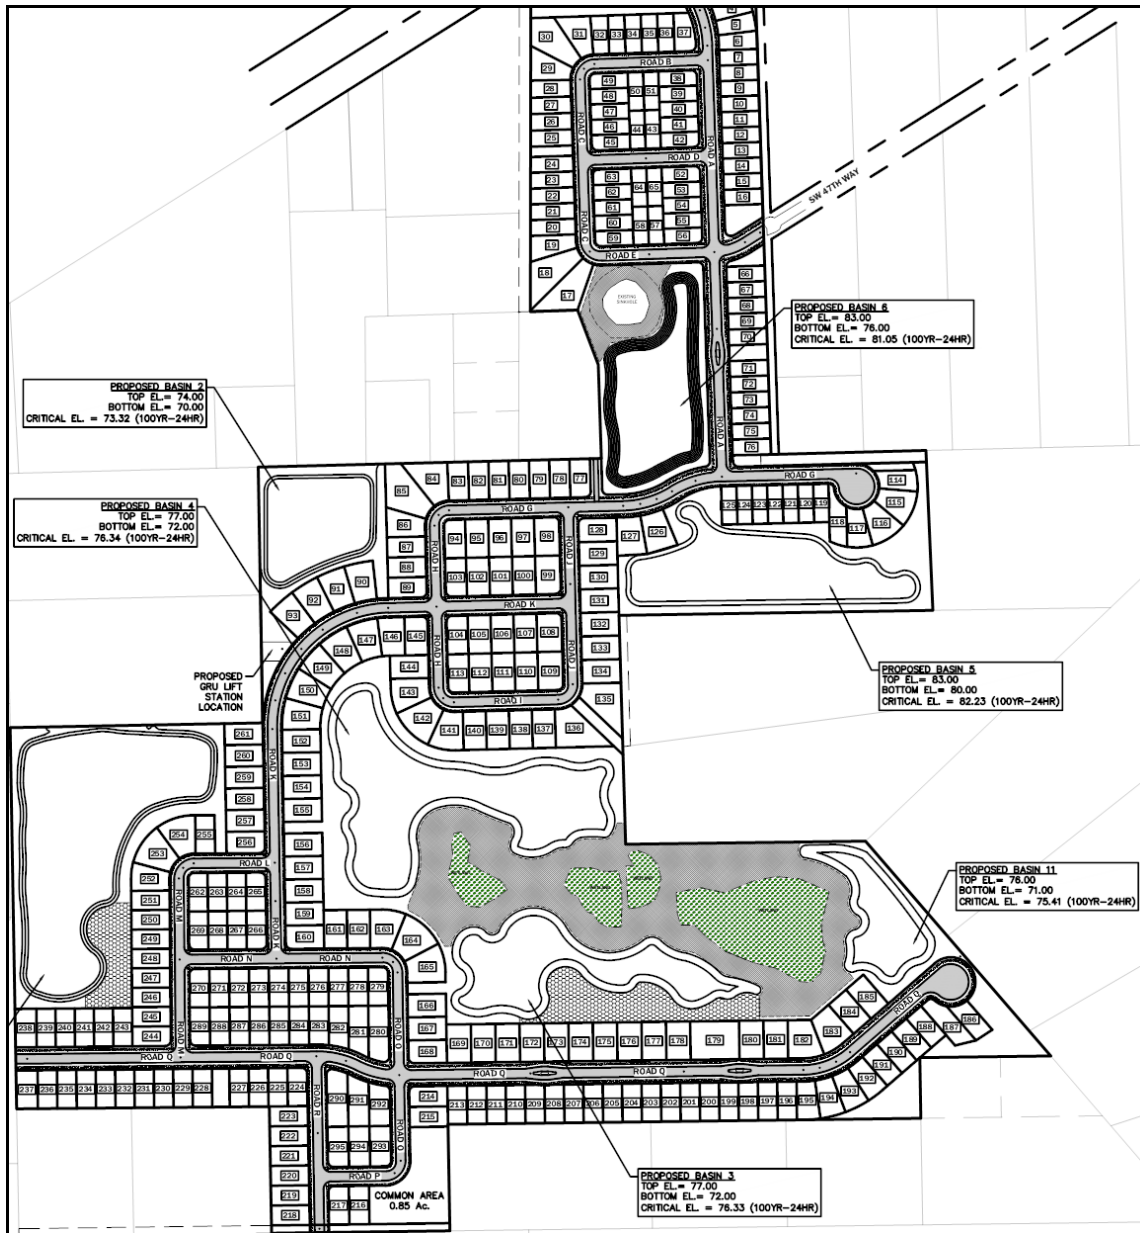
Figure 6: Proposed Wetland Buffers

The proposed Design Plat shows a wetland buffer of a minimum of fifty feet and a maximum of seventy-five feet which significantly exceeds the City's minimum requirements (Fig. 6). In addition, much of the site's stormwater treatment is designed to be adjacent to the wetland buffers creating a larger connected open space and greater potential for supporting habitat restoration. In one such area stormwater facilities are proposed directly to the east of the wetland areas. The applicant has been encouraged to include a more "natural" connection to the Bear Hammock Strategic Ecosystem to establish and promote a larger interconnectivity between conservation areas. However, staff is aware of the various design challenges inherent on the site in regards to connectivity and is largely supportive of the proposed wetland buffer design.

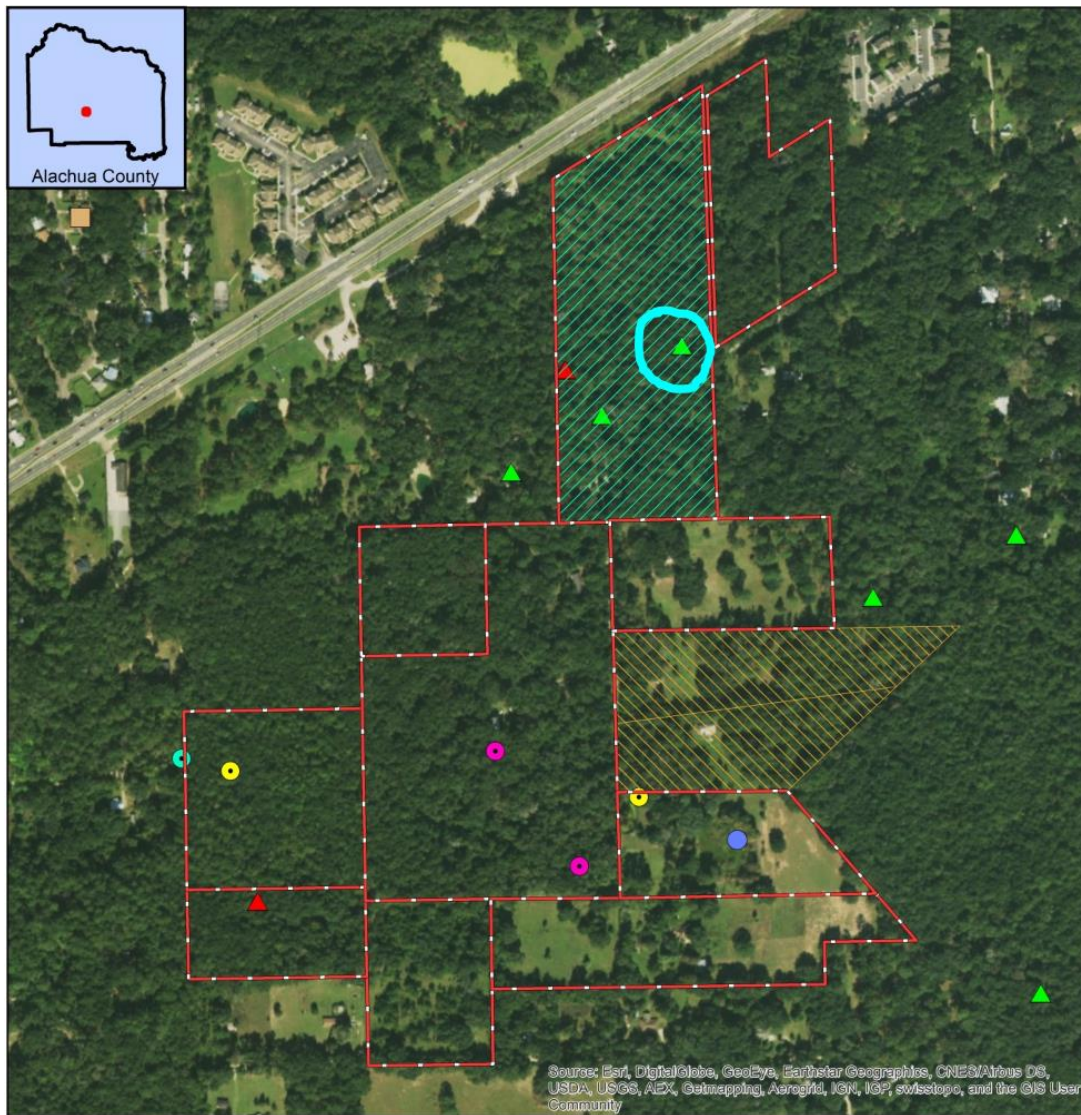
Figure 7: Potential Sinkhole Features (circle shows non-significant feature)

C of G and Alachua County did not have any data on existing sinkholes on the project site at the time of application. The Normandeau report identified four potential locations for sinkholes on the property based on existing topographic data (Fig. 7). Physical review of the site showed that two of these features were non-existent and two were clearly features (shown as red and green triangles in Figure 7). The westernmost of the two features was field verified as a sinkhole. The status of the eastern feature warranted further investigation by a geotechnical specialist.

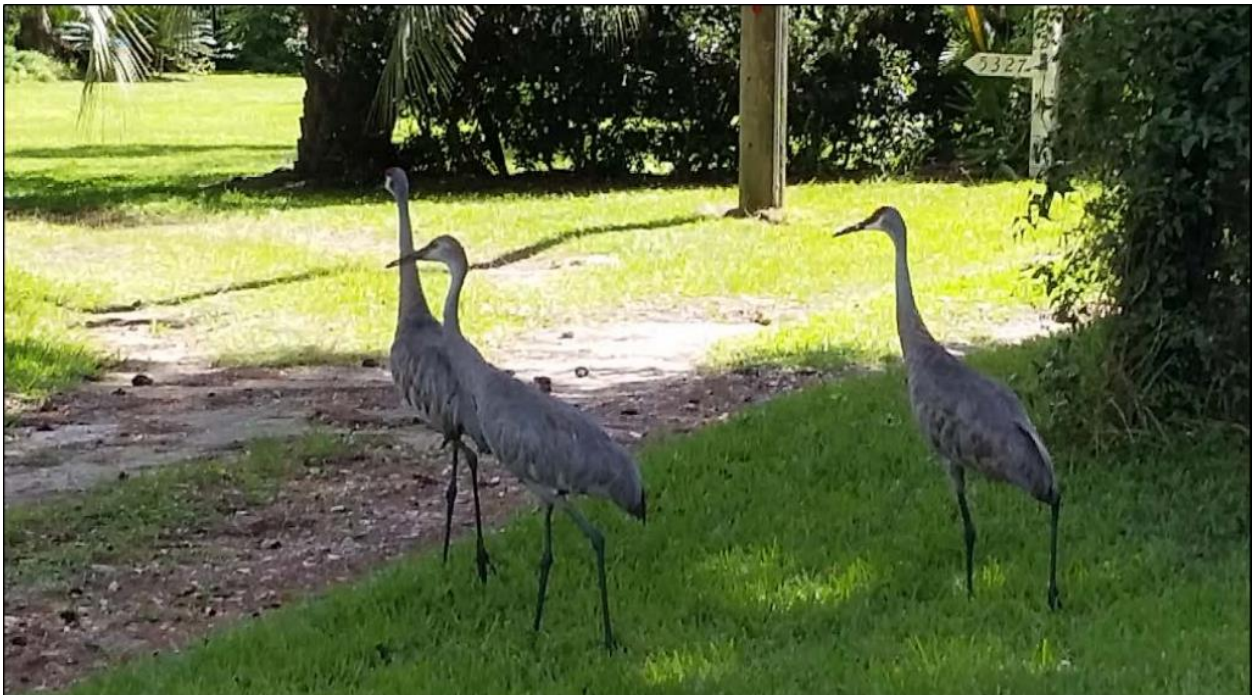
Figure 9: Gopher Tortoise Burrow and Sandhill Cranes

site habitat set-aside has been specifically identified in the design nor have any alternative plans for protection or relocation been submitted. C of G staff is amenable to coordinating with the applicant and the Florida Fish and Wildlife Conservation Commission for alternative mitigation strategies.

- Increased ecological connectivity eastward to the Bear Hammock Strategic Ecosystem is preferred and encouraged. Proposed stormwater is acceptable under Code however some other form of planted or open space is more desirable and could provide on-site habitat set-aside.
- Avoidance or management of existing Gopher Tortoise population will need to be addressed prior to development. Alternative strategies supported by the FFWCC are acceptable.
- Thorough and adequate subsurface analysis near the area of the non-significant geologic feature should be conducted prior to development to further clarify the status of the feature and its stability.
