Petition PB-15-29 LUC May 28, 2015

Appendix B Supplemental Documents

Natural Areas Resource Assessment of Prairie View Trust Parcels Designated for Land Use/Zoning Change

Natural Areas Resource Assessment of the Prairie View Trust Parcels

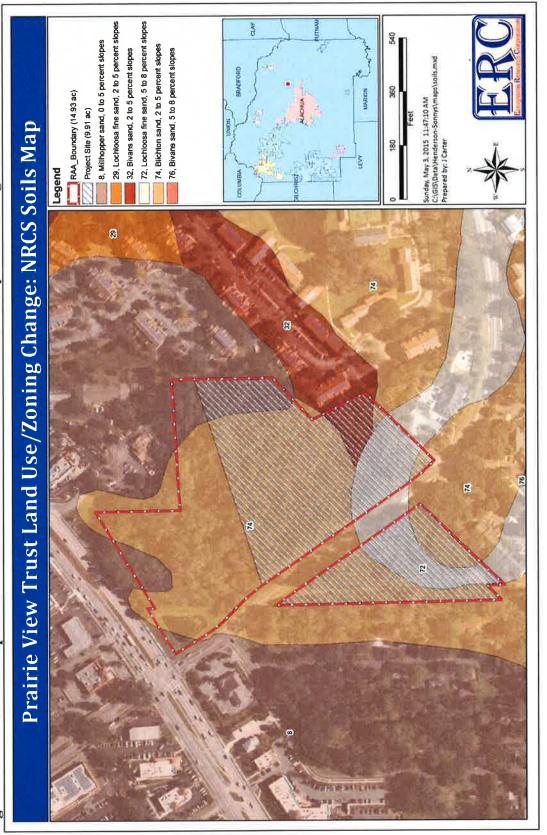
NRCS soils map of the Resource Assessment Area and immediately surrounding area. Figure 5.

The NRCS soil survey map for the RAA and surrounding area is shown on **Figure 5**. Based on the NRCS map, there are four (4) soil mapping units described for the Project Site and RAA. The RAA consists almost predominantly of Blichton sand, 2 to 5 percent slopes with small areas of Millhopper sand, 0 to 5 percent slopes, Bivan sand, 2 to 5 percent slopes, and Lochloosa fine sand, 5 to 8 percent slopes. The characteristics of the soils that occur within the Project Site and RAA are briefly described, as follows:

Mapping Unit No.	Mapping Unit Name	Hydric	Drainage Class	Confining Layer
8	Millhopper sand, 0 to 5 percent slopes	No	Moderately well-drained	58–89"
32	Bivans sand, 2 to 5 percent slopes	No	Poorly drained	15–78"
72	Lochloosa fine sand, 2 to 5 percent slopes	No	Somewhat poorly drained	34–80"
74	Blichton sand, 2 to 5 percent slopes	No	Poorly drained	28–80"

All soils on site have a surficial clay confining layer that restricts the downward percolation of rainwater or storm waters that fall on the surface of the area within the RAA. Generally, the clay begins as high as 15 in. below the surface and extends throughout the limits of the soil profile depth of 78 to 89 in.

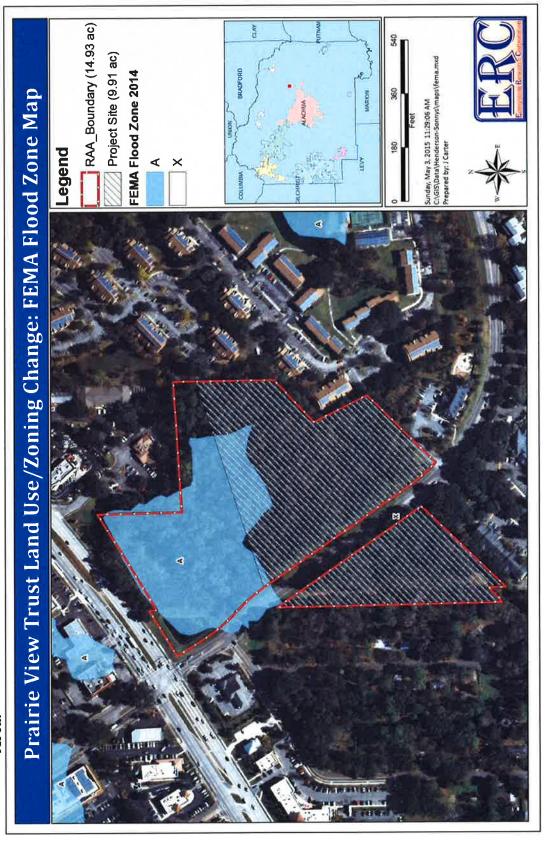
Federal Emergency Management Agency (FEMA) 2013 flood zone map of the Resource Assessment Area. Figure 6.

The FEMA Flood Prone Map for the Project Site is shown on **Figure 6**. The north end of the RAA is located within a FEMA flood prone zone mapped as "A." The mapped zone corresponds roughly to the limits of an onsite wetland located within this area. The "Zone A" as mapped does not include the drainage that extends from the northeast corner of parcel 07240-046-000 north to the mapped FEMA area. This drainage floods under all normal rain events (see Figure 14).

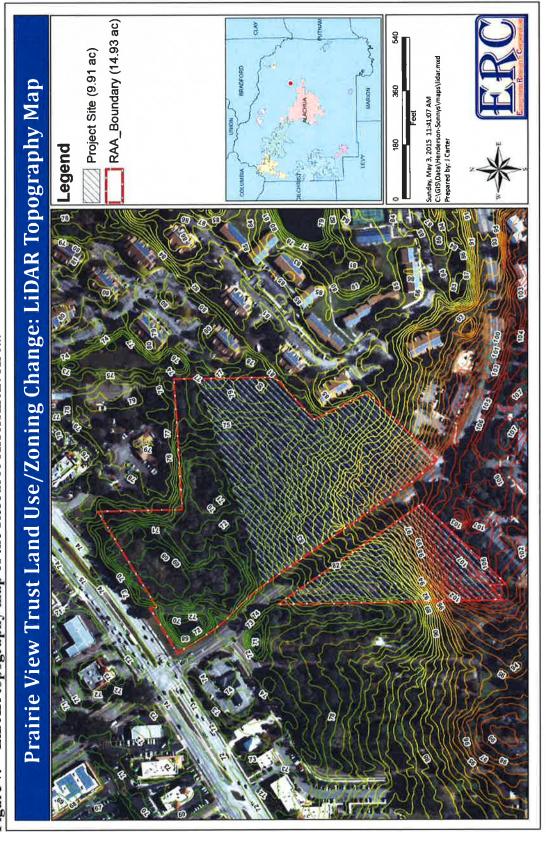
Figure 7. LiDAR topography map of the Resource Assessment Area.

The Alachua County 2001 LiDAR topography map for the RAA and surrounding area is shown on **Figure 7**. Apparent on the LiDAR topo is (1) the wetland floodplain that is located across the northern section of the RAA, (2) the tributary that flows through the RAA from south to north, and (3) the sloping topography of the RAA and Project Site which grades significantly from south to north. Within the RAA, the topography ranges from 107 feet in the southwest corner to 68 feet within the wetland in the northeast corner

of the RAA. The Project Site, located within the southern area of the RAA, ranges in elevation from 107 feet to 72 feet.

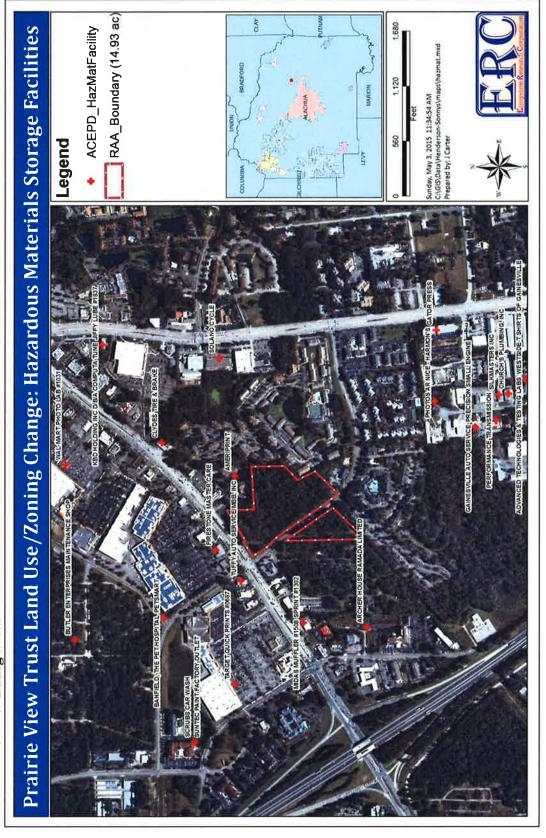
Alachua County hazardous materials storage facilities shown for the Resource Assessment Area and surrounding area. Figure 11.

The location of hazardous materials storage facilities that are monitored by Alachua County are shown on **Figure 11**. There are no storage facilities within the RAA or Project Site. There are numerous facilities associated with other commercial venues located along Archer Road and SW 34th Street surrounding the RAA.

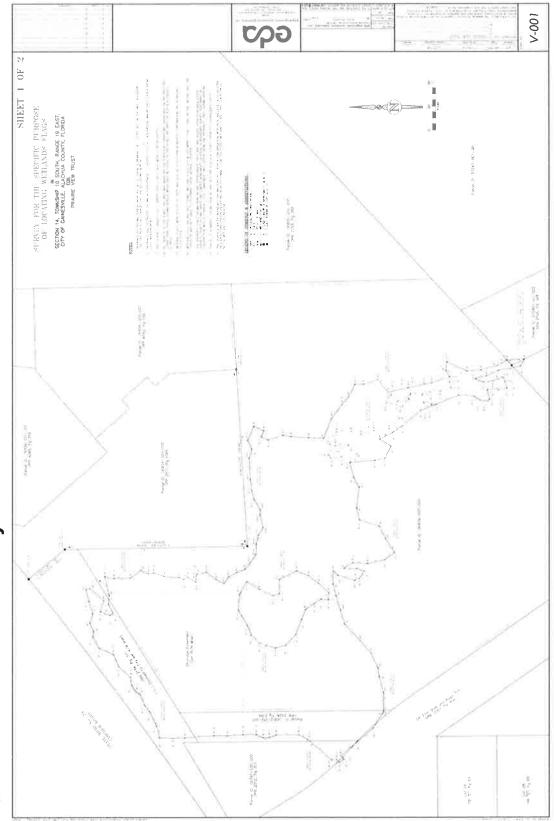
Attachment 2—Wetland Survey

Regulated surface waters/wetlands are present within and adjacent to the petition area on the east side of SW 37th Boulevard, as described above. The delineation and survey of the wetland boundaries of the wetlands of the property have been provided by the petitioner, and reviewed and preliminarily approved by City staff. The Wetland 4 flow-way and the southern margin of Wetland 3 fall within the 6.89 acre eastern part of Parcel 06809-000-000, for a combined total wetland acreage inside the petition area of 0.579 acres. Wetland 3 is described in the ERC report as a natural marsh with a forested wetland periphery. Successional mesic pine-mixed hardwood forests are present on uplands of Parcel 06809 (which were historically cleared for agricultural use) rising on each side of the Wetland 4 flow-way, and these uplands are separated
