CITY OF GAINESVILLE

OLD FIRE STATION 1
ASSESSMENT

SUBMITTED TO:
CITY OF GAINESVILLE

August 31, 2021

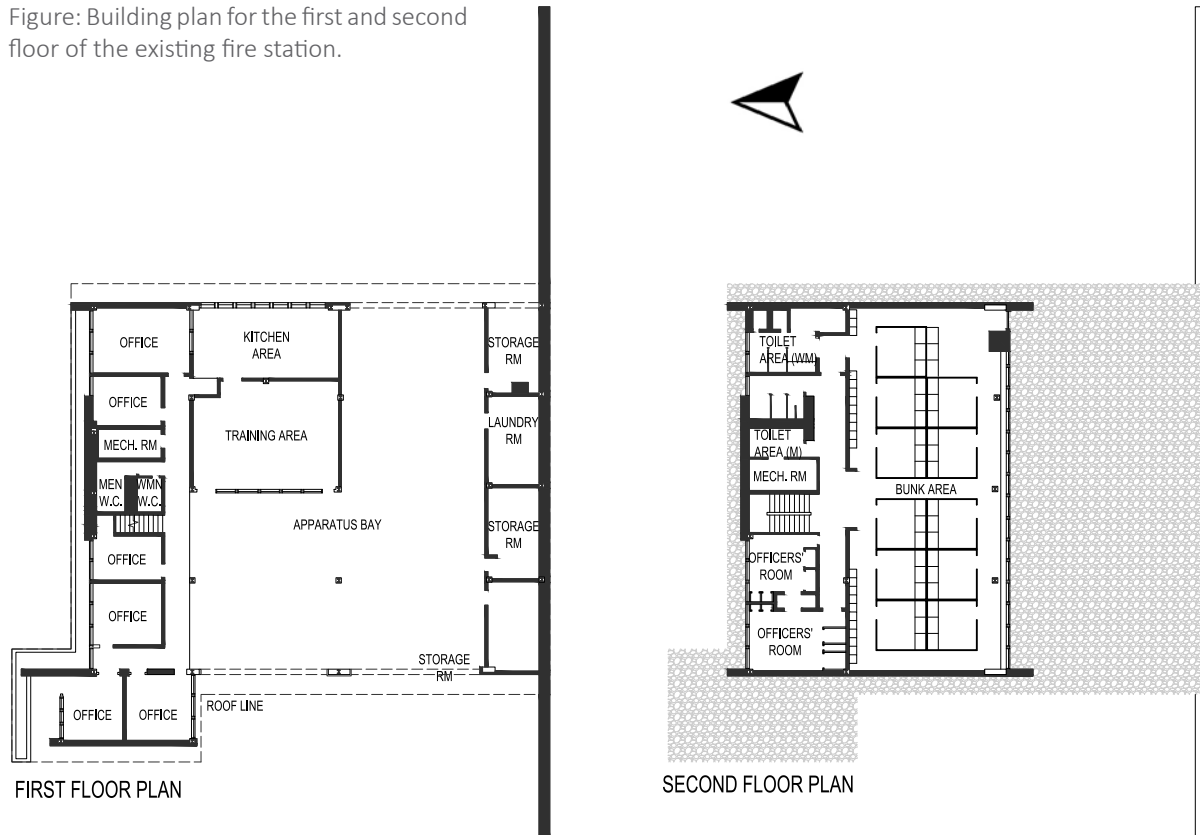
Figure: Building plan for the first and second floor of the existing fire station.

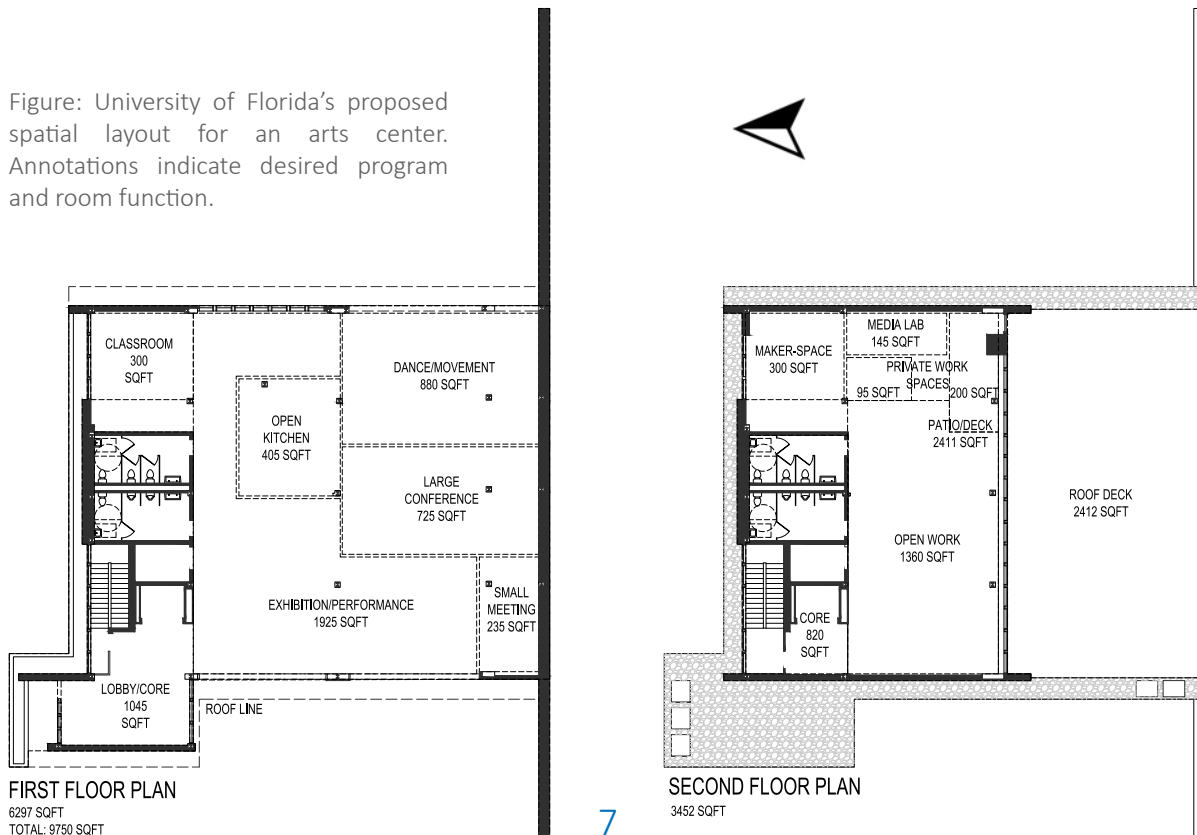
Figure: University of Florida’s proposed spatial layout for an arts center. Annotations indicate desired program and room function.

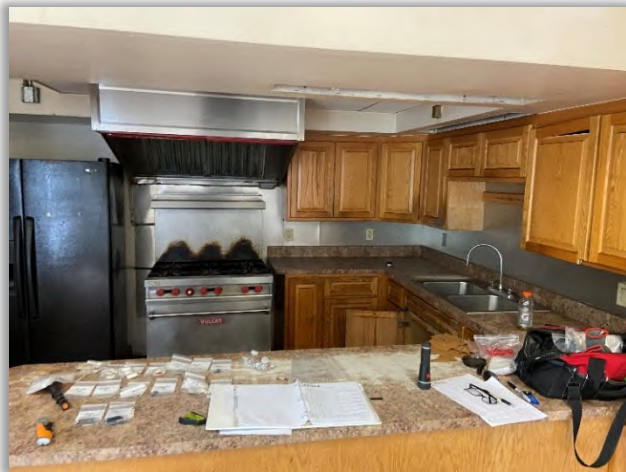
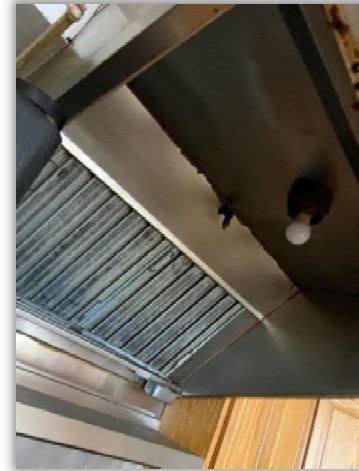
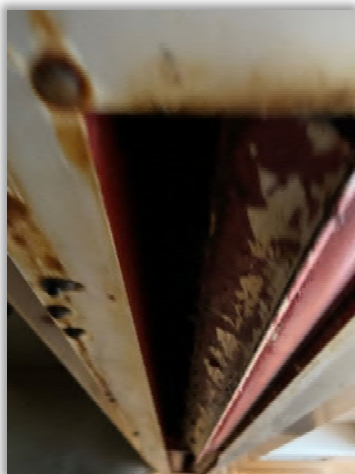
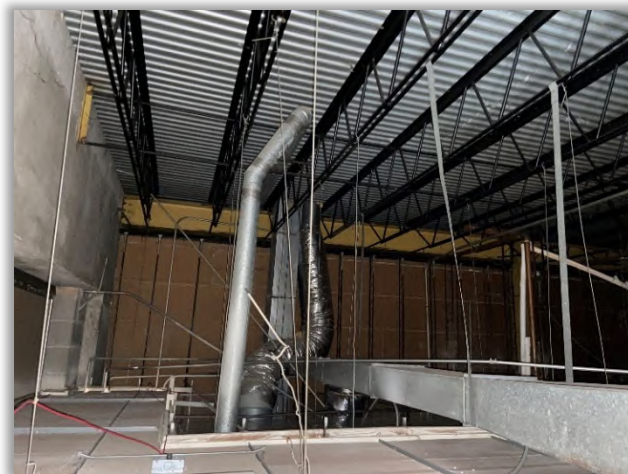
In addition to the heating and cooling systems, the kitchen is provided with a gas-fired range and a small commercial range hood that is connected to a grease exhaust fan at the roof and provided with unconditioned makeup air via a roof supply fan. While the hood and filters were dirty and showing some corrosion due to age, the grease ductwork appears to be in good condition and both fans were observed to be functioning well, controlled by the hood fan switch. The supply air ductwork includes an approximately 10' section of flexible ductwork, which while not a Code violation, is just noted for completeness as this is not standard for hood supply duct. All restroom exhaust fan systems appeared to be working during the visit, but as with the HVAC systems they are generally very old and are likely not providing Code levels of ventilation.

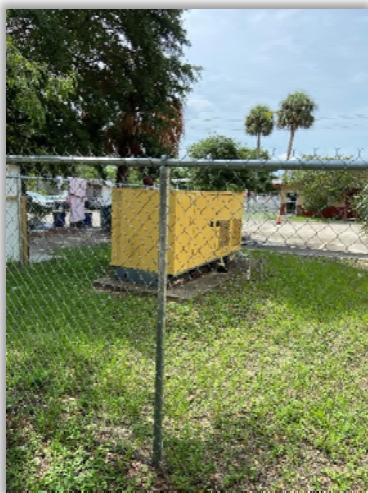
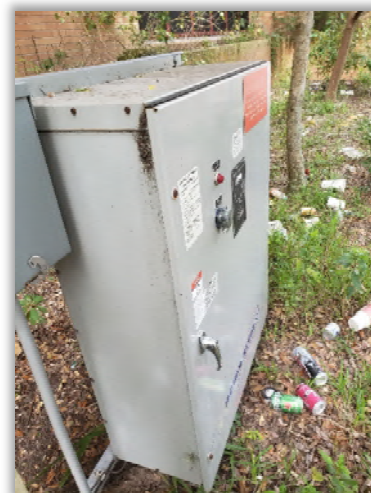
In addition to the utility system, there is an existing natural gas generator system including an automatic transfer switch (ATS) at the building north exterior. The generator is a Cat/Ring Power G75T3S, which is a 75kW generator consistent with the building service size. This generator appears to supply the entire building service in parallel as a whole-building optional standby system per NEC Article 702. With only one ATS, this optional standby power system is prohibited from supplying emergency or life safety loads such as the fire alarm system or egress lighting. Some of these loads appear to be supplied with normal power by the building power currently, which would not be permitted unless these systems also have integral battery backup systems such that they would operate under a malfunction of the optional standby system. It appears that the fire alarm system does have such battery backup, but the existing emergency egress lighting does not appear to.
