Asbestos Survey Update Report

**C.R. Layton U.S. Army Reserve Center (FL005)
1125 Northeast 8th Avenue
Gainesville, Florida**

June 2013

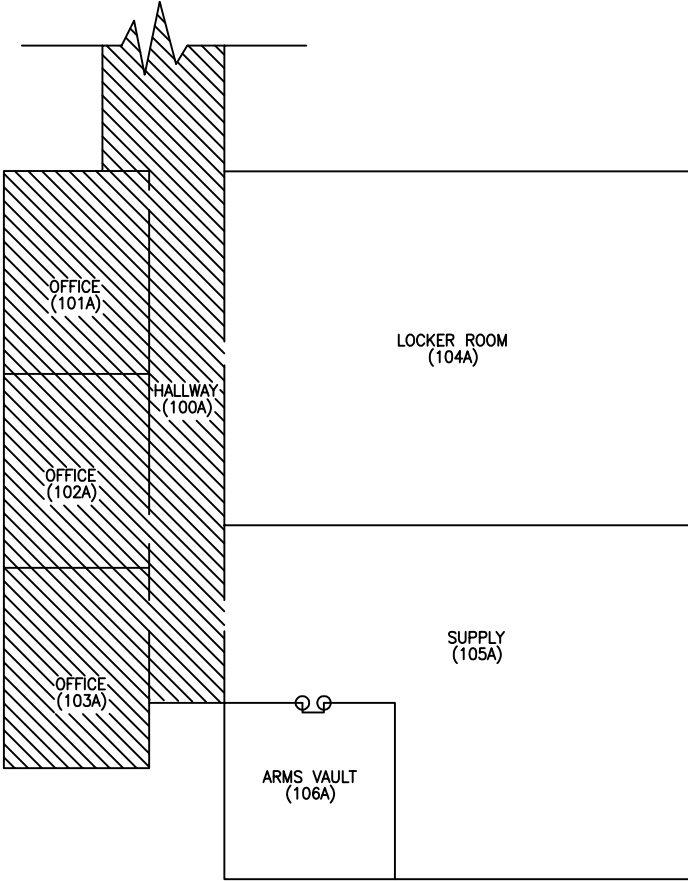
ASBESTOS UPDATE SURVEY
 MAIN BUILDING, 1ST FLOOR, NATIONAL GUARD ANNEX
 C.R. LAYTON USARC
 GAINESVILLE, ALACHUA COUNTY, FLORIDA

- LEGEND**
- ASBESTOS-CONTAINING FLOOR TILE MASTIC
 - STENCILED ROOM NUMBERS IN PARENTHESES
 - ACM 1" WOVEN DOOR GASKET

A one inch wide woven gasket was adhered to the seal of the ammunition vault door. This 24 linear feet of material was sampled and analyzed to contain 65% chrysotile asbestos and is in good condition with no damage at survey time.
