# NW Gainesville Finding of Necessity Study

# 1.0 - Introduction

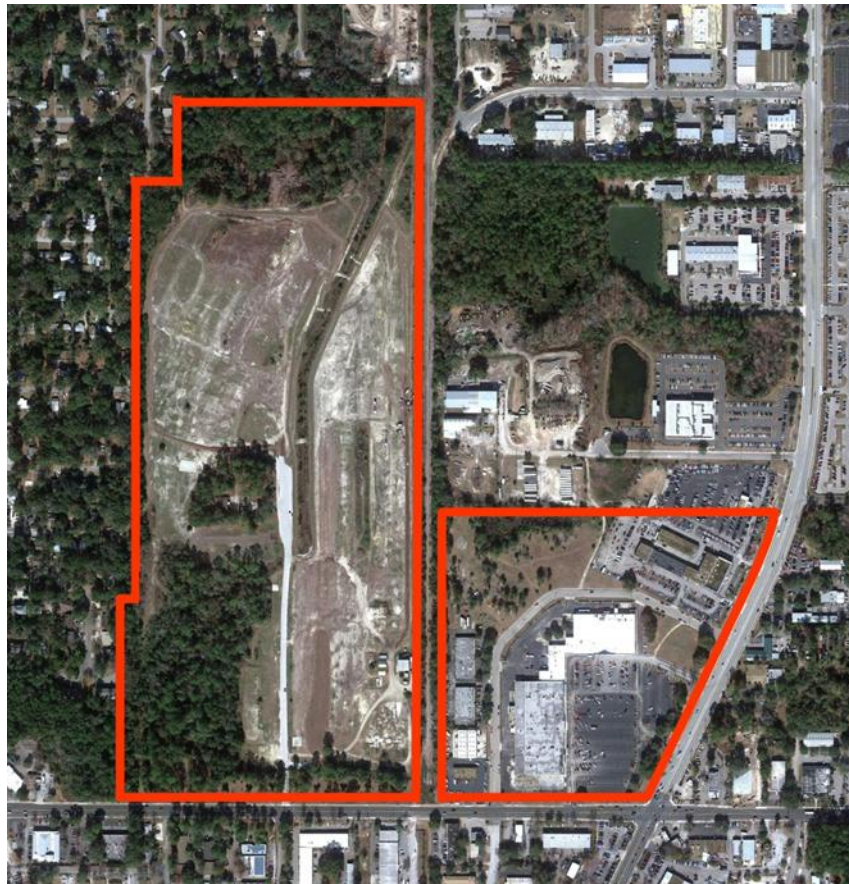
Figure 2-1: Cabot/Koppers Superfund Site

Site investigations by the EPA found contamination in ground water and soil that potentially could harm people in the area. Contamination resulted from waste-handling practices at the site. Contaminants of concern include arsenic, polycyclic aromatic hydrocarbons (PAHs), dioxins/furans, and creosote compounds. The surficial aquifer below the Cabot/Koppers Superfund site is contaminated with numerous compounds from previous processing operations at both sites. Underlying the surficial aquifer is the Hawthorn Group (HG). The HG consists of three clay layers with silty-clayey sand. Underlying the HG is the Floridan aquifer. At the site, the depth to the top of the Floridan aquifer is approximately 150 feet below ground surface. Recent investigations have revealed contamination in the HG and the underlying Floridan aquifer below the site. The City's Murphree Well Field extracts water from the Floridan and supplies the water for Gainesville.

The most recent cleanup plan, or Record of Decision (ROD), was issued in 2011, which finalized cleanup activities for the Koppers area of the site. A consent decree between the EPA and Beazer East who is responsible for cleaning up the site was approved in 2013. The consent decree allows efforts to begin for the final remediation of the Koppers site. As of April 2014 soil removal and replacement is underway in the Stephen Foster neighborhood (adjacent to the western boundary of the former Koppers site) and is expected to

be complete in July 2014. As of April 2014 pilot testing had begun for final remediation strategies from the creosote on the Koppers site.

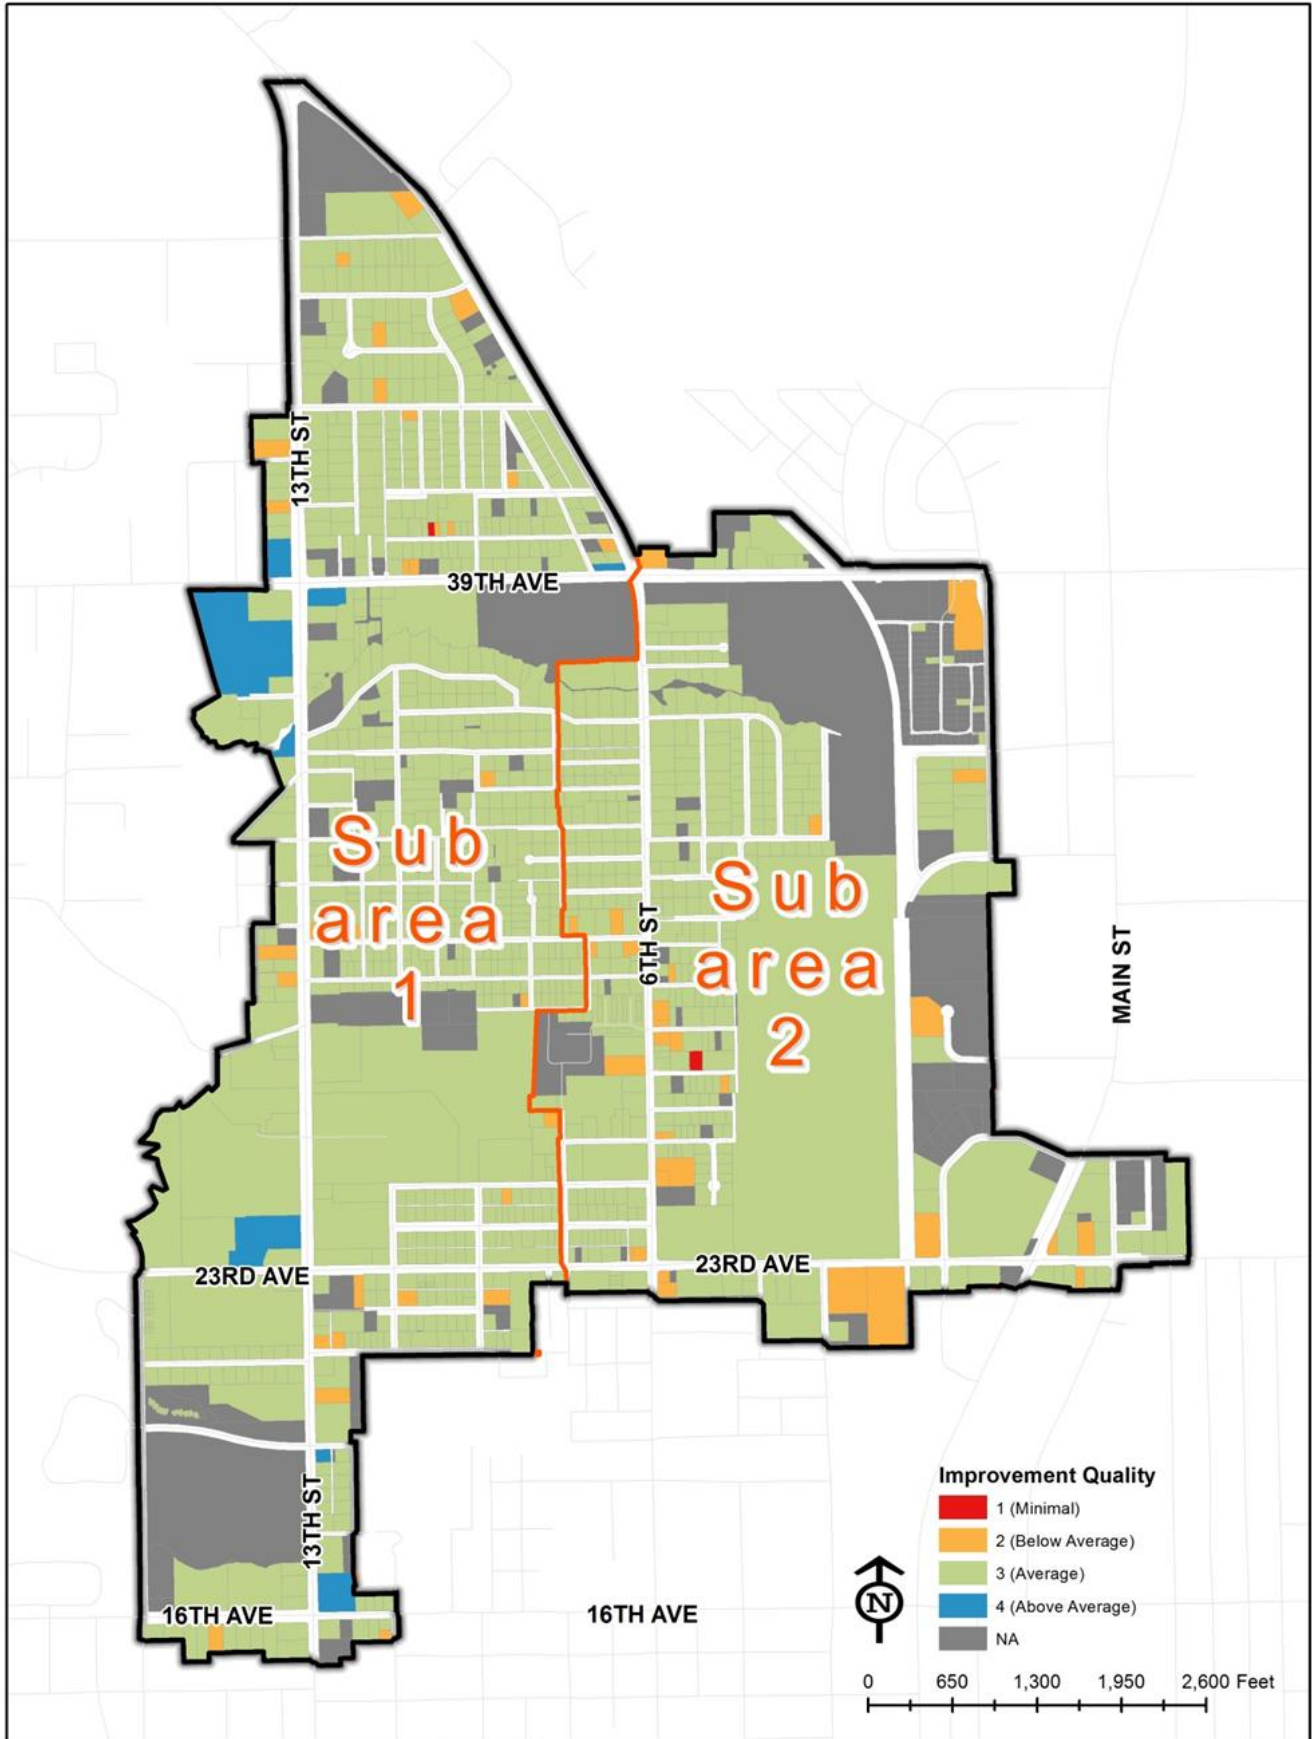
Map 2-1: Study Area Improvement Quality

Subarea 2 has more properties categorized as 3’s and 2’s. With none rated 4 (compared with Gainesville’s 7.5 percent and Alachua County’s 13.3 percent) and none rated 5.

The map does not address the improvement quality of the Cabot/Koppers Superfund site. While the site is categorized as “average” because of its current lack of significant structures, the map does not take into account its polluted nature and the potential threat to the surrounding neighborhoods. Vacant and very difficult to develop, it also has an impact on the stability of development along 23rd Avenue. In the case of the Cabot/Koppers site, the perception of a whole site is as important as a single building. Even if the structures are considered average, the site is functionally obsolete, and therefore considered blighted.

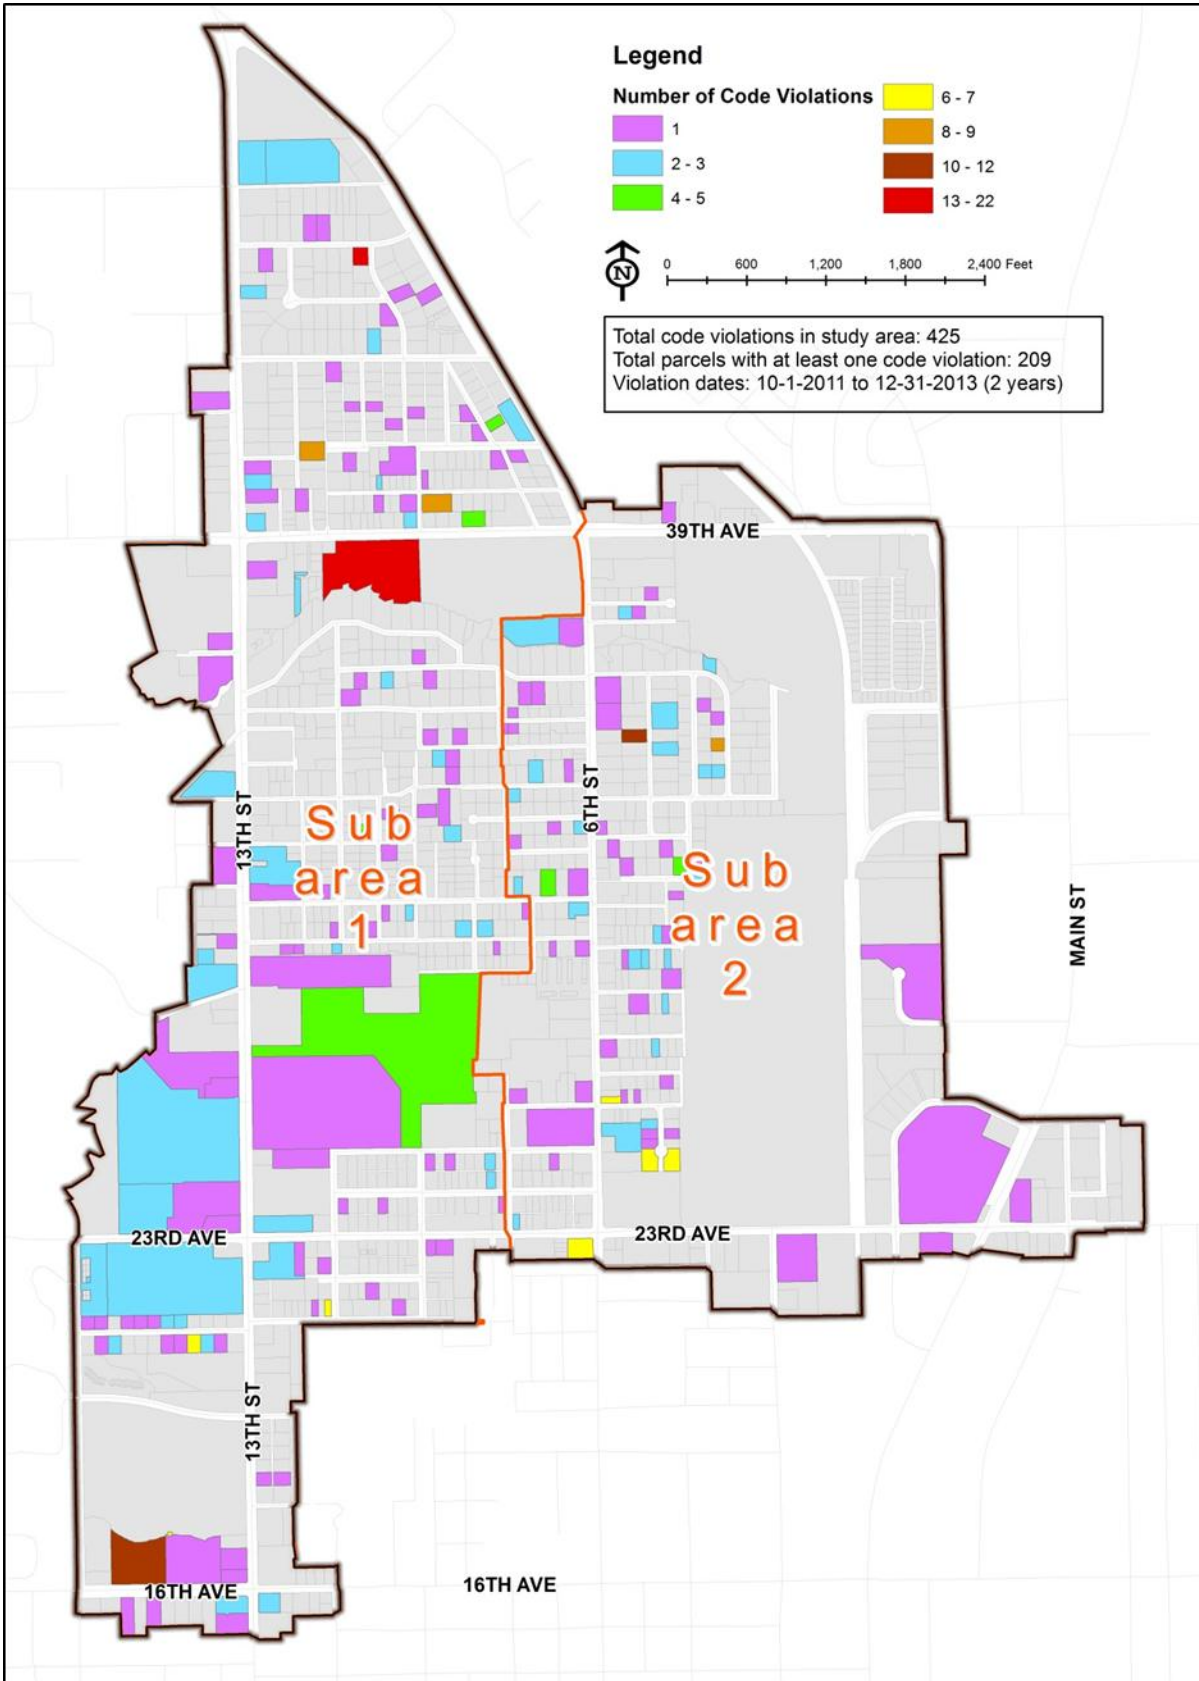
Map 2-2: Study Area Code Violations

In addition, there is a concentration of properties adjacent to the Cabot/Koppers Superfund site to the west. These single-family residential properties have been affected by significant disinvestment and other negative effects in relation to their proximity to the site.

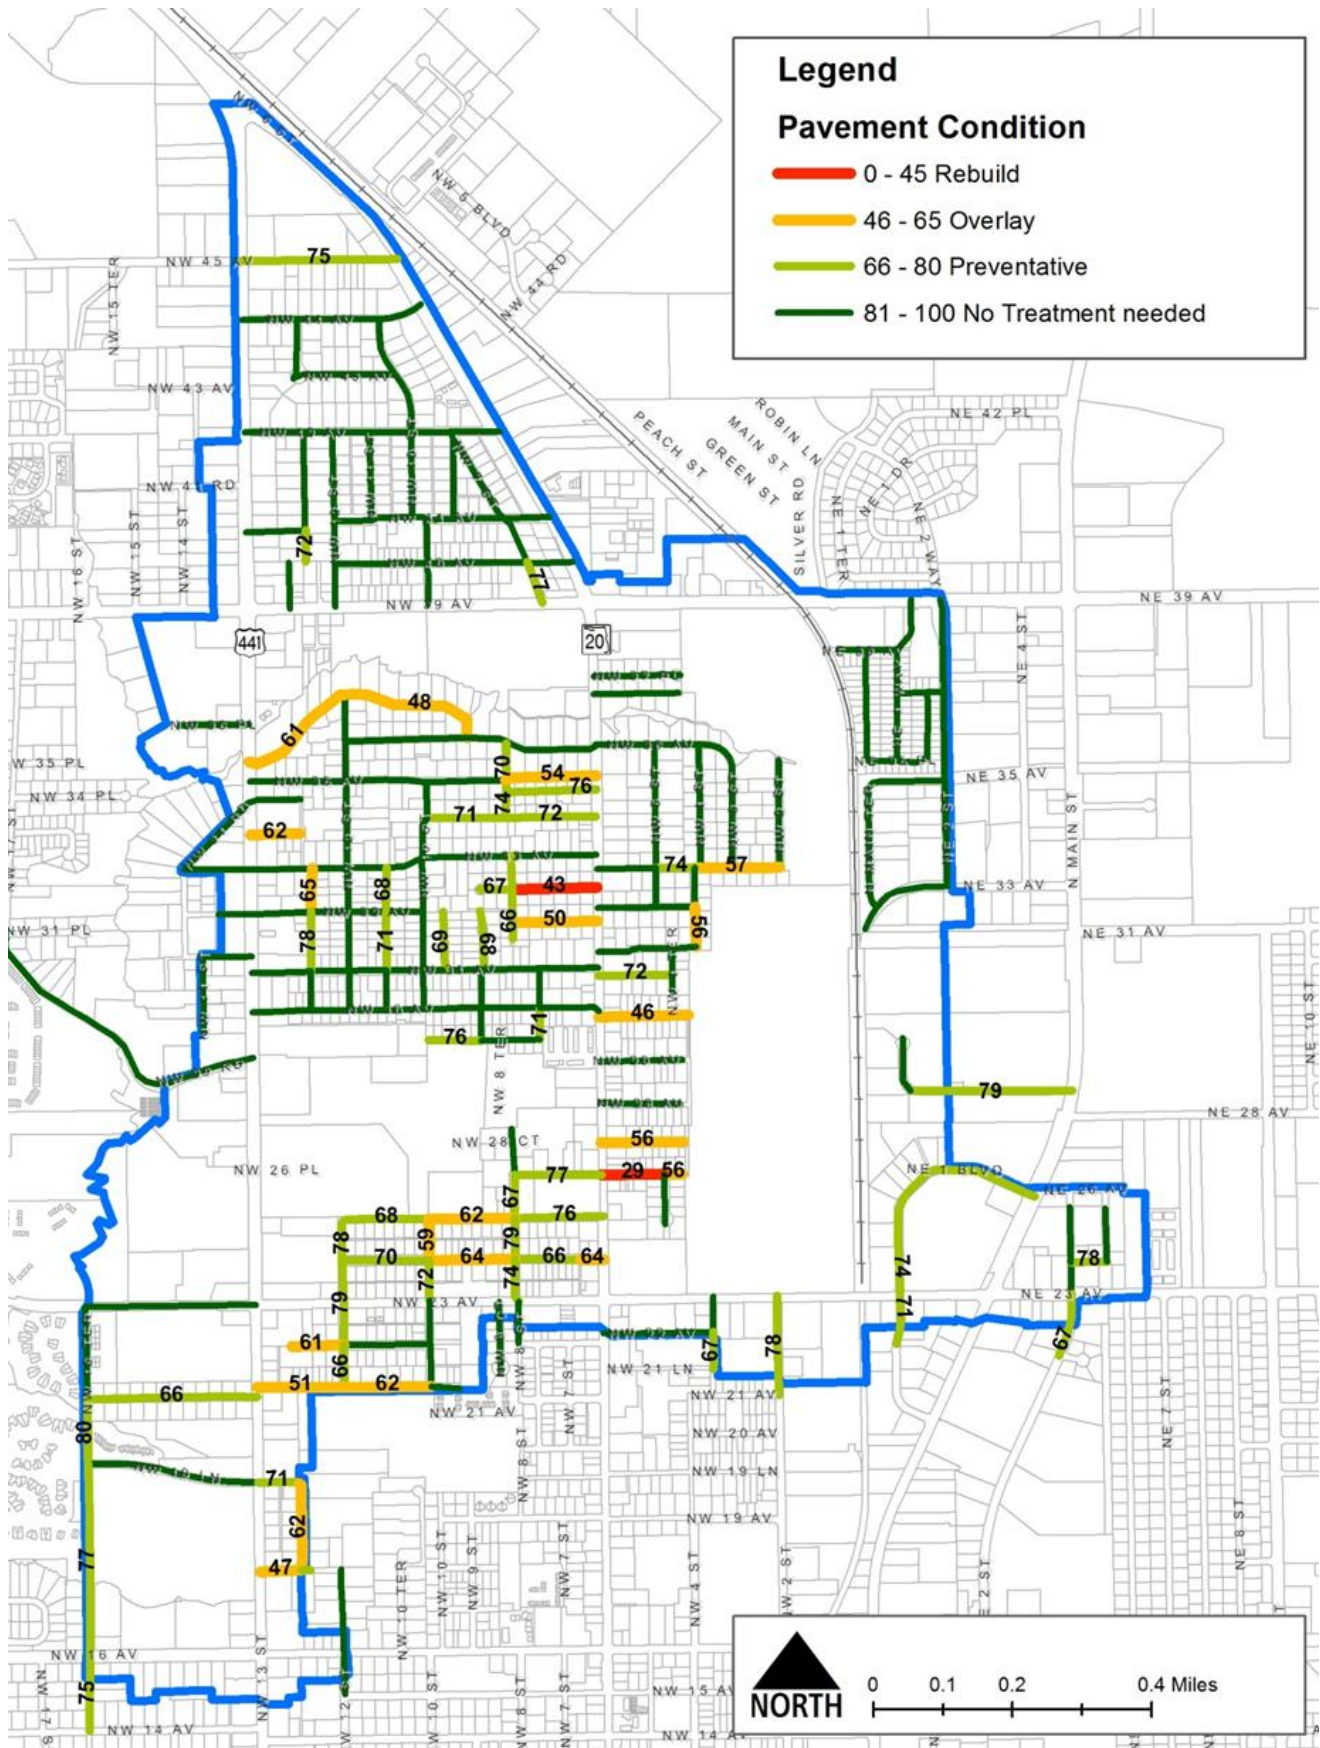
Map 2-12: Pavement Conditions

Field observations identified concerns with the condition of roadway pavement within the Study Area including Subarea 1 and Subarea 2. Map 2-12 documents the condition of streets from a scale of 0 to 100. According to the City of Gainesville's standard, pavement with a rating of 65 or less is in need of resurfacing. Based on that standard, 2.29 miles of roadways of the 20.04 total miles of roadways in the study area are inadequate. The majority of these streets are in the Stephen Foster neighborhood (Subarea 1 and Subarea 2), the neighborhood between NW 6th Street and the Cabot/Koppers Superfund Site (Subarea 2), and adjacent to the NW 23rd Avenue and NW 13th Street corridors (Subarea 1). Figure 2-4 demonstrates the poor roadway condition in parts of the Study Area including Subarea 1 and Subarea 2.

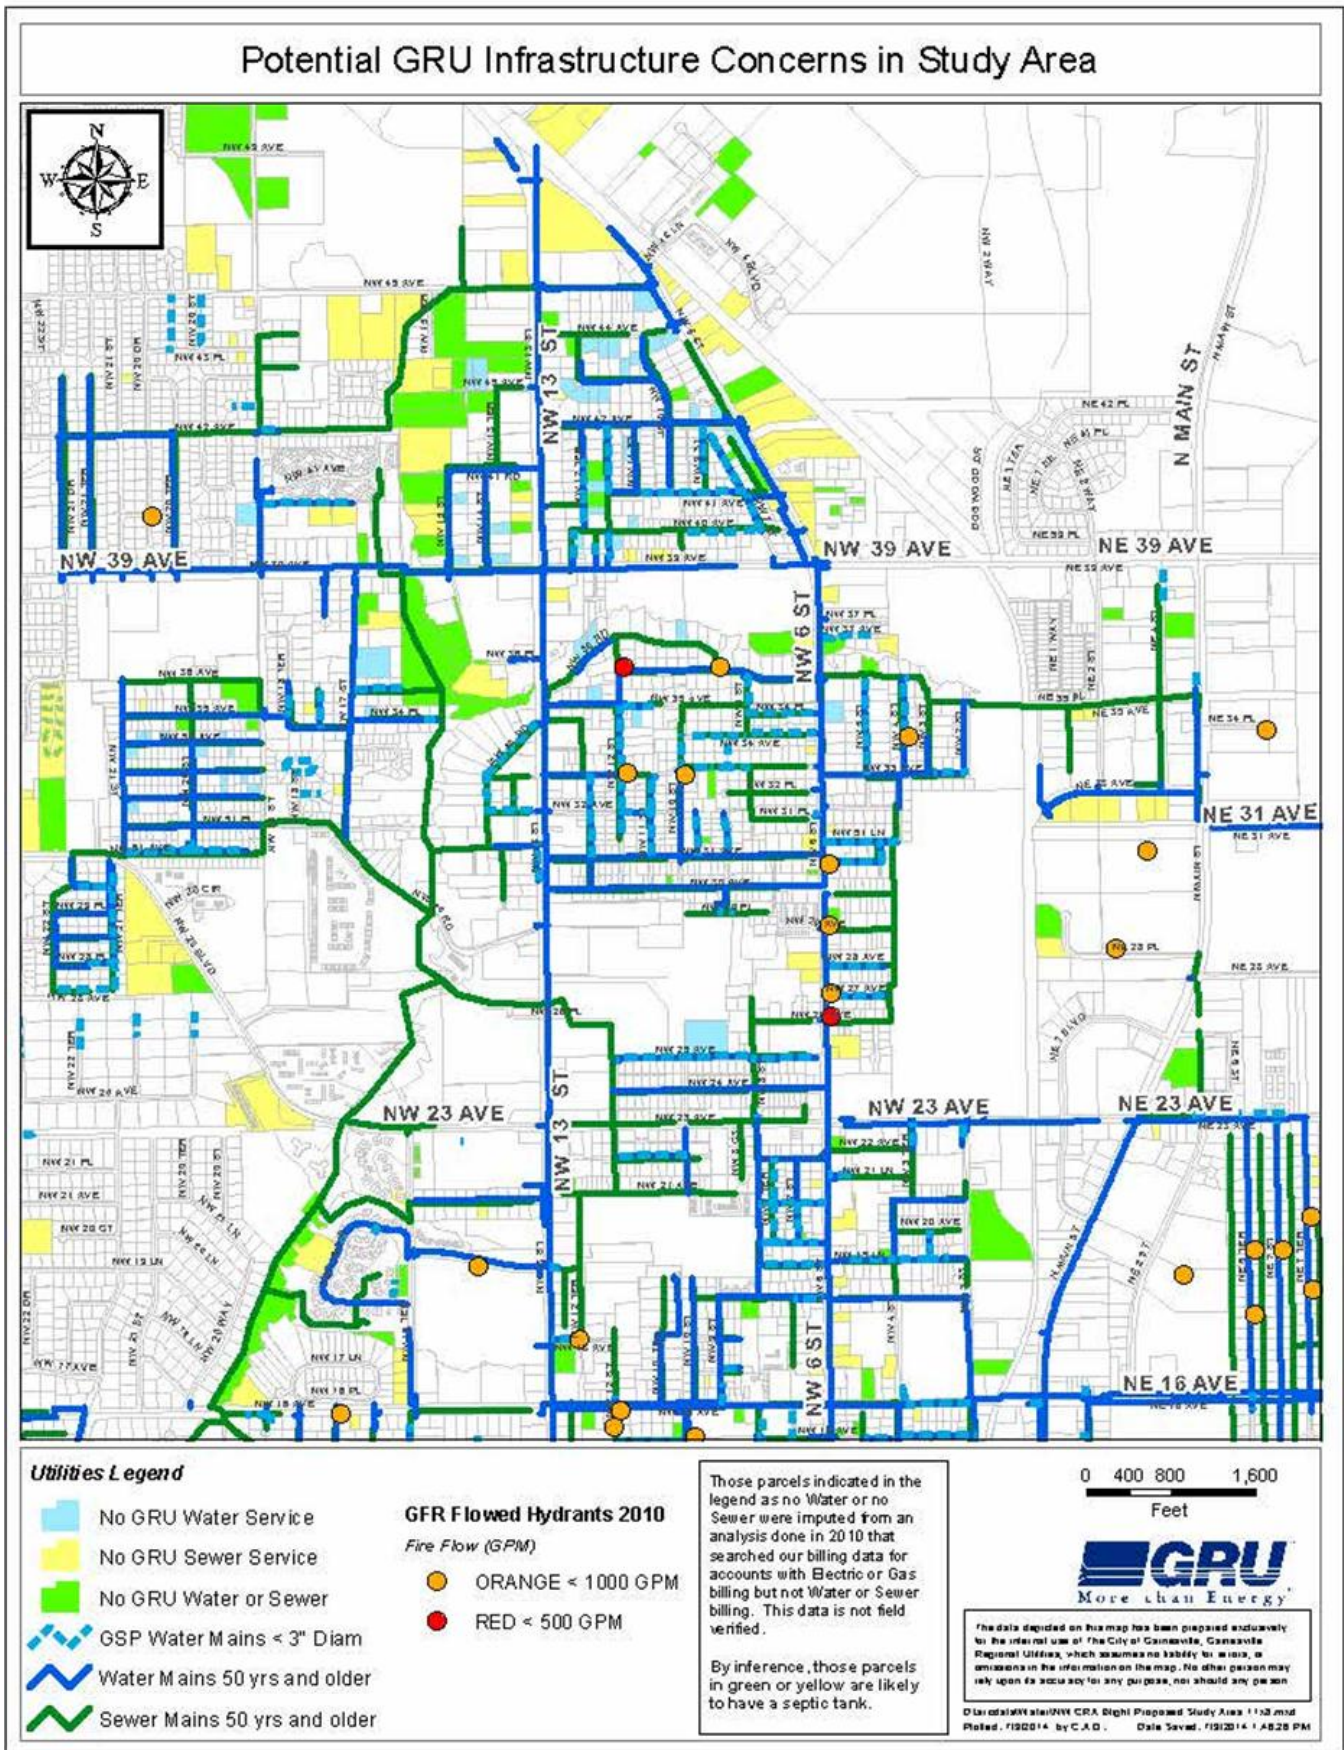
Map 2-18: Potential Utilities Concerns

The Study Area including Subarea 1 and Subarea 2 is served by two lift stations. Lift station 12 is located in Subarea 2, on the north side of the Cabot/Koppers Superfund site and serves a small number (~ 30) of residential parcels. The remainder of the Study Area including Subarea 1 and Subarea 2 is part of a much larger area that is served by Lift Station 1, located near the intersection of SW 2nd Avenue and SW 34th Street. GRU

staff did not identify any deficiencies in the Lift Station 12 service area. Lift Station 1 runs nearly continuously, and is known by GRU staff to be at or above capacity. This deficiency has been identified and GRU staff has programed an additional lift station to serve the area by taking some of the flow from Lift Station 1, as well as providing the ability to bypass Lift Station 1. This lift station, known as the “Loblolly Lift Station” is programed for construction in Fiscal Year 2018.
