# POWER DISTRICT BUILDING NEEDS ASSESSMENTS

May 2015

Gainesville  
Community  
Redevelopment  
Agency

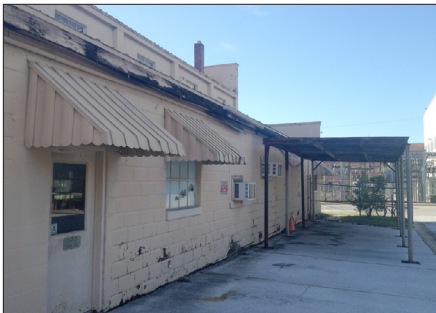
Wall Systems	Exterior Type 1 - CMU. Exterior masonry is in fair condition. Minimal exterior cracks were observed. Paint is in poor condition and repainting is recommended. No wall insulation was observed.

Deteriorating Exterior Paint On CMU

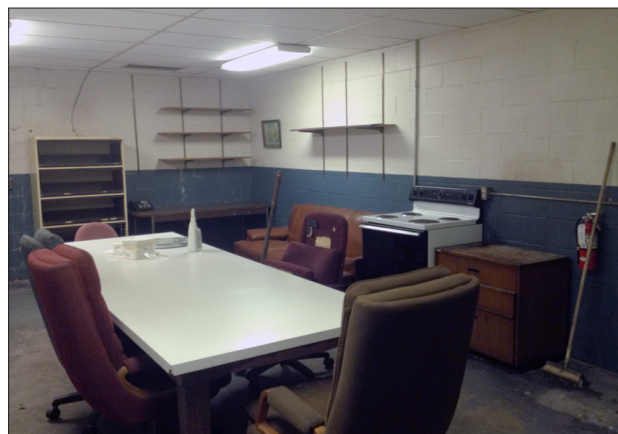
Break Room With Cement Floor

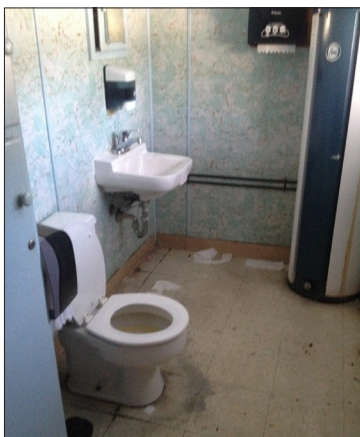
SYSTEM	CONDITION	RECOMMENDATION
Toilet Rooms	Building A has two toilet rooms downstairs and one upstairs. The plumbing fixtures in the toilet rooms are very old and obsolete.

West Toilet Room with Water Heater

<p>Demolish existing plumbing fixtures and piping in toilet rooms back to utility connections. Install new fixtures to meet current code requirements.</p>
Piping	Existing water and waste piping is concealed.	
Hot Water Systems	An existing electric water heater is located in the west toilet room. Water heater casing appears to be damaged.	
Gas System	There are a total of five LP gas tanks serving Building A. These tanks appear to be in serviceable condition.

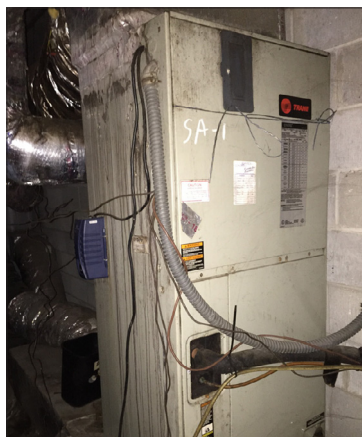
Offices	Cooling: Offices are cooled by a combination of split-system AC units, window AC units and a packaged AC unit. All units are past their expected serviceable life. The second floor heat pump does not have code-required access for maintenance. Most ductwork is comprised of flexible duct attached to galvanized mains. All visible ductwork is in poor condition.	Provide outside air energy recovery unit to supply ventilation air where natural ventilation is not available.
	Heating: Heating in office areas is provided as part of each cooling system.	Demolish and replace existing cooling and heating units with new heat pumps and controls.
	Ventilation: Existing ventilation is provided by operable windows in most spaces. Some office areas do not have exterior openings or ducted outdoor air.	Provide outside air energy recovery unit to supply ventilation air where natural ventilation is not available.

Existing HVAC Equipment

SYSTEM	CONDITION	RECOMMENDATION
Maintenance Bays	Cooling: The maintenance bays in Building A are not mechanically cooled.	Demolish and replace existing cooling and heating units with new heat pumps and controls.
	Heating: The main maintenance bay has LP gas unit heaters installed. The heaters appear to be in serviceable condition. The northeast bay is heated by an LP gas fan heating unit with uninsulated galvanized steel ductwork. The heating unit appears to be in serviceable condition.	Demolish existing process ductwork not connected to equipment.
	Ventilation: Maintenance bay ventilation consists of operable doors and wall-mounted propeller exhaust fans (total of five). The exhaust fans are rusted and appear to be beyond their expected serviceable life.	Demolish existing process ductwork not connected to equipment.
Storage Rooms	Storage areas in this building are not conditioned or ventilated.	Replace propeller ventilation fans serving maintenance bays.

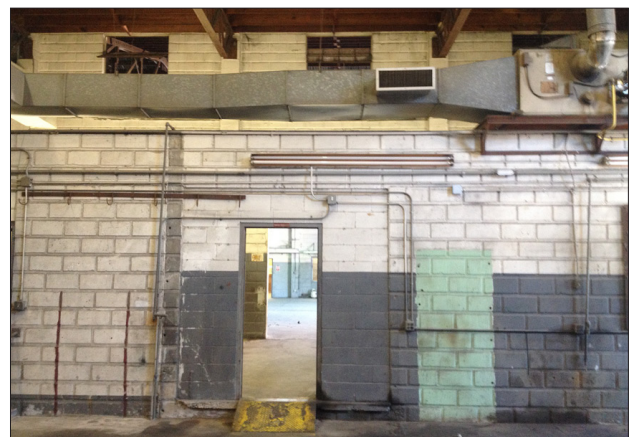
<p>Hire LP gas supplier to inspect tanks, piping and regulators, and replace as needed.</p>
Other	Maintenance bays are piped with multiple process system piping including automatic transmission fluid, grease, compressed air, and process water. The equipment requiring these services is no longer in place. Multiple water coolers, which are old and obsolete, are placed throughout the building.

Maintenance Bay with Ductwork

<p>Demolish existing process piping.</p> <p>Demolish existing water coolers and sinks. Install new water coolers and sinks to serve new tenant layout.</p>

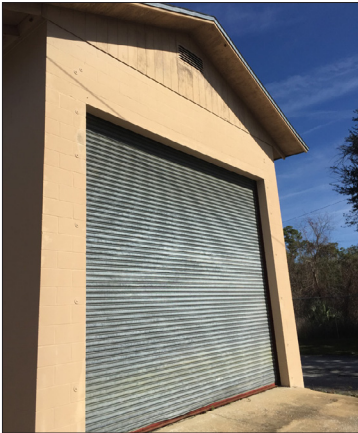
SYSTEM	CONDITION	RECOMMENDATION
Exterior Windows	None.	
Exterior Doors	Type 1: Roll-up garage doors. Door hardware and frame systems are all in good working order.

Roll-Up Door

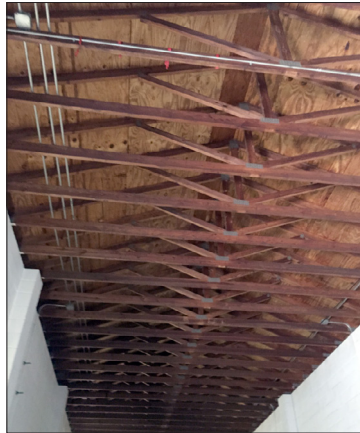
Ceiling System	No ceiling systems. Exposed to the structure above.

Exposed Roof Structure

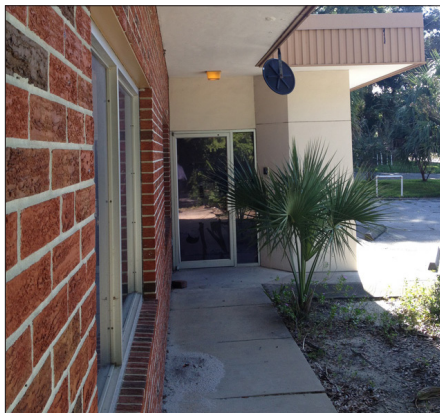
Wall Systems	Exterior Type 1 - Brick on CMU. Exterior brick is in excellent condition. No exterior cracks were observed.

Exterior Brick

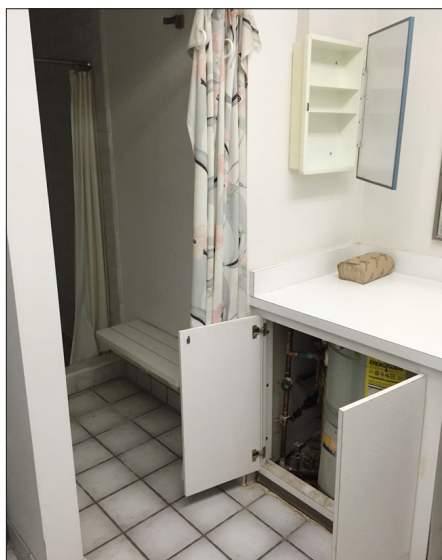
Toilet Room With Under-Counter Water Heater

Demolish existing water heating system. Reinstall water heaters as necessary for new layout.
Other	There is a sink and a water cooler in the break room. Both fixtures are old.	Demolish existing water cooler and sink. Install new water cooler and sink to serve new tenant layout.

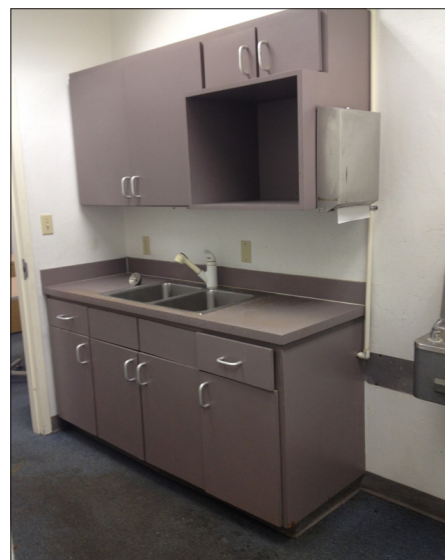
Break Room Sink

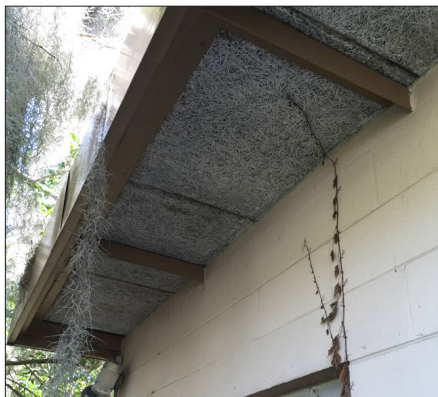
Some water damage was observed on the exterior soffit which indicates a roof leak may be present. No other evidence of roof leaking was observed.	
	System 2: Modified bitumen roof on metal deck.

Tectum Roof Deck

Repair water damage and roof leaks.

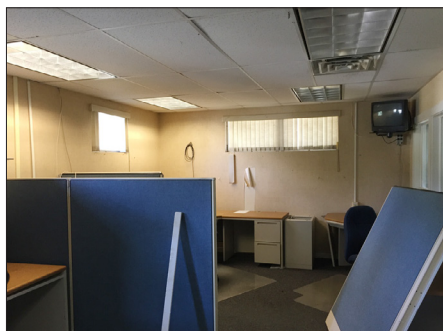
Replace all finishes.
	System 2: Ceramic Tile. Varied sizes and colors and in fair condition. (Toilet rooms)	
	System 3: VCT. 12x12 In fair condition (Lobby areas)	
Ceiling System	Type 1: Office spaces have standard sound absorbent 2x2 or 2x4 acoustic ceiling tile. There has been some exposure to moisture which is evidenced by the sagging tiles.

Office With Sagging Ceiling Tile

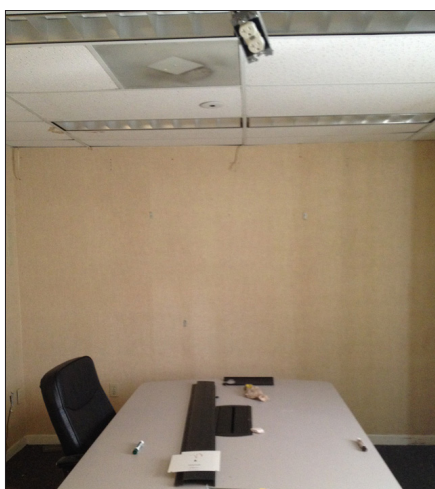
Electrical Components Hanging From Ceiling

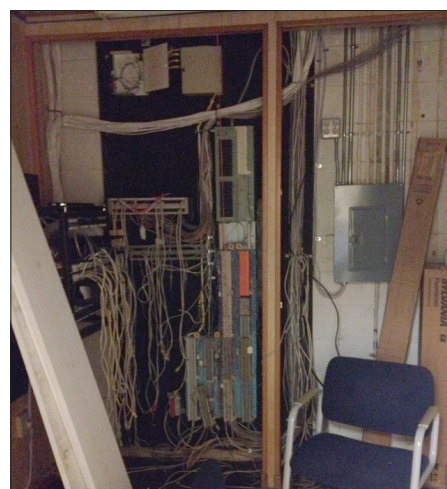
Electrical Panel

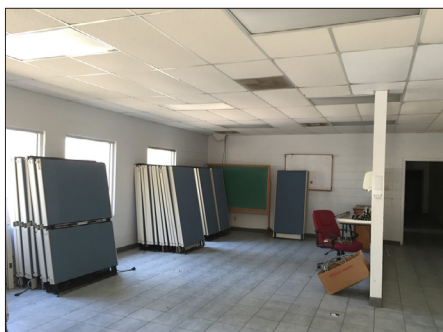
Replacement is recommended.
Ceiling System	Type 1: Office spaces have standard sound absorbent 2x2 or 2x4 acoustic ceiling tile. There has been some exposure to moisture which is evidenced by the sagging tiles.

Office With Sagging Ceiling Tile

Replacement is recommended.

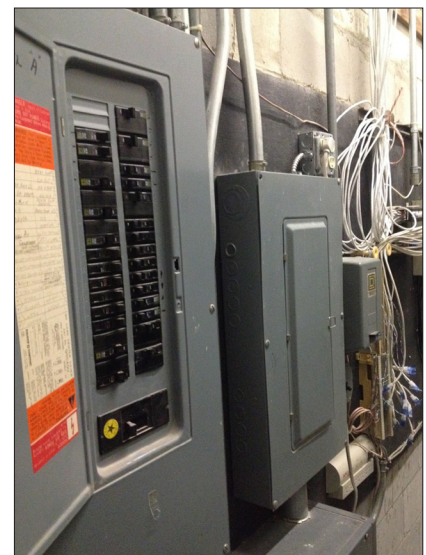
Electrical Panel

SYSTEM	CONDITION	RECOMMENDATION
Electrical Distribution Equipment	Panels are in fair condition.

Retain main electrical panels.
Emergency Lighting	Inadequate.

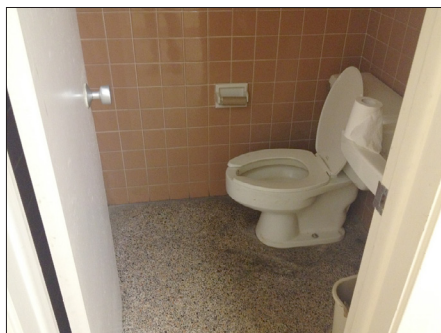
SYSTEM	CONDITION	RECOMMENDATION
Floor Coverings	System 1: Terrazzo. (Offices, corridors). Most of the terrazzo floor system is in salvageable condition.

Toilet Room With Terrazzo Floor

If terrazzo is to be reused, clean and seal.
	System 2: Ceramic Tile. Varied sizes and colors and in fair condition. (Toilet rooms and lobby areas)

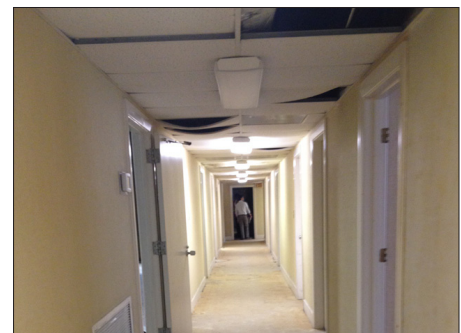
System 3: Sealed concrete. Fair condition.	
Ceiling System	Type 1: Office spaces have standard sound absorbent 2x2 or 2x4 acoustic ceiling tile. There has been some exposure to moisture which is evidenced by the sagging tiles.

Sagging Ceiling Tiles

Remove and replace tiles.

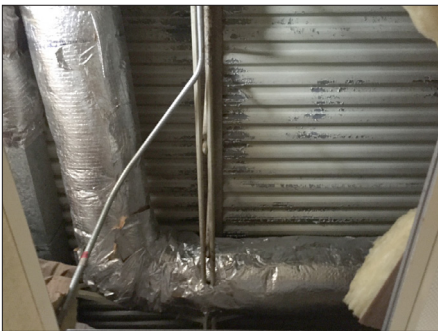
SYSTEM	CONDITION	RECOMMENDATION
Cooling	The building is cooled throughout all office spaces with a total of six split-system heat pumps, three packaged rooftop units, and one packaged terminal AC unit. All units appear to be beyond their serviceable life. The building has a mixture of galvanized steel and ductboard ducts. Due to the high amount of visible mold on the building walls, it is likely that the ductwork contains mold.	Demolish and replace existing cooling and heating units with new heat pumps and controls. If desired, natural gas may be used for heat in each unit.
Heating	Heating in the office areas is provided as part of each cooling system. The warehouse area is heated by natural gas unit heaters. The unit heaters are old and appear to be beyond their serviceable life.	Replace gas unit heaters with new.
Ventilation	There is no apparent ventilation provided to the occupied spaces of the building.	Demolish existing ductwork. Install new insulated galvanized steel ductwork.

Ductwork Above Ceiling

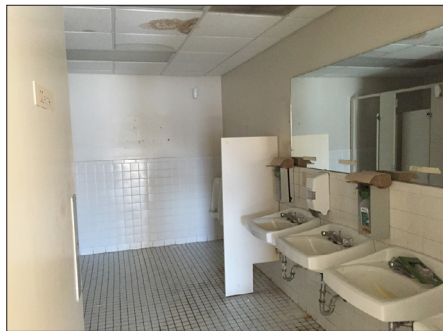
SYSTEM	CONDITION	RECOMMENDATION
Toilet Rooms	All toilet rooms contain old plumbing fixtures which are obsolete.

Dilapidated Toilet Room

Demolish existing plumbing fixtures and piping in toilet rooms back to utility connections. Install new fixtures to meet current code requirements.
Piping	Existing water and waste piping is concealed.	
Hot Water Systems	A single 4,500 watt, 65 gallon water heater is located in the toilet room near the main north entrance. The water heater casing is rusted and visible piping is corroded.

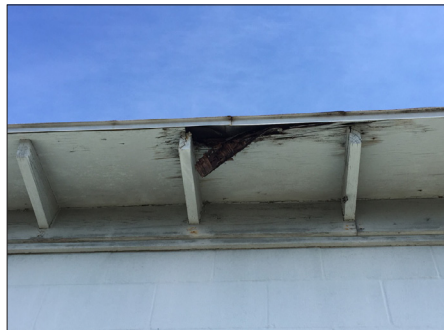
Rotten Wood At Roof Eave

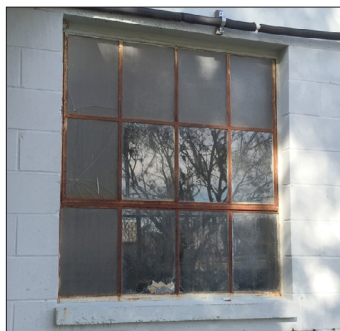
Rusting Window Panes

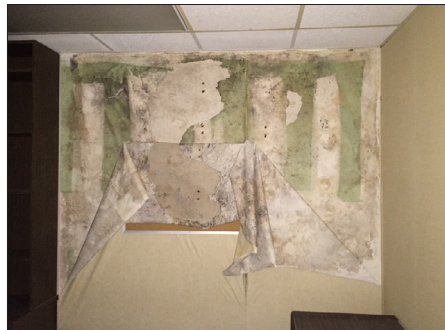
Mold Growth On Interior Wall

SYSTEM	CONDITION	RECOMMENDATION
Cooling	Cooling: Building is partially conditioned by two packaged rooftop AC units and one split-system AC unit. All units appear to be beyond their serviceable life. Ductwork is comprised of galvanized steel ducts and ductboard. The ductboard has visible mold growth.

Mitigate all mold.
Termites	Evidence of subterranean termites was found.

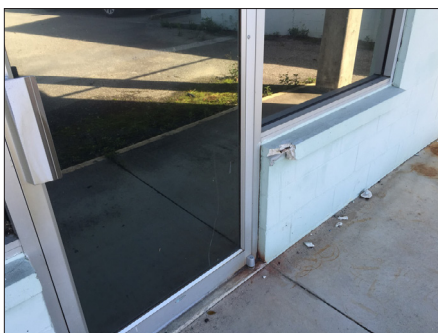
SYSTEM	CONDITION	RECOMMENDATION
Exterior Windows	All exterior storefront glazing and sealant systems are in fair condition. No leaks or potential leaks were noted on initial walk-through.

Storefront

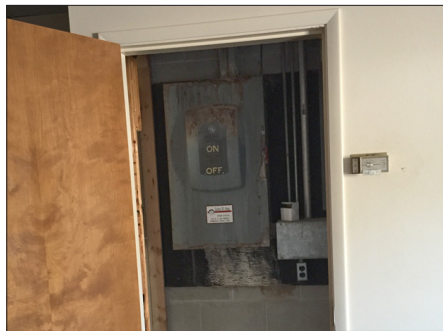
SYSTEM	CONDITION	RECOMMENDATION
Electrical Distribution Equipment	Panels are old and obsolete.

Electrical Panel

Gut and replace all electrical systems.
Emergency Lighting	None exists.	
General Lighting	Old and obsolete T12 fluorescent fixtures.	
Lighting Controls	No automatic or occupancy sensors.	
Fire Alarm System	There is no existing fire alarm system.	
Exit Signage	Inadequate.	
Telecom	Cabling is old and obsolete; poorly installed and routed.

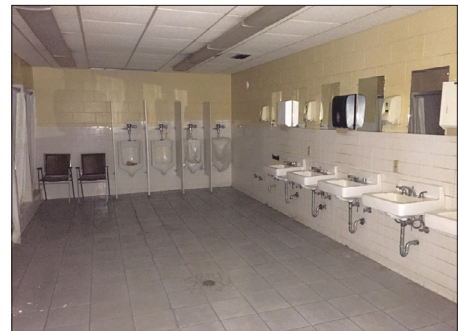
SYSTEM	CONDITION	RECOMMENDATION
Toilet Rooms	There is one toilet room on the west side of the building, two on the south exterior wall, and a large gang toilet and locker room on the east end of the building. All plumbing fixtures appear to be in poor condition.

Locker Room
