# Gainesville *Florida*

# GROWTH AND EXPANSION FEASIBILITY MASTER PLAN 2021

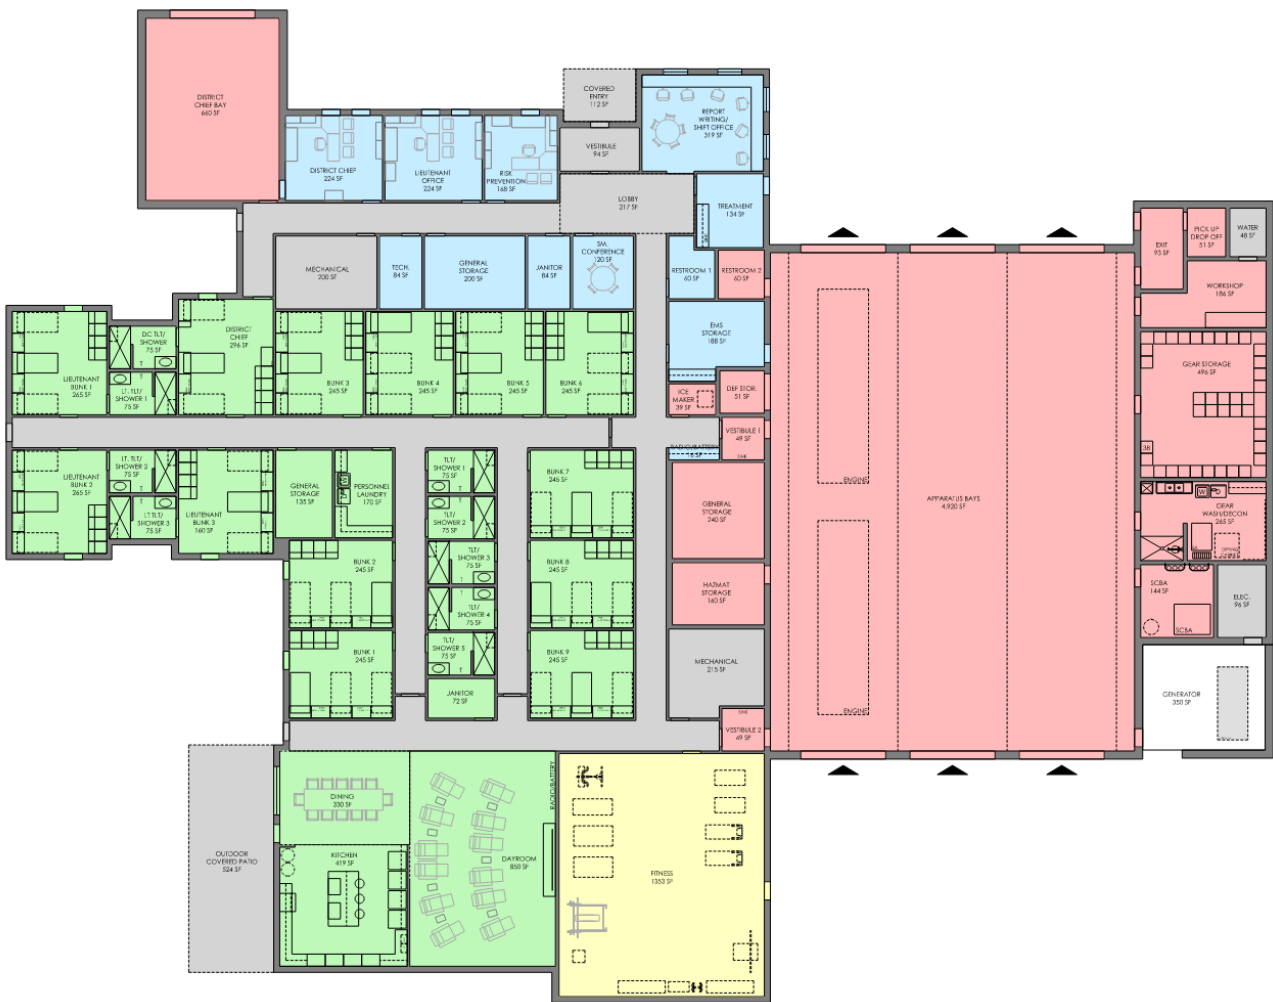
The areal requirement for the GFR Prototype Station is approximately 21,000 GSF. The station would be designed to meet current "Essential Facilities" design criteria as well as current best practices for firefighter health, safety, and wellness. The estimated value of this type of building is approximately \$425 to \$450 per square foot. This would place the cost of this building at approximately \$8.925 to \$9.45 M. The estimated value of fixtures, furniture, and equipment (FF&E) is \$0.425 M. The total construction and equipment cost is approximately \$9.35 to \$9.875 M. These costs are exclusive of land purchase, design, and apparatus costs.

The prototype design provides crew space for up to nine firefighters and four command staff as well as apparatus bay space for up to six vehicles, however, it is uncommon for all bay spaces to be occupied as flexibility in bay use is desired and required. Additionally, the design provides for drive-thru apparatus bays. A separate apparatus bay is provided for the District Chief to remove this vehicle traffic from the fire apparatus bays.

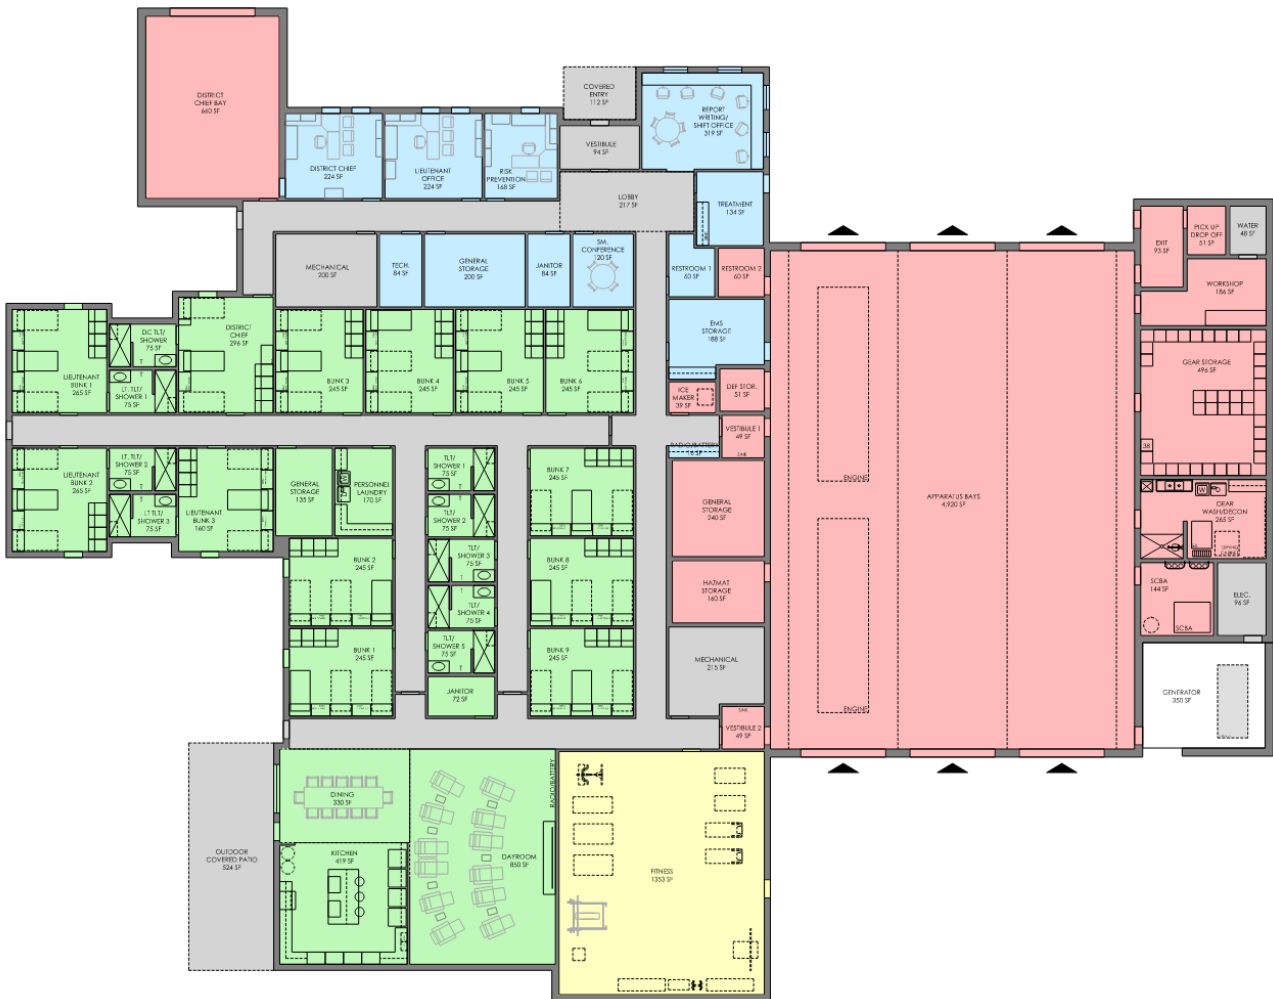
Figure 73: GFR Conceptual Fire Station Design

The prototypical station design provides approximately 21,000 gross square feet of space. This area is based on the Space Needs Programming and is to be proven with the prototype (conceptual) design. As was noted earlier, the final area will likely vary from the space needs area. The image shown in the figure below is the final prototype design for GFR’s future stations. This plan provides approximately 21,330 gross square feet.

The fitness space is placed near the rear apparatus aprons for ease of personnel to use the aprons for fitness purposes (CrossFit fitness exercises). Additionally, the remote location helps to isolate the noise generated by the fitness use from the other areas of the station that could be impacted by such use.

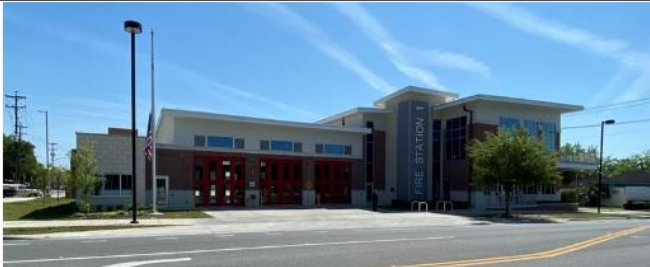
<b>STATION NAME/NO.:</b>	Fire Station #1				
<b>STATION ADDRESS/LOCATON:</b>	525 S. Main Street

<p><i>(Brief Description of station)</i></p> <p>The station is the Department's newest station. This station provides some administrative services in addition to being a normal fire station. The station project encompasses the station and support services. As a 2-story station, daytime functions are housed on the 1st floor and bunkroom functions are housed on the 2nd floor.</p>					
<b>STRUCTURE</b>					
Date of Construction	2018				
Date(s) of Renovation/Expansion	N/A				
Building Age	3				
Construction Type	II-B				
Building Construction	CMU Masonry, Steel Bar Joists				
Building Area (SF):	~22,260				
Number of Stories:	Two - Living Quarters/Gym upstairs				
Site Area (SF & Acres):	SF: ~66,924	Acres: ~1.54			
Maximum Station Staffing Capability	18 Fire Personnel, 3 Administrative Personnel

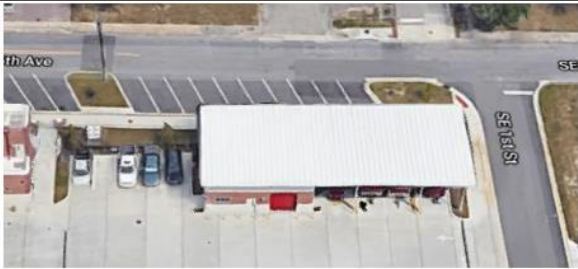
<b>STATION NAME/NO.:</b>	Logistics & Supply Warehouse (at Station #1)		
<b>STATION ADDRESS/LOCATON:</b>	525 S. Main Street

<p><i>(Brief Description of station)</i></p> <p>The facility is a support facility for GFR providing warehousing for Department-wide supply needs. Additionally, this facility has a open-air structure at the east end providing 4 bays of covered, outdoor storage for GFR trailers and similar equipment.</p>			
<b>STRUCTURE</b>			
Date of Construction	2018		
Date(s) of Renovation/Expansion	N/A		
Building Age	3		
Construction Type	II-B		
Building Construction	PEMB w/Masonry & Stucco Veneer		
Building Area (SF):	~1,390 SF		
Number of Stories:	1		
Site Area (SF & Acres):	SF: N/A	Acres: N/A	
Maximum Station Staffing Capability	5		
Seismic Protection <i>(if required)</i>	Unknown		
Category IV Conformance <i>(if required)</i>	Unknown		
ICC 500 Conformance <i>(if applicable)</i>	Unknown

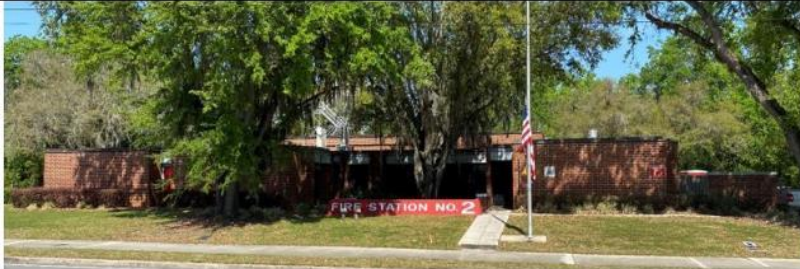
<p><i>(Brief Description of Station)</i></p> <p>Three-bay, drive-thru, single level design with a small storage/hose drying ramp at the north side of the apparatus bays. This station houses the GFR Hazmat Team and a Truck company. This station is the primary responder to the UF Campus.</p>					
<b>STRUCTURE</b>					
Date of Construction	1975				
Date(s) of Renovation/Expansion	N/A				
Building Age	46				
Construction Type	II-B				
Building Construction	CMU and brick masonry framed structure w/precast and cast-in-place concrete roof decks and a concrete slab on grade.				
Building Area (SF):	~8,791 SF				
Number of Stories:	One				
Site Area (SF & Acres):	SF: ~50,400			Acres: ~1.15	
Maximum Station Staffing Capability	12				
Seismic Protection (if required)	N/A				
Category IV Conformance (if required)	Non-conforming

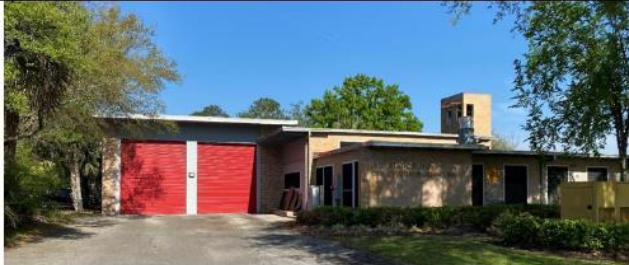
<p><i>(Brief Description of station)</i></p> <p>This station houses one of the busiest engine companies. This Station is a one-story design with flat roof structure. It is co-located on the campus with the Fire Headquarters, Fire Training, CRP and Safety City. The Fire Training facilities are located in close proximity to the Station.</p>			
<b>STRUCTURE</b>			
Date of Construction	1960		
Date(s) of Renovation/Expansion	1994		
Building Age	61		
Construction Type	II-B		
Building Construction	Masonry load bearing walls supporting precast concrete T-beams		
Building Area (SF):	~5,300 SF		
Number of Stories:	1		
Site Area (SF & Acres):	SF: ~42,800	Acres: ~0.9	
Maximum Station Staffing Capability	7		
Seismic Protection <i>(if required)</i>	N/A		
Category IV Conformance <i>(if required)</i>	Non-conforming		
ICC 500 Conformance <i>(if applicable)</i>	Non-conforming

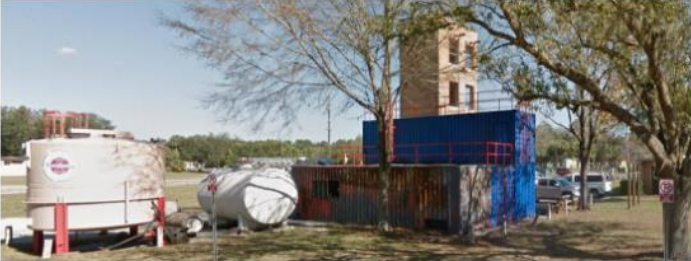
<p><i>(Brief Description of station)</i></p> <p>The Training Facilities consist of; 1) 4-story drill tower w/laddering, repelling, hose advancement, standpipe training and hose drying elements, 2) 4-metal containers (2-stacked) for live Class A burn training, and 3) horizontal confined space training.</p>							
<b>STRUCTURE</b>							
Date of Construction	Unknown						
Date(s) of Renovation/Expansion	N/A						
Building Age	Unknown						
Construction Type	II-B						
Building Construction	CIP Concrete Structure w/Masonry Infill						
Building Area (SF):	~720/Tower; ~1,280/Containers						
Number of Stories:	4-story tower, 2-story containers						
Site Area (SF & Acres):	SF:	~5,000	Acres:	~0.11			
Maximum Station Staffing Capability	N/A						
Seismic Protection <i>(if required)</i>	N/A

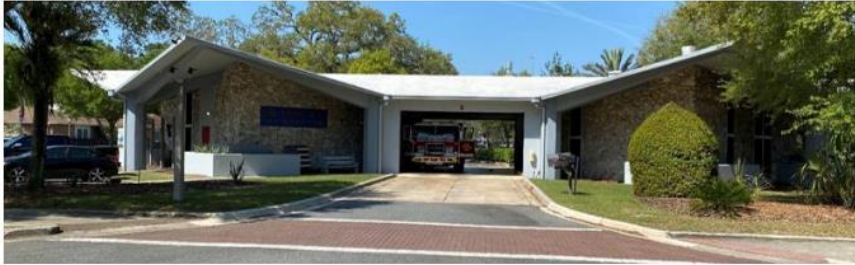
<p><i>(Brief Description of station)</i></p> <p>Located between two busy roads this station is near the UF campus providing secondary coverage to the campus. Built during the 'Cold War Era' this Station was designed to withstand a nuclear event and presents a rather unique, if not unorthodox design. While this facility is likely the most durable station, it is likely the most in hospitable.</p>					
<b>STRUCTURE</b>					
Date of Construction	1964				
Date(s) of Renovation/Expansion	N/A				
Building Age	57				
Construction Type	I-B				
Building Construction	CIP concrete structure with masonry infill and a concrete roof deck				
Building Area (SF):	~3,640 SF				
Number of Stories:	One				
Site Area (SF & Acres):	SF:	~53,290	Acres:	~1.22	
Maximum Station Staffing Capability	Single Company				
Seismic Protection <i>(if required)</i>	Compliant

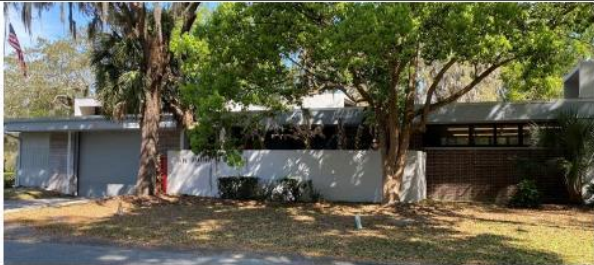
<p><i>(Brief Description of station)</i></p> <p>This Stations is located on a residential side street. The apparatus bay was lowered after the Station was constructed requiring the addition of storm water drains at the rear and front aprons. However, the drain inlets are outside of the bays.</p>			
<b>STRUCTURE</b>			
Date of Construction	1965		
Date(s) of Renovation/Expansion	N/A		
Building Age	56		
Construction Type	II-B		
Building Construction	Masonry bearing walls and steel trusses		
Building Area (SF):	~3,900 SF		
Number of Stories:	1		
Site Area (SF & Acres):	SF: ~21,650	Acres: ~0.75	
Maximum Station Staffing Capability	4		
Seismic Protection <i>(if required)</i>	Non-conforming		
Category IV Conformance <i>(if required)</i>	Non-conforming		
ICC 500 Conformance <i>(if applicable)</i>	Non-conforming

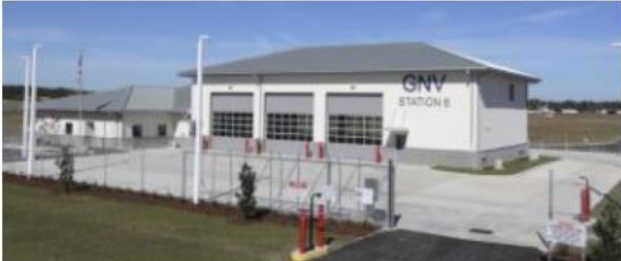
<p><i>(Brief Description of station)</i></p> <p>A relatively modern station built by and located at the Gainesville Regional Airport. This Station houses the GFR ARFF unit. While this Station is not owned by GFR, staff wanted to assess the Station for conformance against current design standards for like facilities.</p>			
<b>STRUCTURE</b>			
Date of Construction	2018		
Date(s) of Renovation/Expansion	-		
Building Age	3		
Construction Type	IV-B		
Building Construction	CMU apparatus bays, framed living quarters (assume)		
Building Area (SF):	~8,800 GSF		
Number of Stories:	1		
Site Area (SF & Acres):	SF: NA	Acres: NA	
Maximum Station Staffing Capability	3		
Seismic Protection <i>(if required)</i>	Compliant		
Category IV Conformance <i>(if required)</i>	Unknown		
ICC 500 Conformance <i>(if applicable)</i>	Unknown

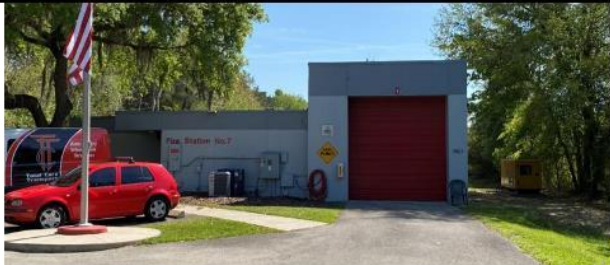
<b>STATION NAME/NO.:</b>		Fire Station #7	
<b>STATION ADDRESS/LOCATON:</b>		5601 NW 43rd Street

<p><i>(Brief Description of station)</i></p> <p>Located in the northwest area of the City, Station 7 appears to be in very poor condition and is very undersized for efficient and effective daily fire service operations. This Station was "inherited" with the City's city limits expansion. The Station has very limited space for personnel and equipment.</p>			
<b>STRUCTURE</b>			
Date of Construction	1981		
Date(s) of Renovation/Expansion	N/A		
Building Age	40		
Construction Type	V-B		
Building Construction	Load-bearing CMU w/steel bar joists; wood non-load-bearing		
Building Area (SF):	~2,036 SF		
Number of Stories:	1		
Site Area (SF & Acres):	SF: Unknown	Acres: Unknown	
Maximum Station Staffing Capability	3		
Seismic Protection <i>(if required)</i>	Non-conforming		
Category IV Conformance <i>(if required)</i>	Non-conforming

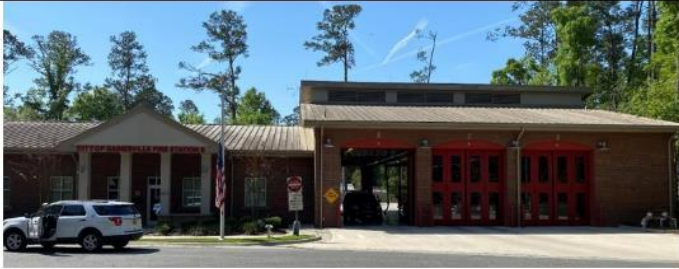
<b>STATION NAME/NO.:</b>		Fire Station #8	
<b>STATION ADDRESS/LOCATON:</b>		3223 NW 42nd Ave

<p><i>(Brief Description of station)</i></p> <p>This station is built in a residential community at the very end of a cul-de-sac. This location inherently requires extended response time to all calls. It was noted that when the Station was built, GFR had difficulty finding adequate land for the Station.</p>			
<b>STRUCTURE</b>			
Date of Construction	2011		
Date(s) of Renovation/Expansion	N/A		
Building Age	10		
Construction Type	II-B		
Building Construction	Load-bearing CMU, w/cold-formed metal trusses		
Building Area (SF):	~10,400 SF		
Number of Stories:	One		
Site Area (SF & Acres):	SF: ~59670	Acres: ~1.37	
Maximum Station Staffing Capability	5		
Seismic Protection <i>(if required)</i>	Y		
Category IV Conformance <i>(if required)</i>	N		
ICC 500 Conformance <i>(if applicable)</i>	N		
Hardened Space / Storm Shelter	<input type="checkbox"/> Yes	<input checked="" type="checkbox"/> No

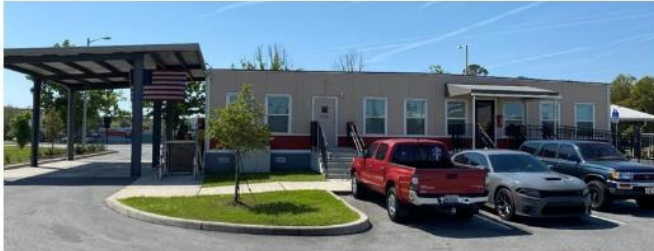
<b>STATION NAME/NO.:</b>	Fire Station #9 - Temporary Facility			
<b>STATION ADDRESS/LOCATON:</b>	4213 SW 30th Ave

<p><i>(Brief Description of station)</i></p> <p>The existing double-wide station is a temporary facility. The City has earmarked \$4.5 million for construction of new station. The proposed site for the new station may also include Fire Administrative and Department facilities. It is not known exactly where the new station should be built. Alachua County has an existing station in the general vicinity of the temporary station which they will abandon in the near future as the City grows.</p>				
<b>STRUCTURE</b>				
Date of Construction	2017			
Date(s) of Renovation/Expansion	-			
Building Age	4			
Construction Type	V-B			
Building Construction	Modular Prefabricated Units (2)			
Building Area (SF):	~2,480 GSF			
Number of Stories:	1			
Site Area (SF & Acres):	SF:	~32,040 GSF	Acres:	~0.74

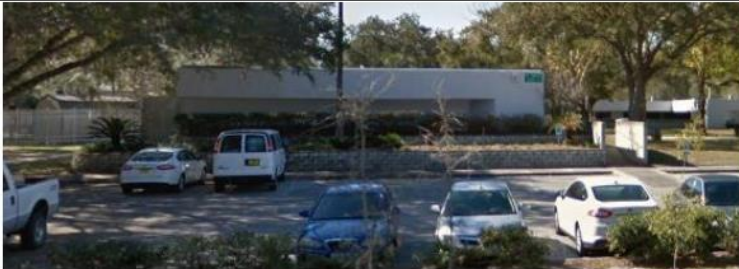
<b>STATION NAME/NO.:</b>	GFR Training (Building A)							
<b>STATION ADDRESS/LOCATON:</b>	1024 NE 14th Street

<p><i>(Brief Description of Facility)</i></p> <p>This facility is used by Gainesville FR for Community Resource Paramedic purposes. This facility is a re-purposed clinic. This facility provides community outreach services to Gainesville. As this building design is very introverted and oriented away from the public, it is not welcoming.</p>								
<b>STRUCTURE</b>								
Date of Construction	1976							
Date(s) of Renovation/Expansion	1993							
Building Age	45							
Construction Type	II-B							
Building Construction	Conc. covered masonry bearing walls w/ conc-topped metal decks							
Building Area (SF):	~3,000							
Number of Stories:	One							
Site Area (SF & Acres):	SF:	N/A	Acres:	3				
Maximum Station Staffing Capability	N/A							
Seismic Protection (if required)	Unknown

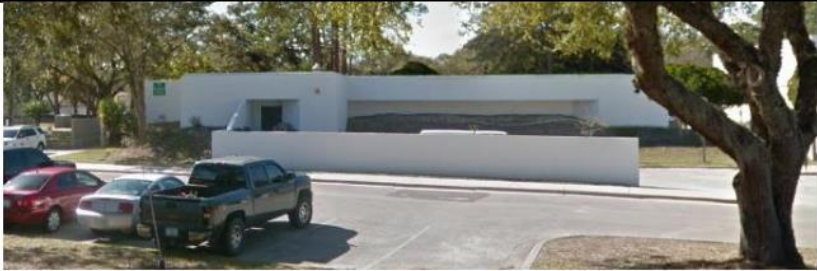
<b>STATION NAME/NO.:</b>	GFR Administration Annex (Building B)						
<b>STATION ADDRESS/LOCATON:</b>	1026 NE 14th Street

<p><i>(Brief Description of Facility)</i></p> <p>This facility is used by Gainesville FR for staff training purposes. This facility is a re-purposed senior center. The facility recently experienced a partial roof collapse making the facility partially unsafe and unusable. As GFR has no other options for housing training staff, the facility remains in use.</p>							
<b>STRUCTURE</b>							
Date of Construction	1976						
Date(s) of Renovation/Expansion	1993						
Building Age	45						
Construction Type	II-B						
Building Construction	Conc. covered masonry bearing walls w/ conc-topped metal decks						
Building Area (SF):	~4,800 GSF						
Number of Stories:	One						
Site Area (SF & Acres):	SF:	N/A	Acres:	3			
Maximum Station Staffing Capability	N/A						
Seismic Protection (if required)	Unknown

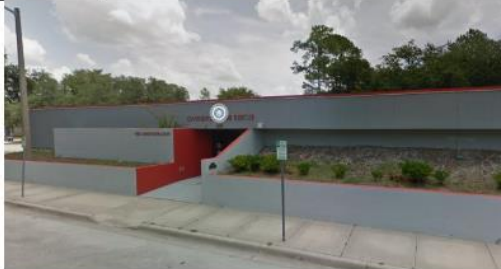
<b>STATION NAME/NO.:</b>		GFR Administration (Building C)				
<b>STATION ADDRESS/LOCATON:</b>		1025 NE 13th Street

<p><i>(Brief Description of station)</i></p> <p><i>This facility houses the Gainesville Fire Rescue Administrative and Operations Offices for the Department. This facility is commonly referred to as Bldg. 'C' of the Northeast Neighborhood Facilities Complex. This building is a re-purposed Day Care facility.</i></p>						
<b>STRUCTURE</b>						
Date of Construction	1976					
Date(s) of Renovation/Expansion	1993					
Building Age	45					
Construction Type	II-B					
Building Construction	Conc. covered masonry bearing walls w/ conc-topped metal decks					
Building Area (SF):	~6,884 SF					
Number of Stories:	One					
Site Area (SF & Acres):	SF:	N/A	Acres:	3/Complex Area		
Maximum Facility Staffing Capability	18					
Seismic Protection <i>(if required)</i>	Non-conforming					
Category IV Conformance <i>(if required)</i>	Non-conforming

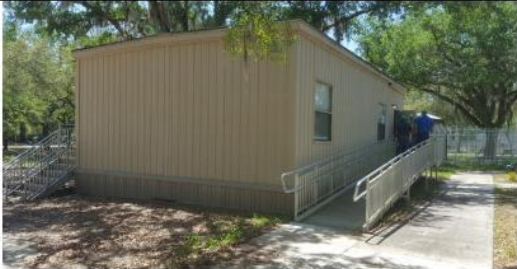
<b>STATION NAME/NO.:</b>	GFR Modular Training Classroom						
<b>STATION ADDRESS/LOCATON:</b>	1022 NE 14th Street

<p><i>(Brief Description of station)</i></p> <p>This facility is a dedicated, modular, classroom that was provided facilitate GFR fire training as a result of the partially collapsed roof over the classroom in Bldg. B. This facility is a self-contained classroom unit.</p>							
<b>STRUCTURE</b>							
Date of Construction	N/A						
Date(s) of Renovation/Expansion	N/A						
Building Age	N/A						
Construction Type	V-B (assumed)						
Building Construction	Prefabricated/modular units						
Building Area (SF):	~600 SF (estimated)						
Number of Stories:	1						
Site Area (SF & Acres):	SF:	N/A	Acres:	~3			
Maximum Station Staffing Capability	N/A						
Seismic Protection <i>(if required)</i>	Unknown						
Category IV Conformance <i>(if required)</i>	N/A						
ICC 500 Conformance <i>(if applicable)</i>	N/A

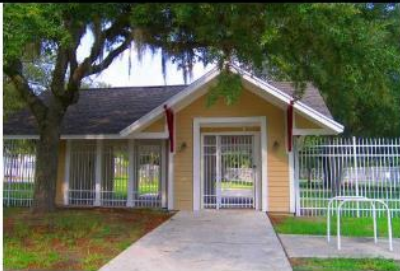
<b>STATION NAME/NO.:</b>		GFR Kiwanis Safety City				
<b>STATION ADDRESS/LOCATON:</b>		1025 NE 13th Street

<p><i>(Brief Description of station)</i></p> <p>Safety City is a campus of structures that was provided to the City to provide both recreational as well as educational opportunities for school-age children. This fenced campus, provides demonstrational and situational education encompassing Fire Safety to Police Safety in a secure, outdoor setting.</p>						
<b>STRUCTURE</b>						
Date of Construction	Unknown					
Date(s) of Renovation/Expansion	N/A					
Building Age	N/A					
Construction Type	V-B					
Building Construction	Wood Frame Structures					
Building Area (SF):	Varies					
Number of Stories:	1					
Site Area (SF & Acres):	SF:	~400,000	Acres:	~3.7A		
Maximum Station Staffing Capability	N/A					
Seismic Protection (if required)	N/A					
Category IV Conformance (if required)	N/A
