609 NE 6th St.

Materials to be utilized will visibly match with the neighborhood and historic design of the original home.

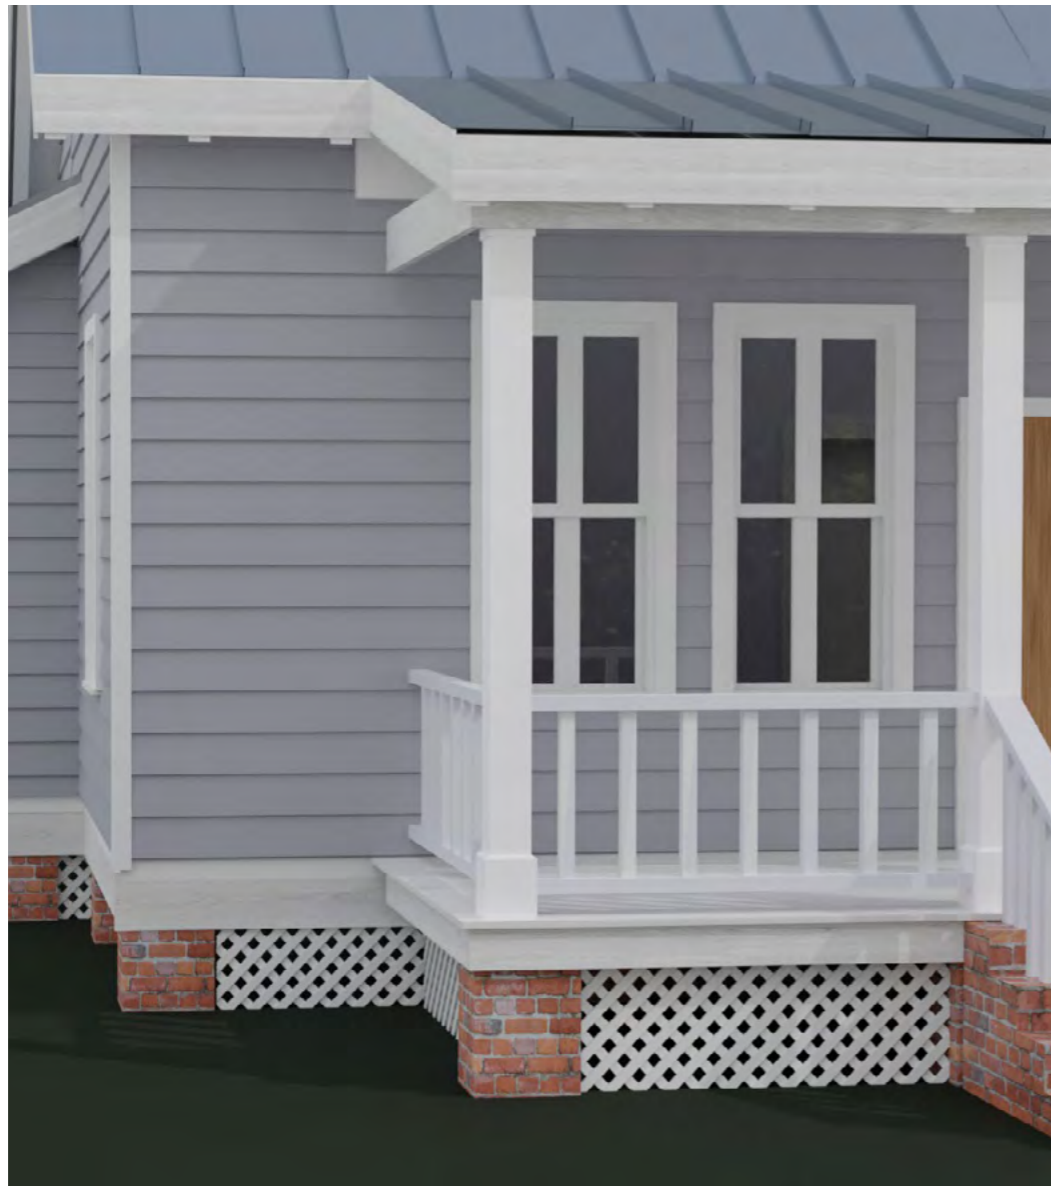
Conceptual rendering of front porch showing lap siding finish material:

The front porch will be rebuilt with reclaimed brick piers and stairs, and painted wood skirting, posts and newel, and balustrade.

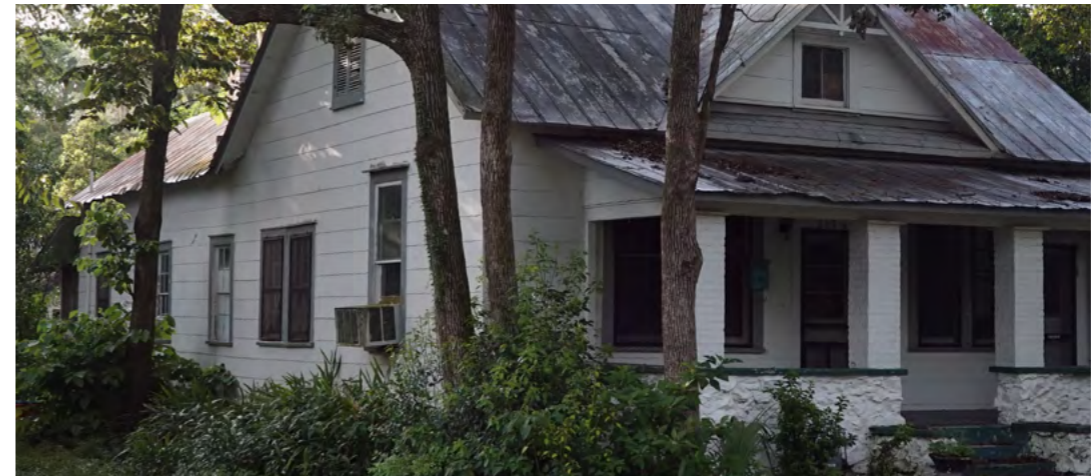
Photo of original structure with lap siding and metal roof:

The materials used in the original home will remain true with wood grain lap siding exterior and double hung windows with a metal roof.

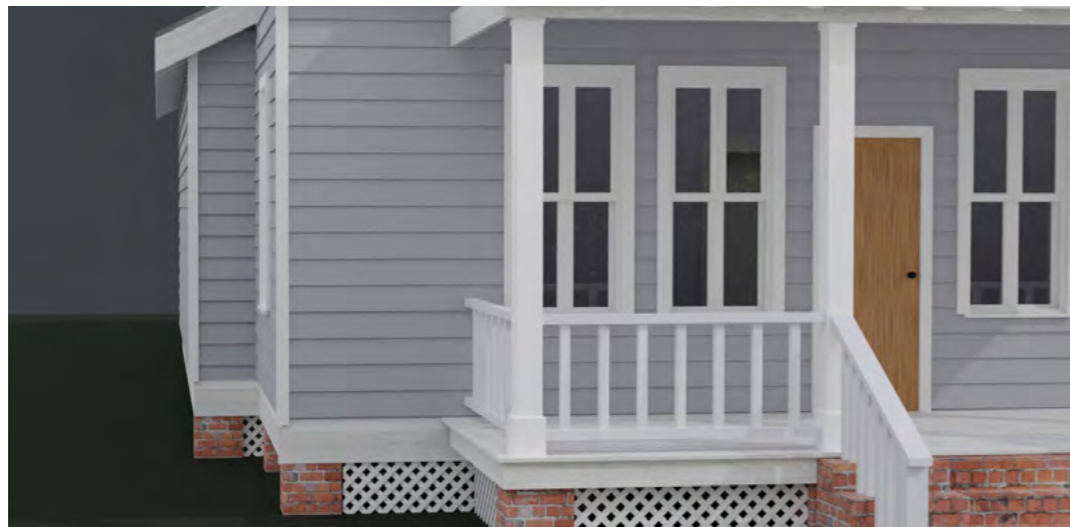
Conceptual rendering of the house:

- Metal standing-seam roof
- Painted wood grain lap siding
- Reclaimed brick stairs/piers, walkway

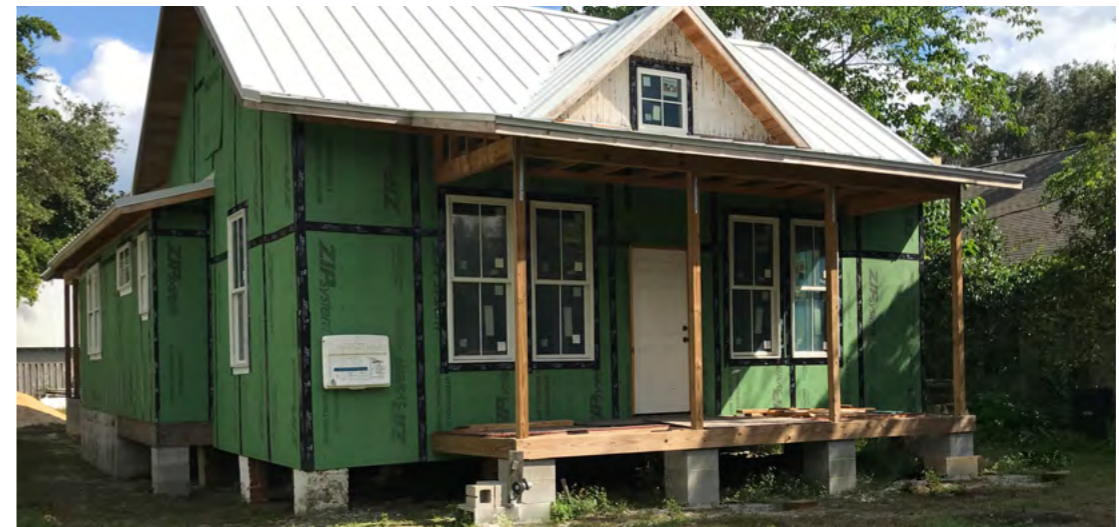
Photo of current stage of renovations:
