MULTIFAMILY RETROFIT DEMONSTRATION PROJECTS DATA ANALYSIS REPORT

Florida Department of Agriculture and Consumer Services
Adam H. Putnam, Commissioner

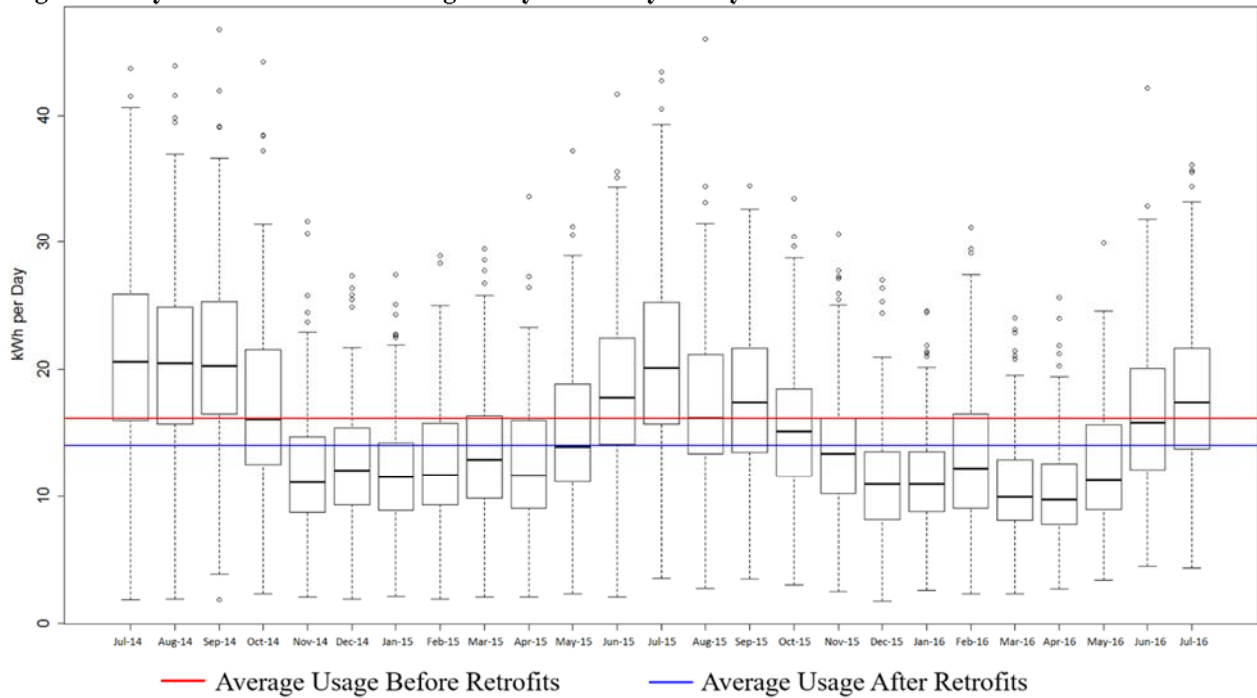
Figure 1: Crystal Lakes Manor Average Daily Electricity Use by Month⁷

Analysis shows that the retrofits project was successful in lowering the electricity consumption throughout Crystal Lakes Manor. Prior to retrofits, average electricity consumption throughout Crystal Lake Manor was 16.15 kWh per day per unit. This fell in the year after retrofits to an average of 13.99 kWh per day per unit. This change shows overall daily electricity use throughout Crystal Lake Manor decreased 13.34 percent from the year before to the year after retrofits (Figure 1).

⁷ In this box-and-whisker plot, each box represents a month of electricity use data, and the line in the middle represents the average. Half of the observations are contained within the box. Flat line 'whiskers' represent the minimum and maximum, while dots outside the whiskers represent outliers.

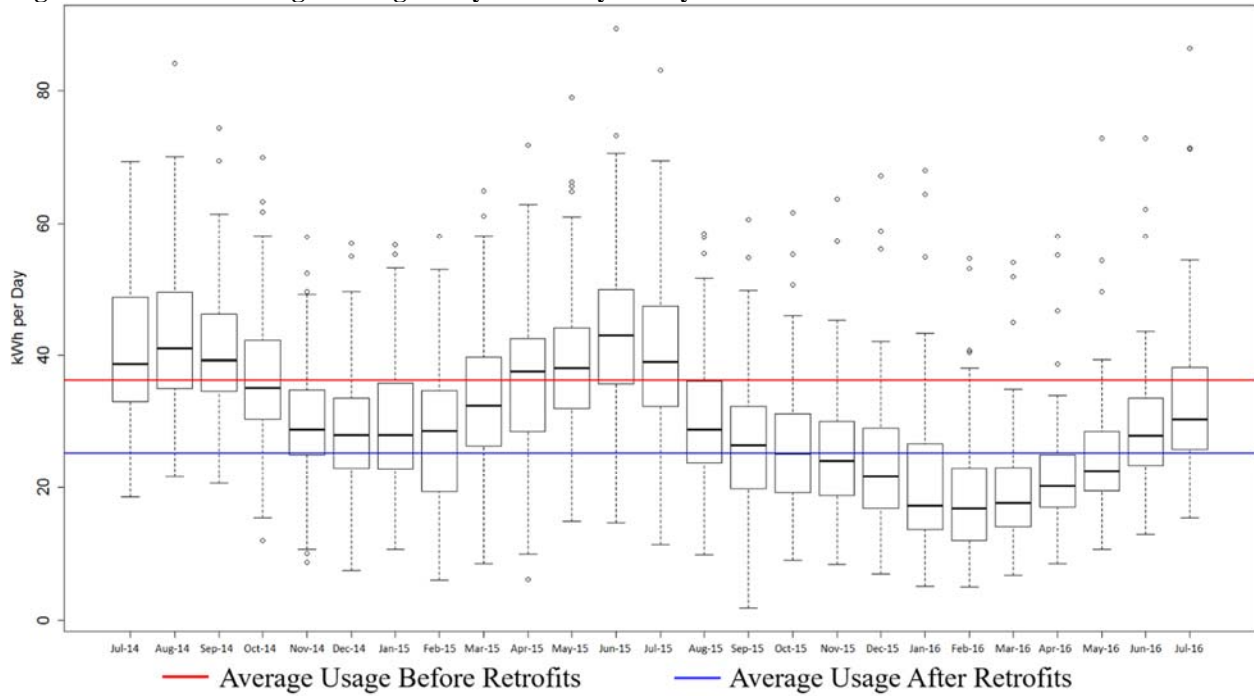
Figure 2: Robinson Village Average Daily Electricity Use by Month⁸

The analysis shows that the Retrofit Demonstration Project was successful in lowering the electricity consumption throughout WPBHA. Prior to retrofits, the average electricity consumption throughout Robinson Village was 36.25 kWh per day per unit. This fell to an average of 25.24 kWh per day per unit in the year after retrofits, which is a 30.4 percent decrease of overall daily electricity use throughout all Robinson Village units from the year before to the year after retrofits (Figure 2).
